## Activation of ballistic airframe parachute: cognitive, emotional and physical mechanisms

### Appendix: Statements from pilots who activated a ballistic airframe parachute between 2015 and 2022

## 1 ACCIDENT TO THE AIRLONY SKYLANE IDENTIFIED 54AXD ON 9 JULY 2022 AT BOUEE

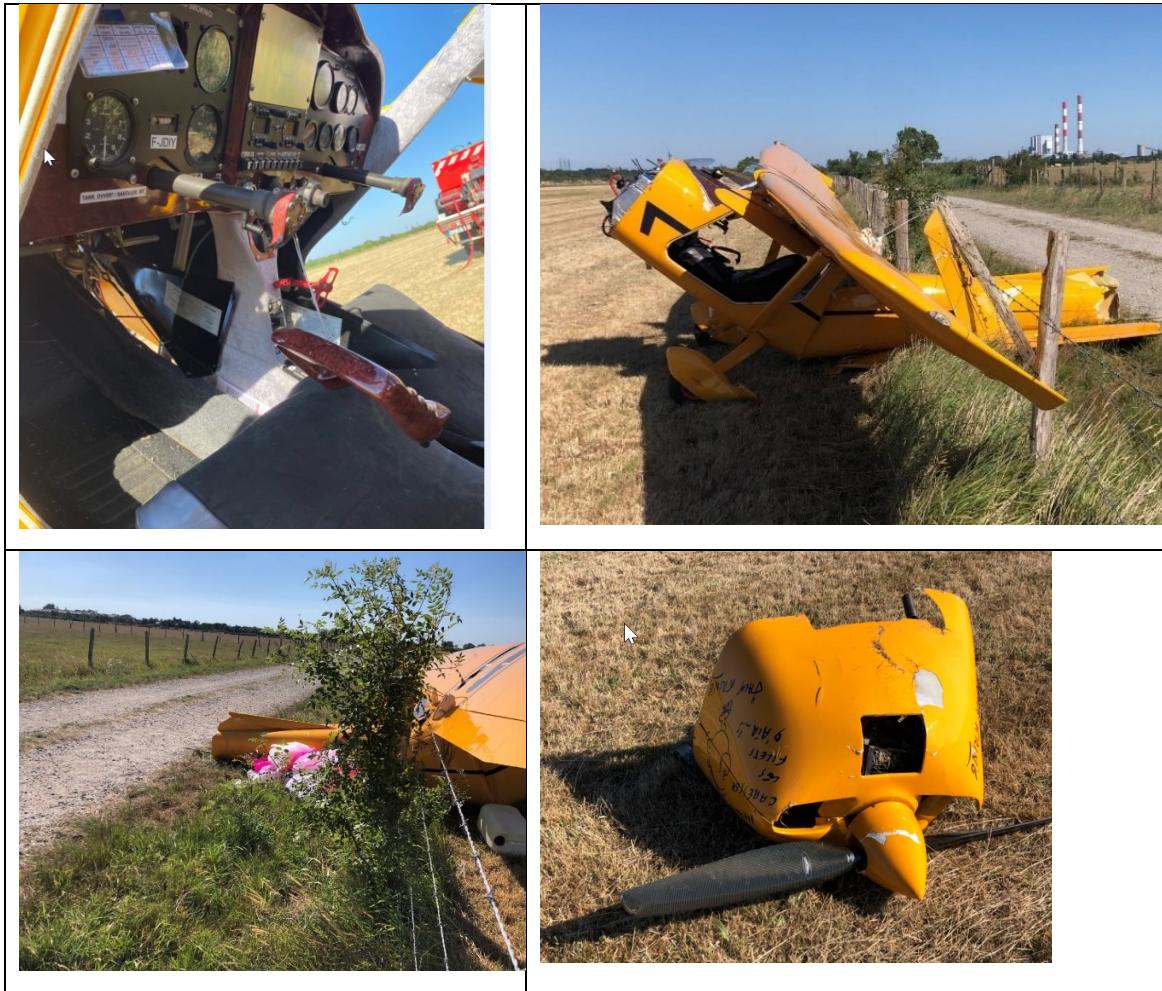
The pilot tried to regain control but the control wheel ruptured. He then tried to pilot with what remained of the tube and then with the wheel on the passenger's side. This wheel also ruptured (see **Figure 1**). He stated that at this point he was in a spin heading towards the ground at a nose-down angle of 45°. Below him, he saw that the field was very close and activated the ballistic airframe parachute.

Figure 1: wreckage of microlight: ruptured wheels, airframe with parachute, separated engine mount

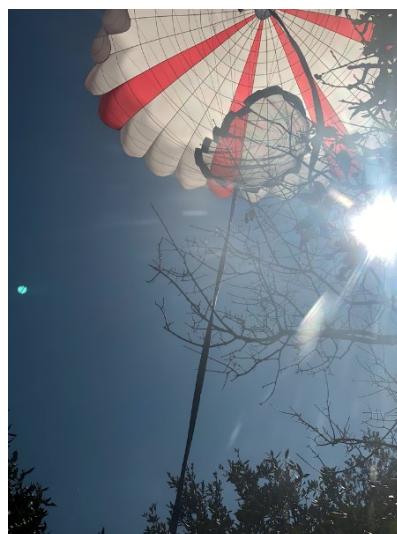
After landing, the parachute remained inflated and pulled the microlight upwards.

Figure 3: photo of parachute taken from microlight

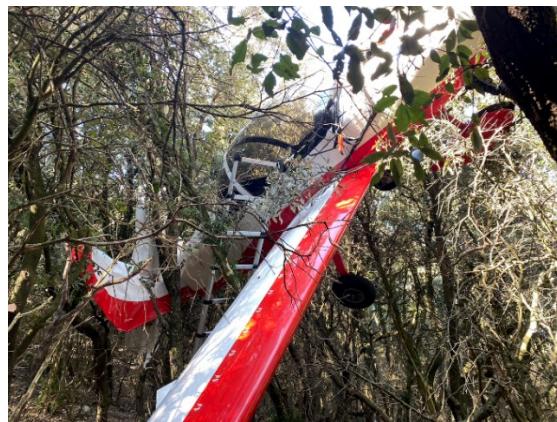
middle of the instrument panel. The microlight was substantially damaged and could not be repaired. The pilot did not find bird impact marks on the wreckage.

Figure 4: accident microlight in trees (source: pilot)

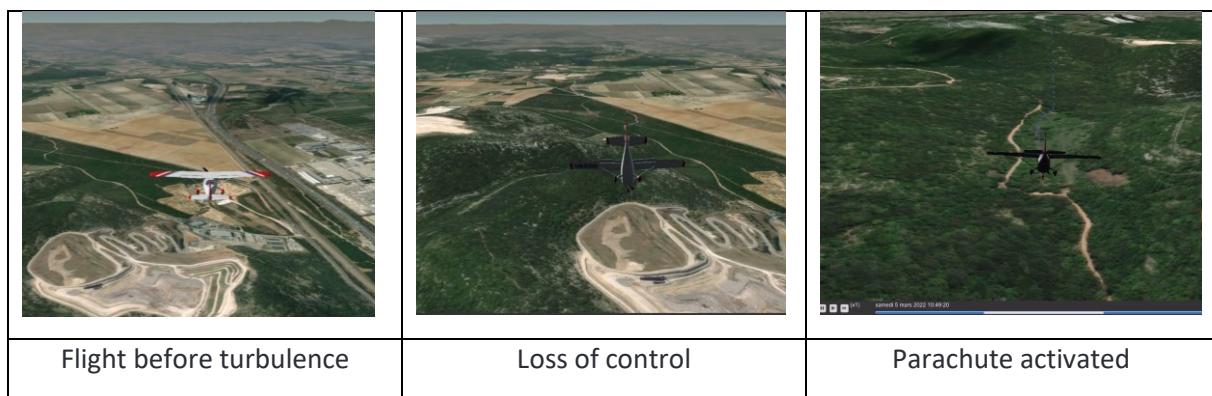
The video provided by the pilot seems to show that there was an interval of around 40 s between the manoeuvre to avoid the storks at a height of 1,800 ft and the collision with the ground.

Figure 6: images of flight in NeuroSky

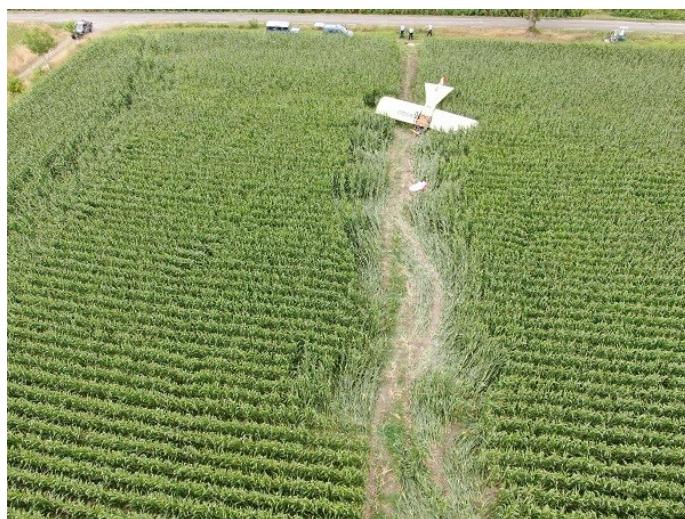
He heard the explosion of the ejection rocket. He explained that he had hardly had the time to raise his head to look at the parachute before the microlight was on the ground. He had not had time to cut off the engine. He struck his nose on the instrument panel. On the ground, the microlight turned over and was dragged over several dozen metres by the effect of the wind on the parachute. The pilot managed to exit the microlight.

Figure 8: microlight dragged through the field by the parachute

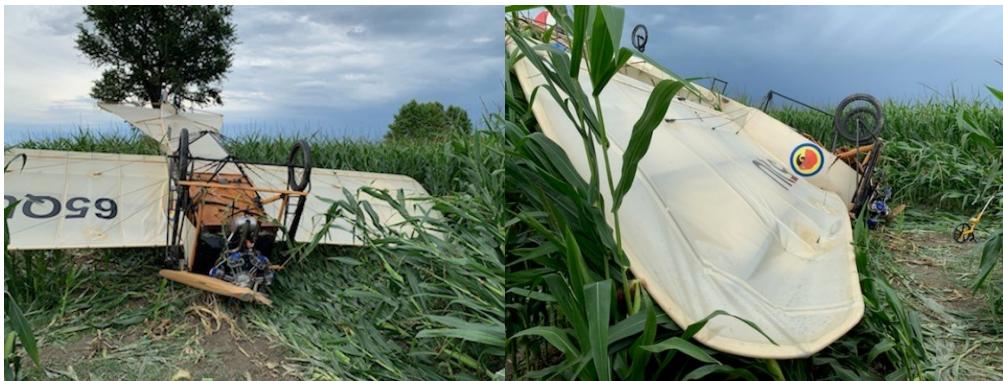
Figure 9: microlight on its back

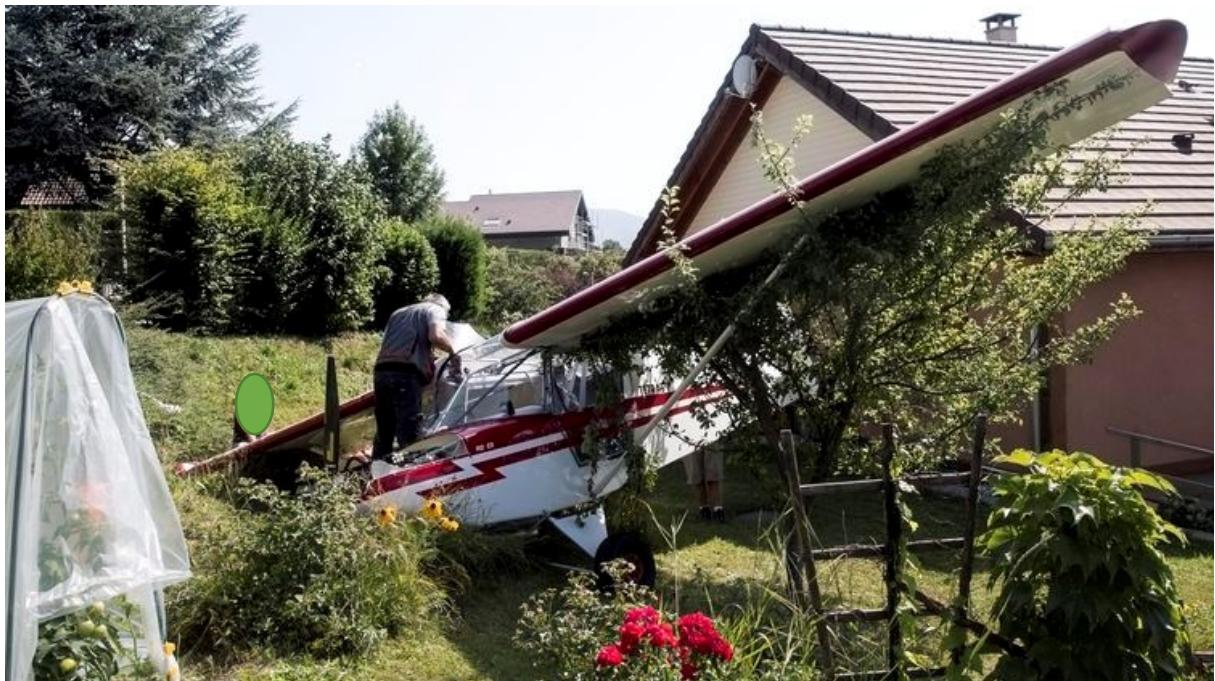
During the fall, the microlight adopted a steep nose-down attitude. The impact was less violent than the opening of the parachute. The left-hand wing struck a tree and the right-hand landing gear ruptured.

Figure 10: accident Tetras 74-AJA in the garden (source: pilot)

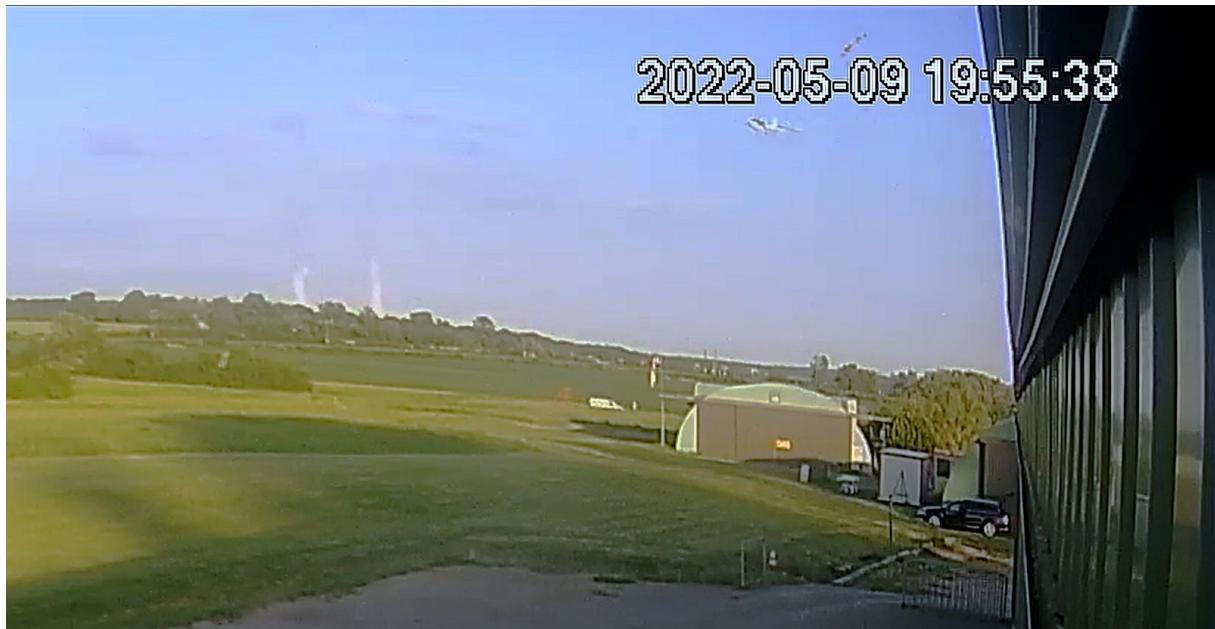
Figure 13: activation of ballistic airframe parachute

The parachute was activated at 19:55:38, and the impact with the ground was at 19:55:43, i.e. approximately five seconds later.

The height at which the pilot activated the parachute was very probably below the height recommended by the manufacturer. For a stabilized flight with the aircraft upright, the manufacturer specifies a deployment height of around 40 m<sup>4</sup>.

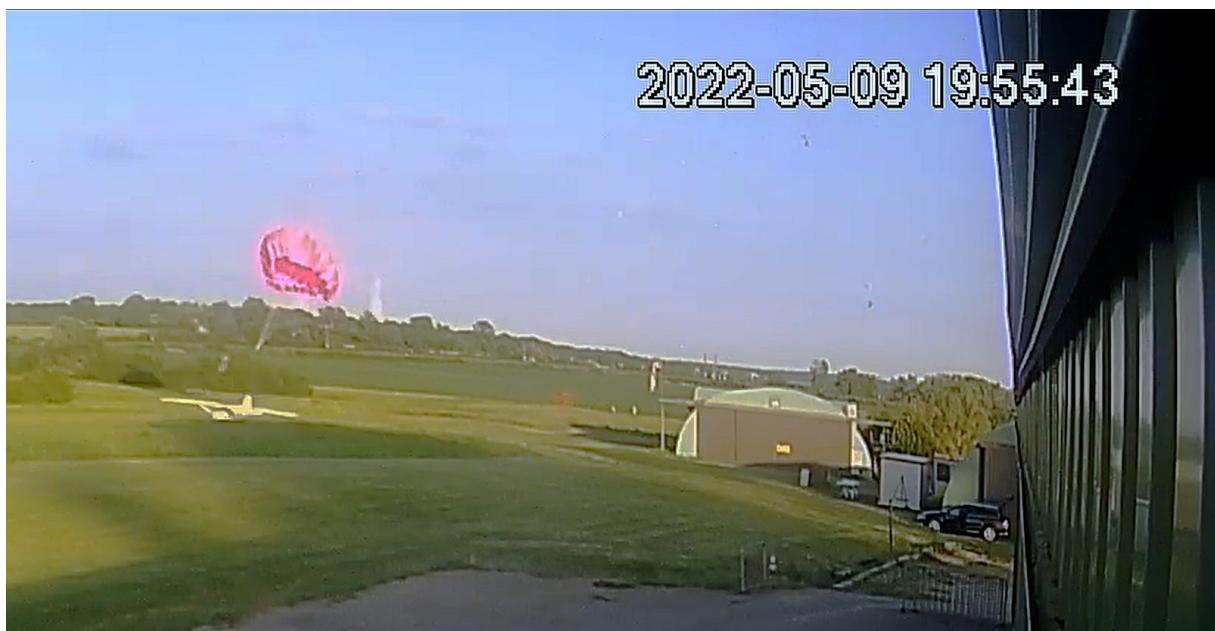
Figure 14: collision with ground

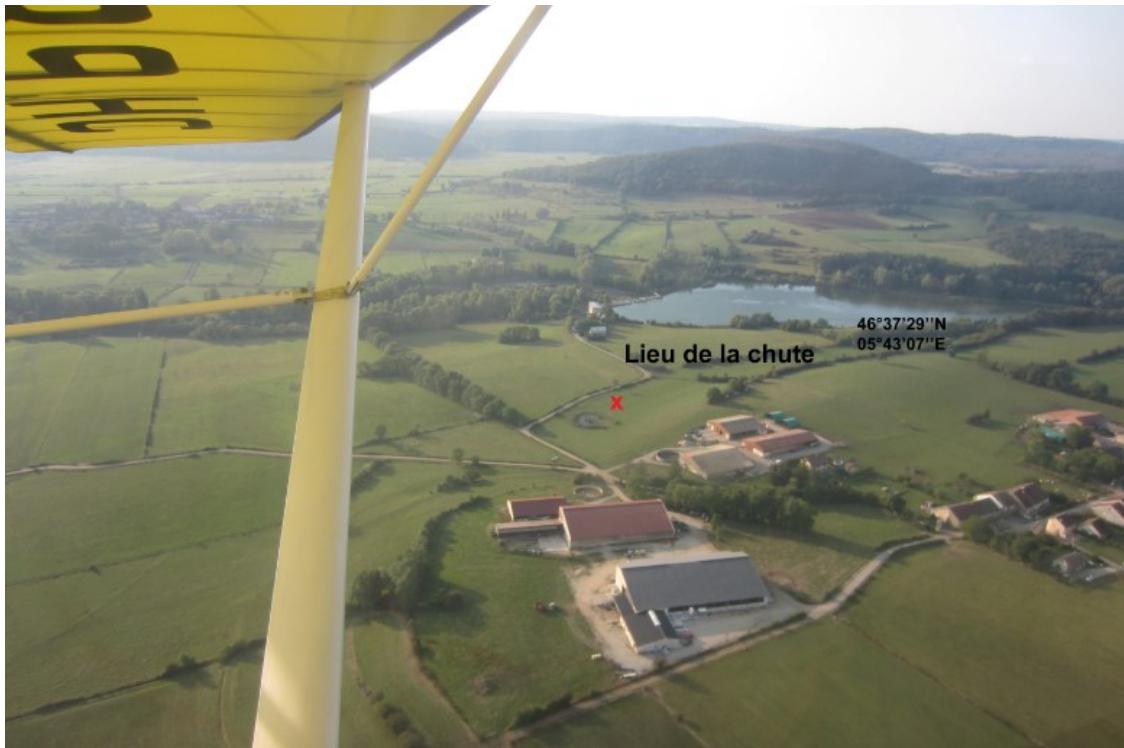
Figure 16: area of impact (source: photo taken by pilot)

After the accident, the pilot noticed that the pin was missing from the right-hand wing. He explained that during the walk-around inspection, he first unfolded the left-hand wing and inserted the pin. Then after unfolding the right-hand wing, he received a message on his telephone and broke off the inspection to go into the hangar. When he came back to the microlight, he saw the right-hand wing unfolded and forgot he had not inserted the pin. He explained that in flight, during a sideslip manoeuvre, the right-hand wing folded and the microlight pitched down in a spin towards the ground.

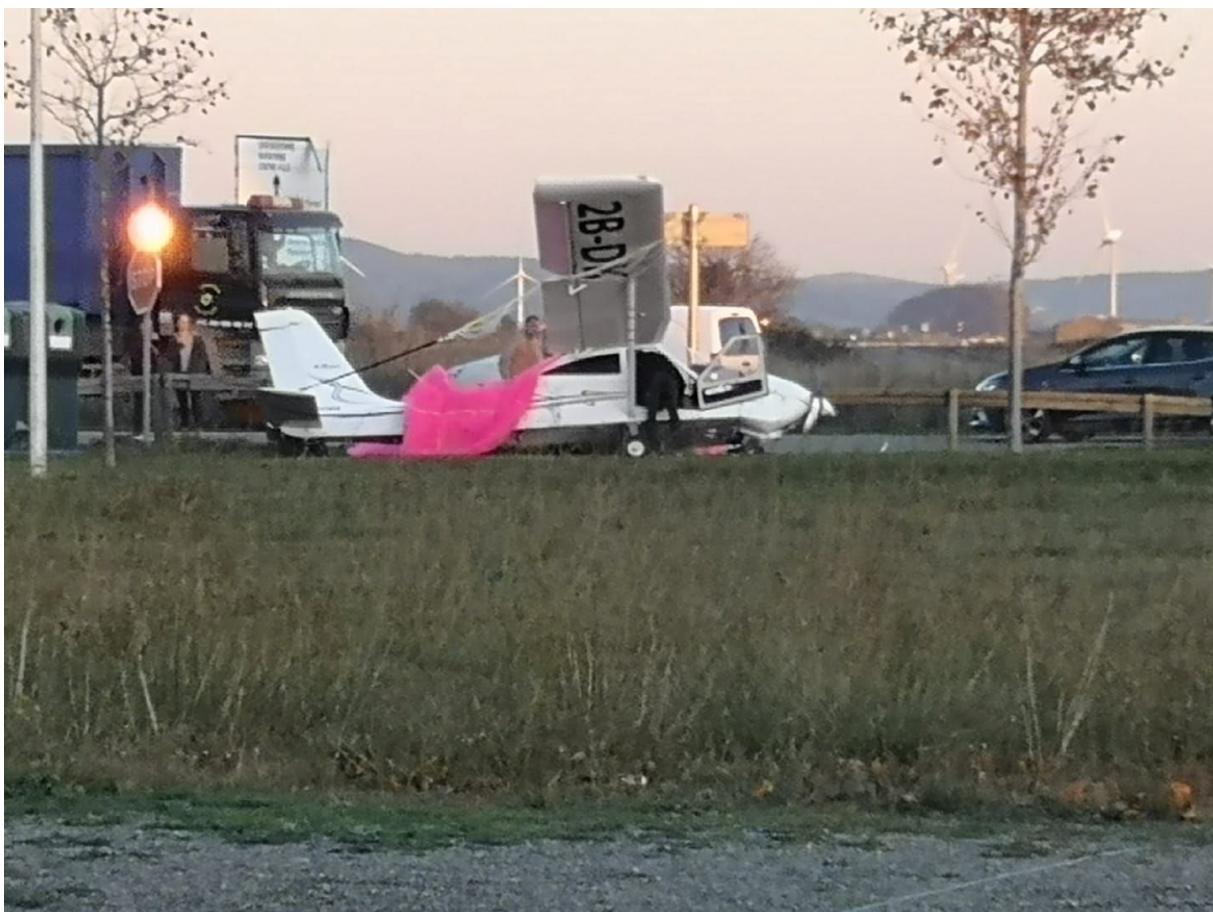
The pilot was carrying out a local flight from Lézignan-Corbières aerodrome. Observing that the weather conditions were deteriorating, he returned to the departure aerodrome. He stated that between the downwind leg and the base leg, he experienced a downdraft which tipped the microlight by 90° to the right-hand side. The microlight stabilized. Just after this, the engine spluttered and shut down and the propeller stopped. The pilot managed to restart the engine but it shut down again. He noticed that while he was trying to restart the engine, he had extended the downwind leg and exceeded the base leg. He understood that he would not be able to reach the aerodrome and chose a field to land in. He explained that he arrived too fast and too high, he pitched up to slow down but this was not sufficient. He indicated that he activated the parachute at a height of 30 ft. He explained that the deployment of the parachute slowed down the microlight and gave it a nose-down attitude. The nose rose before the microlight struck the ground. The microlight struck a sign and came to a stop on the shoulder of a road.

Figure 17: 2BDK after activation of the parachute (source: Raynald Cornart, [L'indépendant](#))
