Study BEA

Piston engine induction system icing

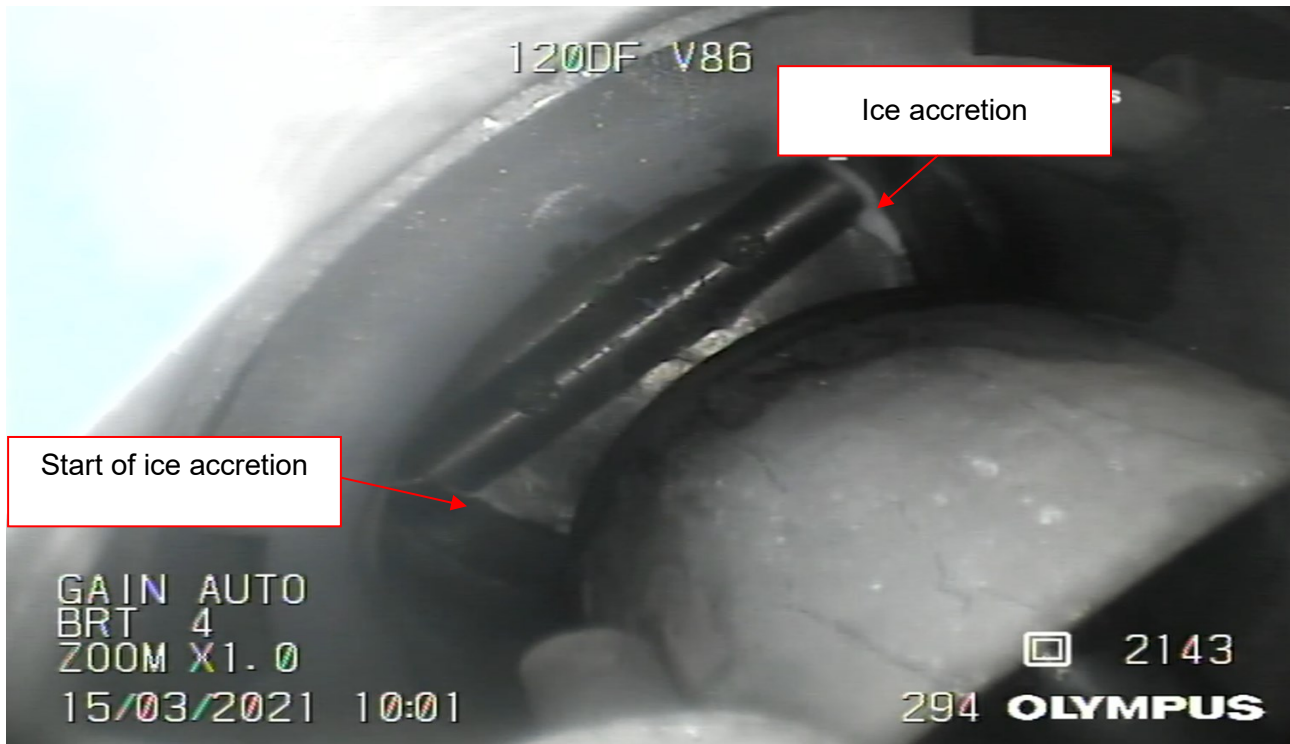
Ice gradually built up in the aforementioned zone. In addition, ice started to form on the other side of the butterfly valve. The figure below shows the situation at $t_0 + 2 \text{ min}$ (**Figure 104**). At this time, no modification of the engine speed and the EGT was observed.

Figure 104: progress of icing => time designated $t_0 + 2 \text{ min}$
Source: BEA

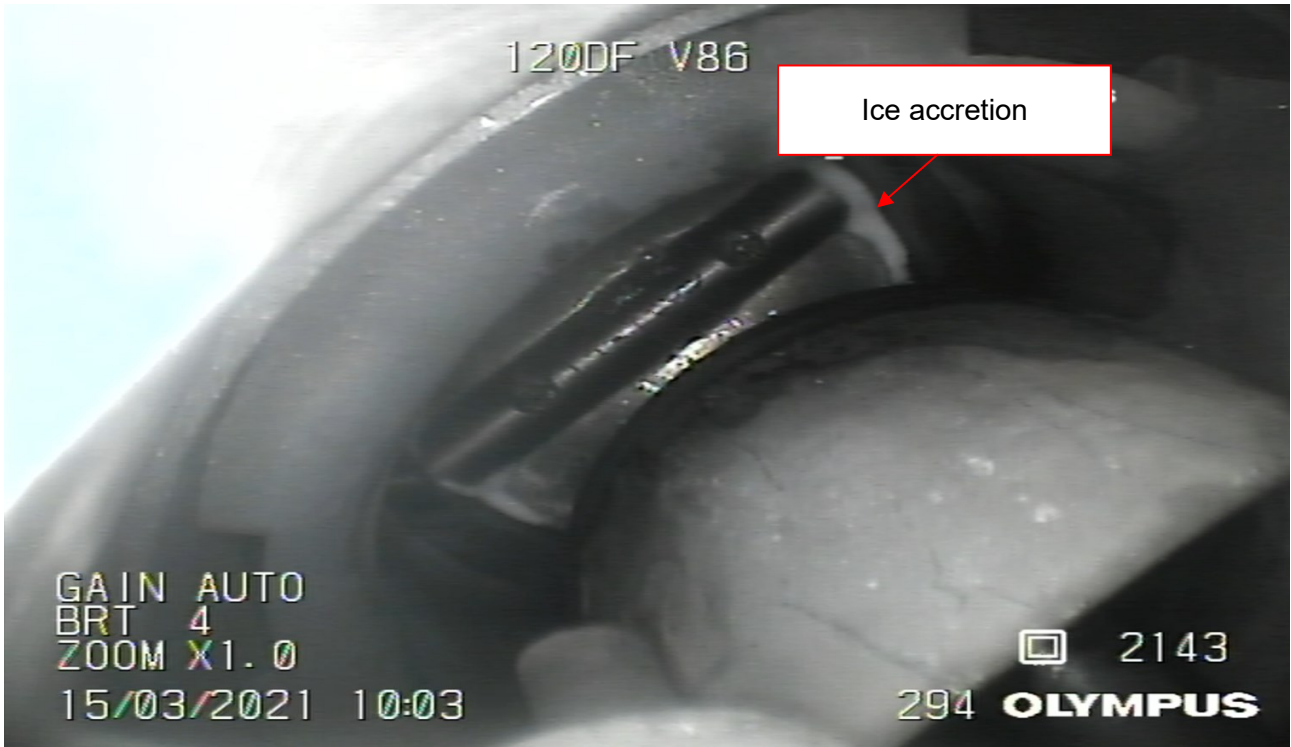
The formation of ice does not seem to follow a linear growth. Indeed, we note the amount of ice formed in the time period $[t_0, t_0 + 2 \text{ min}]$ is lower than that formed in the time period $[t_0 + 2 \text{ min}, t_0 + 4 \text{ min}]$ (**Figure 105**).

Figure 105: progress of icing => time designated t_{0+4min}
Source: BEA

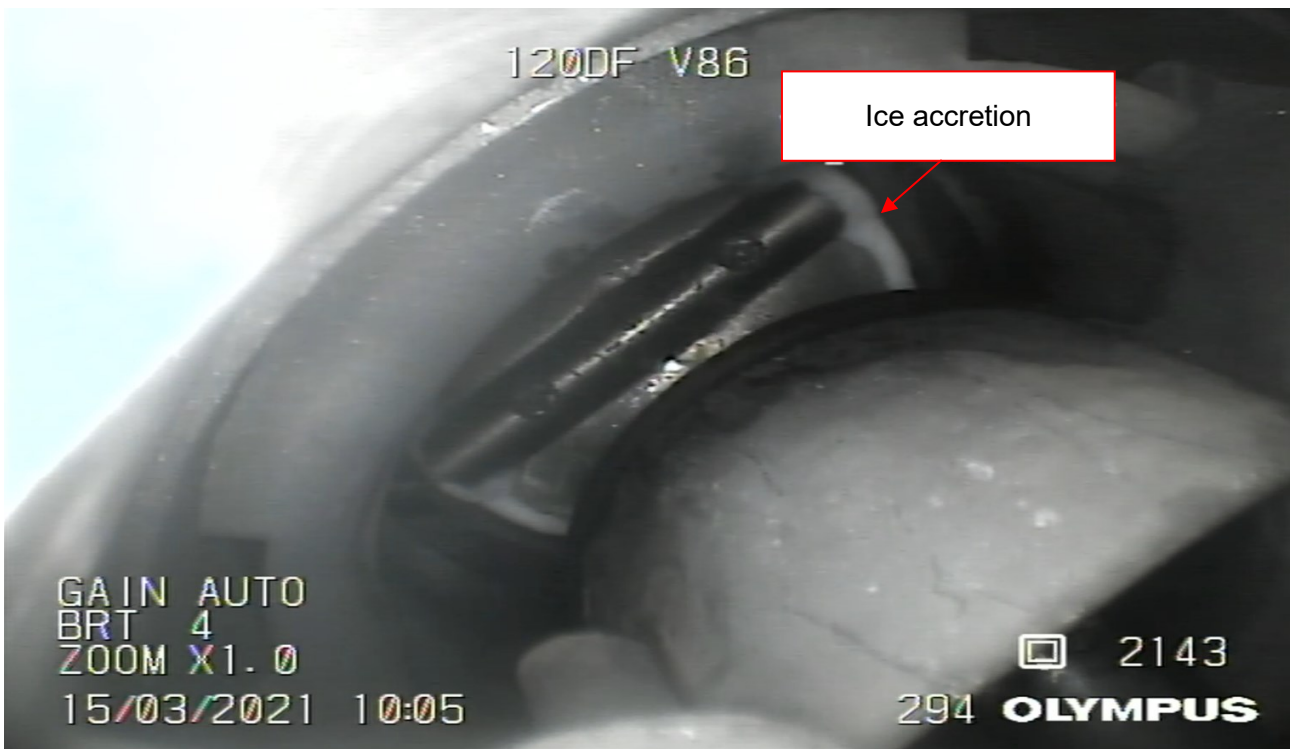
A very slight decrease in engine speed of around ten revolutions was observed at $t_0 + 5 \text{ min } 43 \text{ s}$ (Figure 106). The decrease in engine speed reached around 50 to 60 rpm at $t_0 + 16 \text{ min}$ (Figure 107).

Figure 106: progress of icing => time designated $t_0 + 5 \text{ min } 43 \text{ s}$.
Source: BEA

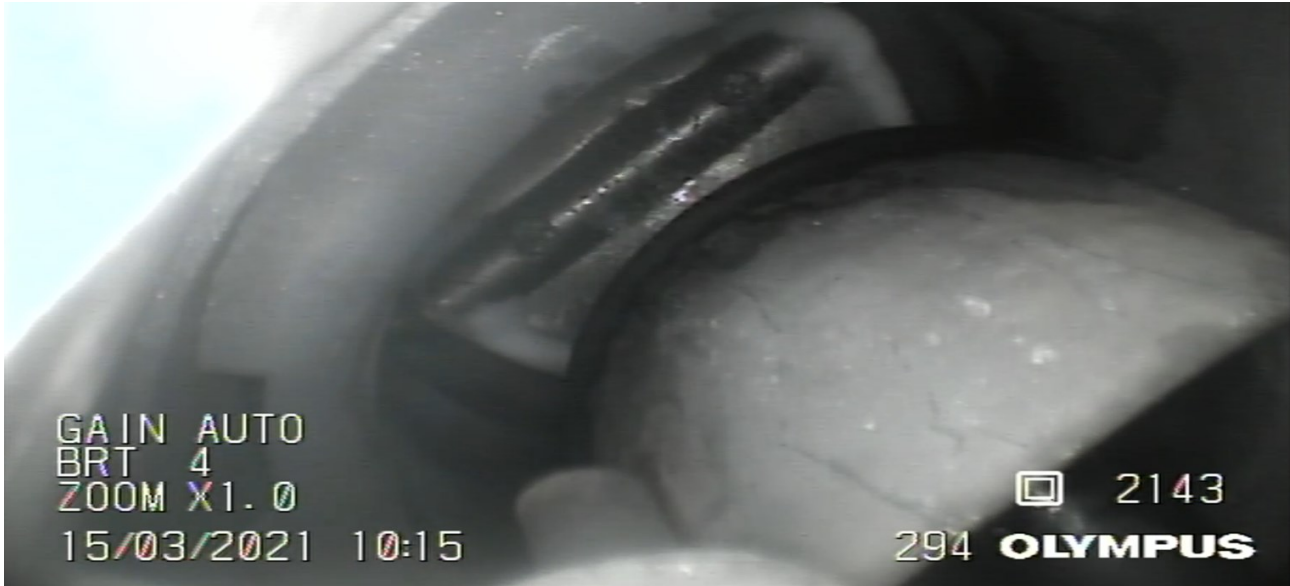
- The temperature of the outer surface of the carburettor increased from 5°C to 8°C during this time period.
- The temperature downstream of the butterfly valve rose from -4.5°C to -2°C.

Figure 107: progress of icing => time designated $t_0 + 16\text{min}$
 Source: BEA

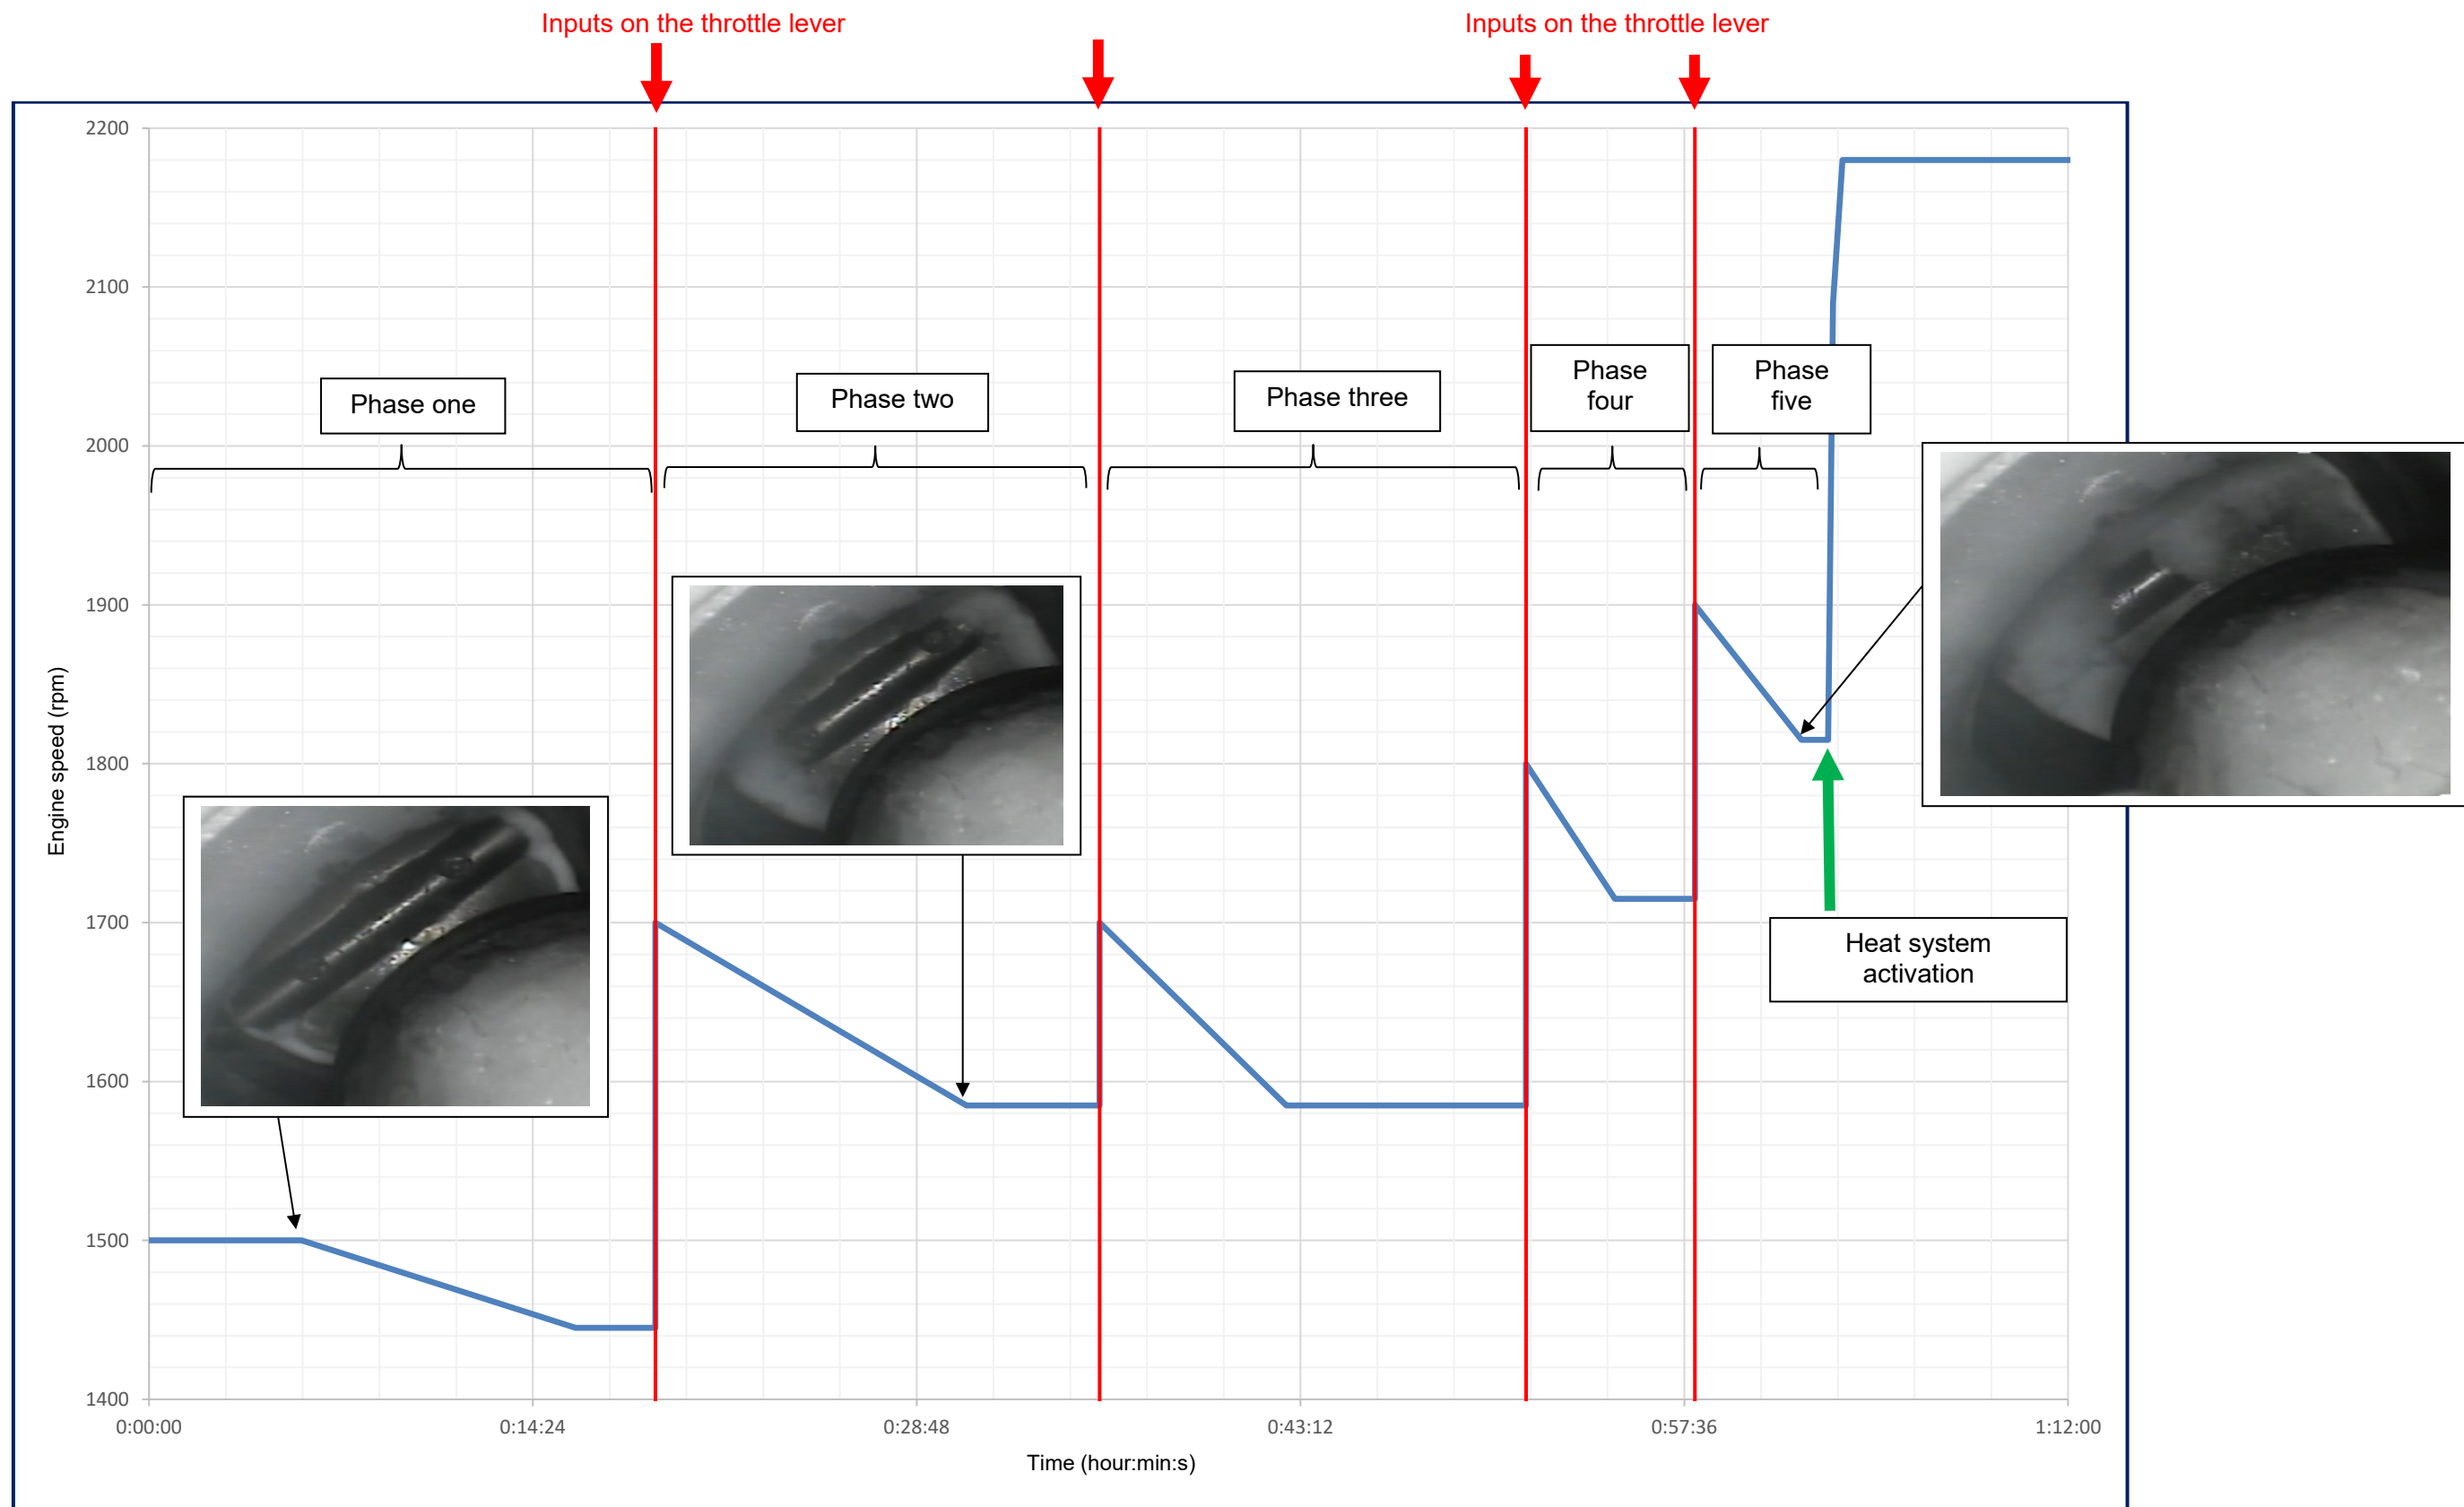
Figure 120: variation in engine speed during the 1st identified occurrence of icing
 Source: BEA

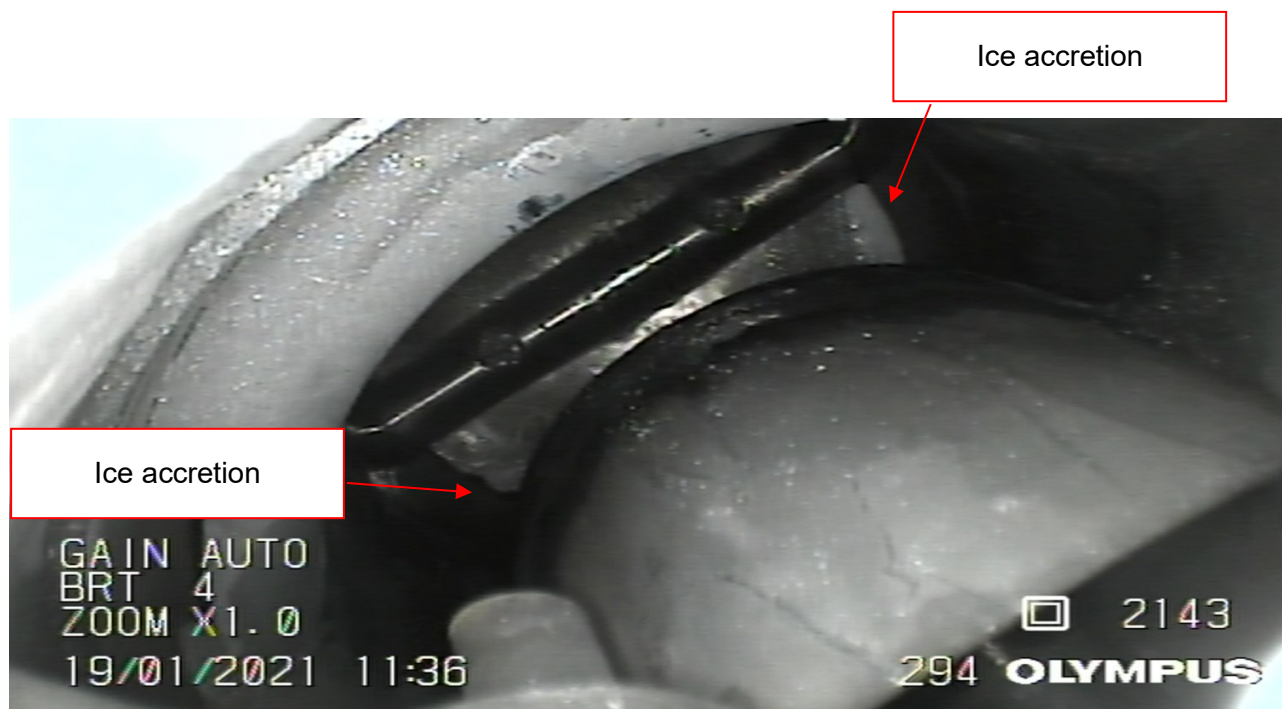
Figure 121: ice present on the edge of the butterfly valve
Source: BEA
