## **FOREWORD**

*This report presents the conclusions reached by the BEA on the circumstances and causes of this accident.*

The aircraft took off from Geneva Cointrin Airport bound for Bordeaux Mérignac at 7 h 42 and reached cruise level 200 at 8 h 24. At 9 h 03, as he had just started the descent, the pilot reported an engine failure. He decided to continue on track to the destination. He later informed Air Traffic Control that he could not feather a propeller. The aircraft continued to descend. At 9 h 29, the aircraft crashed into a field and caught fire.

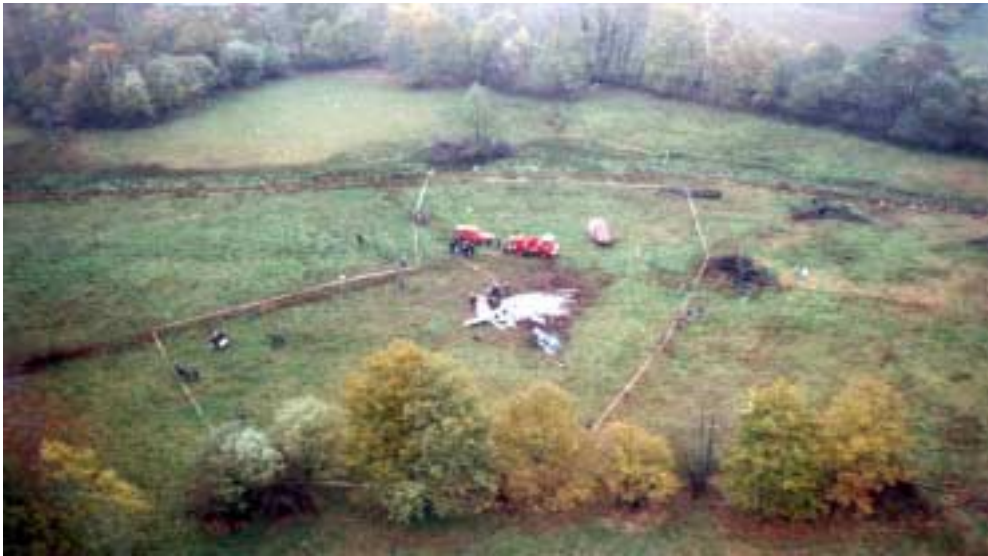
Three craters were visible in the loose earth and peat:

- the first contained a part of the right wing, the RH engine and propeller. It was 1.90 m long, 1.50 m wide and 0.75 m deep,
- the second was one meter deep and contained the nose of the aircraft and part of the cabin,
- the third was from 0.70 to 0.80 m deep and contained the LH engine and propeller.

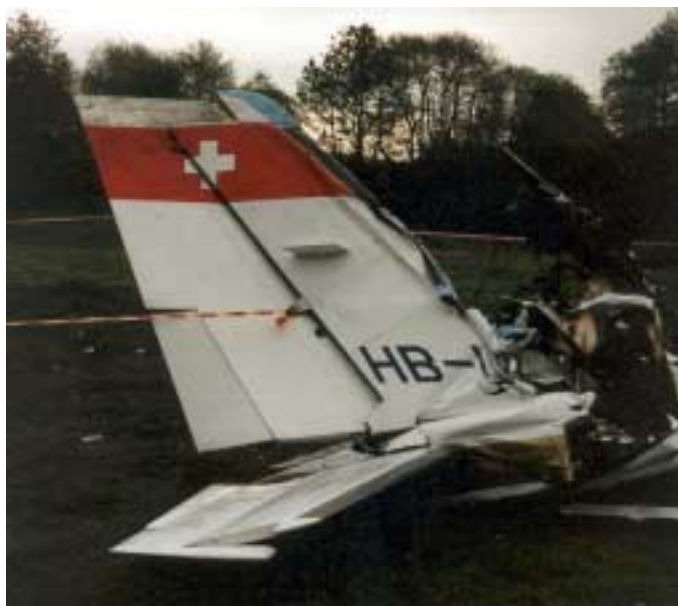
Due to the opposite deflections of the elevator and the rudder trim, the latter was subjected to an additional inspection to determine the direction of deflection before impact. Both cables of the trim mechanical actuator drive control line were broken in static traction. The attachment link of the right strand was at stop on the toothed pinion. The trim line was unwound on the side of the left cable. The toothed pinion bore marks between the linking teeth resulting from stresses greater than those encountered in service.

These observations are helpful in understanding the rupture sequence. On rotation of the aircraft's tail to the left, the trim cables were pulled. The right cable broke first, pulled to the left by the overall movement. The line was blocked against the pinion when the right cable attachment came into contact on the pinion. The stress created by traction of the cable broke the line. When the latter broke, the trim positioned itself mechanically on the left stop. This deflection thus resulted from the impact.

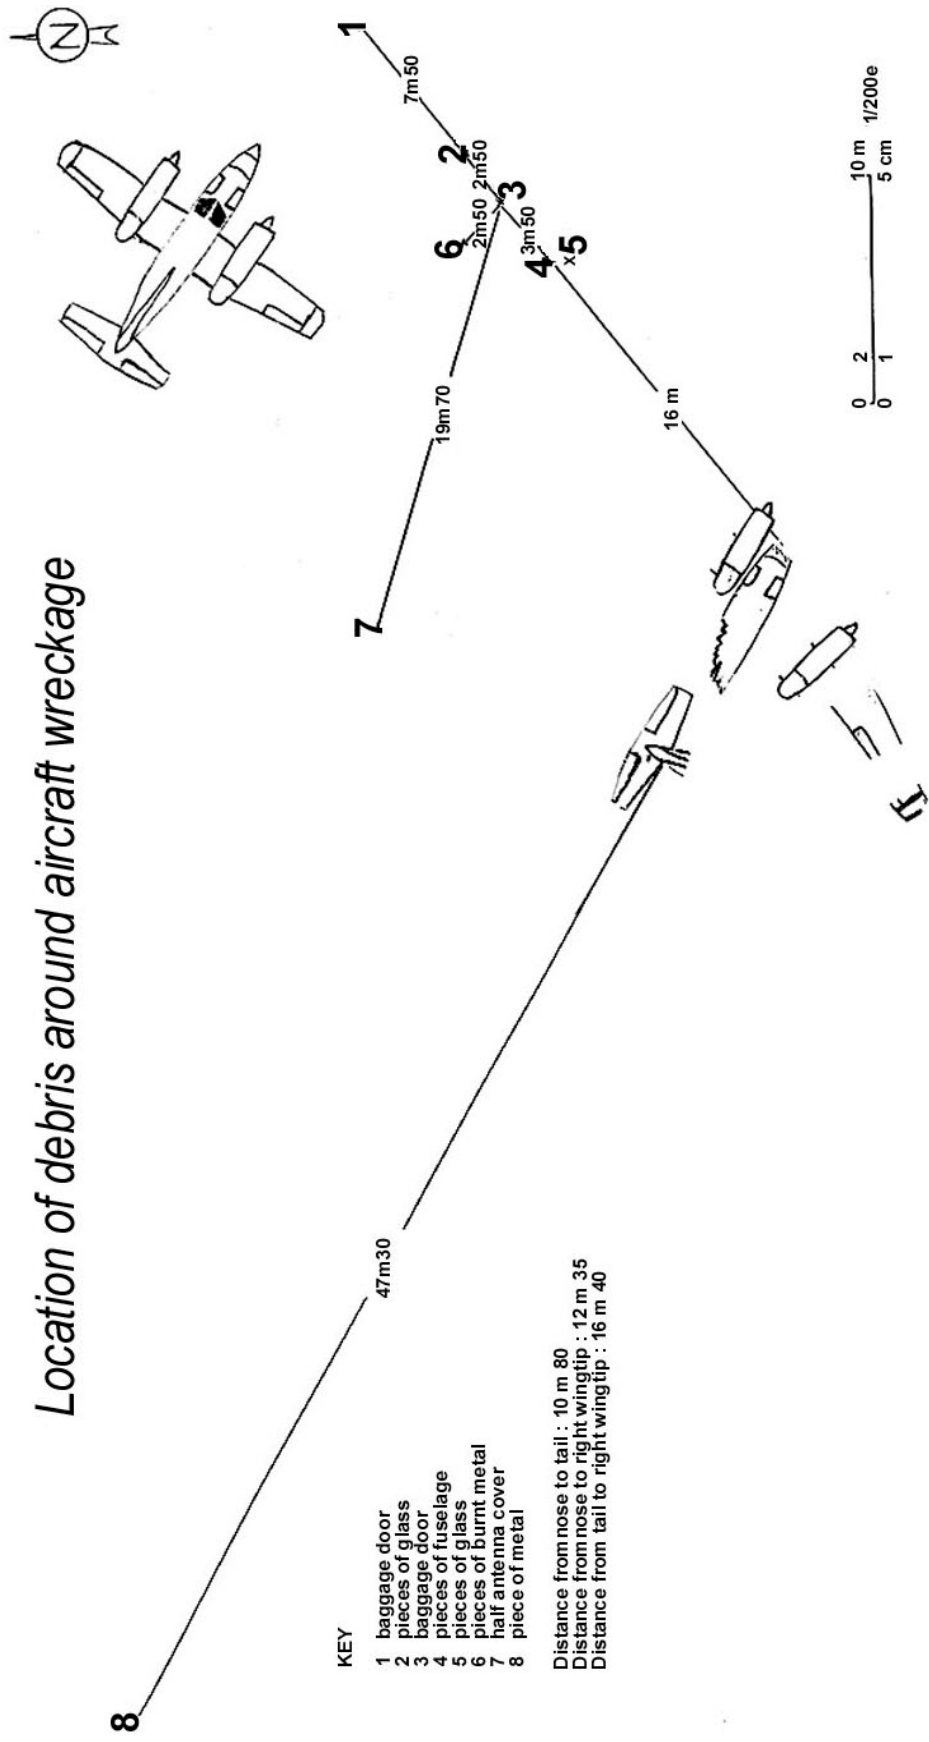
# Location of debris around aircraft wreckage

The accompanying sketch represents the distances and the orientation of marks on the ground observed on the site (main magnetic orientation 130°). The nose of the aircraft was driven deeply into the ground. The traces left by the end of the RH wing and the relative position of the wing tip in relation to the rest of the wing indicate that the aircraft hit the ground with a slight tilt to the right.

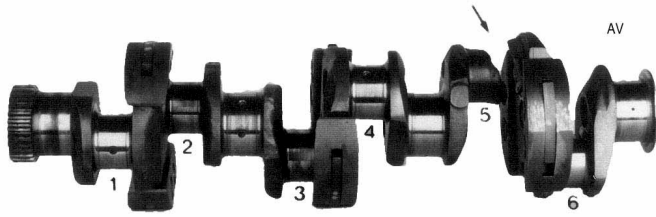
**METALLURGICAL EXAMINATION**

Removal of the cylinders showed complete rupture of the crankshaft on rod journal No. 5 and connecting rod No. 5.

Rod journal No. 5 suffered a fatigue rupture. The rupture observed on rod journal No. 5 had an oblique plane going from the fillet and ending towards the middle of the cylindrical bearing surface. The orientation of the rupture lines, which were extremely pronounced, show that the area where this crack started was located in the rod journal fillet on arm M5/M6. On either side of the rupture, the area where the crack started was completely obliterated. Traces of friction show that jamming of the engine shaft was not immediate and thus that the engine was running after the rupture. It is, however, difficult to evaluate this operating time.

View of ruptured crankshaft

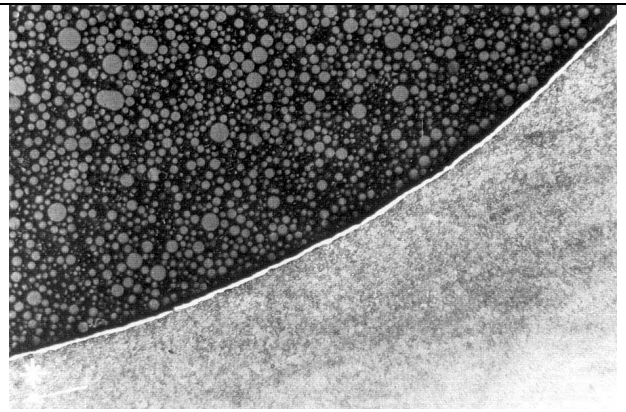
Rod journal No. 5 : Nitride layer in middle of fillet

A micrographic cross-section made in the fillet of rod journal No. 5 showed that the thickness of the nitride layer, allowing the surface to be hardened, gradually diminished as it got closer to the rupture. Another crosssection made on rod journal No. 3, which was in good condition, also showed that the nitride layer only kept its original thickness on the two fillets. The nitride layer even disappears towards the arm cheek.

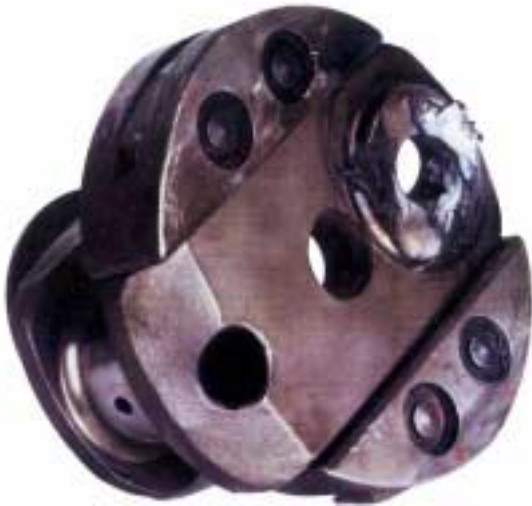
Face of rupture near M5/M6 arm

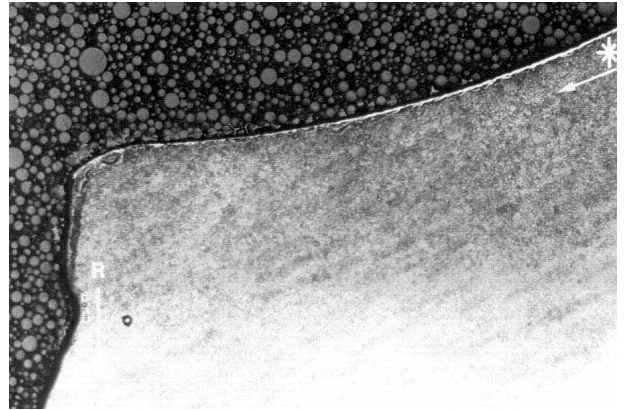
Rod journal No. 5 : Thin white layer near the rupture ©

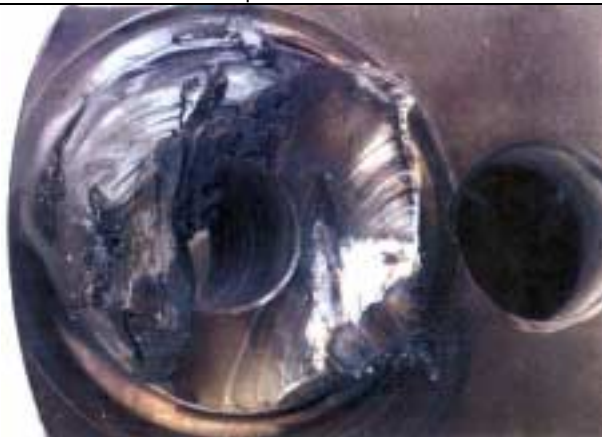
Rupture on rod journal No. 5 arm M5/M6 connection

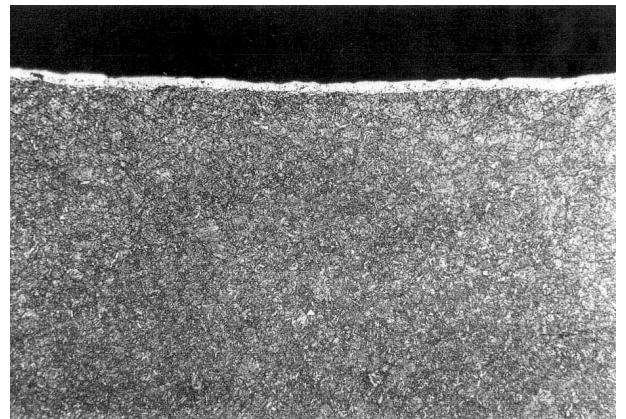
The results of micro-hardness measurements on rod journal No. 3 give hardness values lower than the values required in the cylindrical bearing, which indicates start of wear while those for the radii of the fillet were close to the specified values.

Rod journal No. 3 : Structure of the acid and nitride layer in the fillet

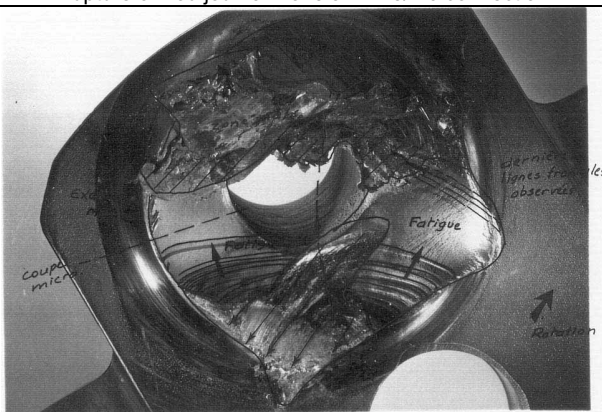
Overall view of rupture

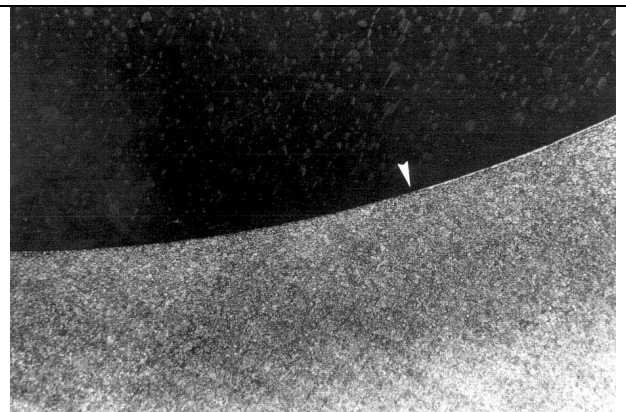
Rod journal No. 3 : End of nitride layer towards arm cheek
