Bureau Enquêtes-Accidents

R E P O R T

*on the events to the MD83
registered F-GHEI and F-GFZB
operated by Air Liberté
on December 2 1997
at Orly (94)*

**F-EI971202A
F-ZB971202A**

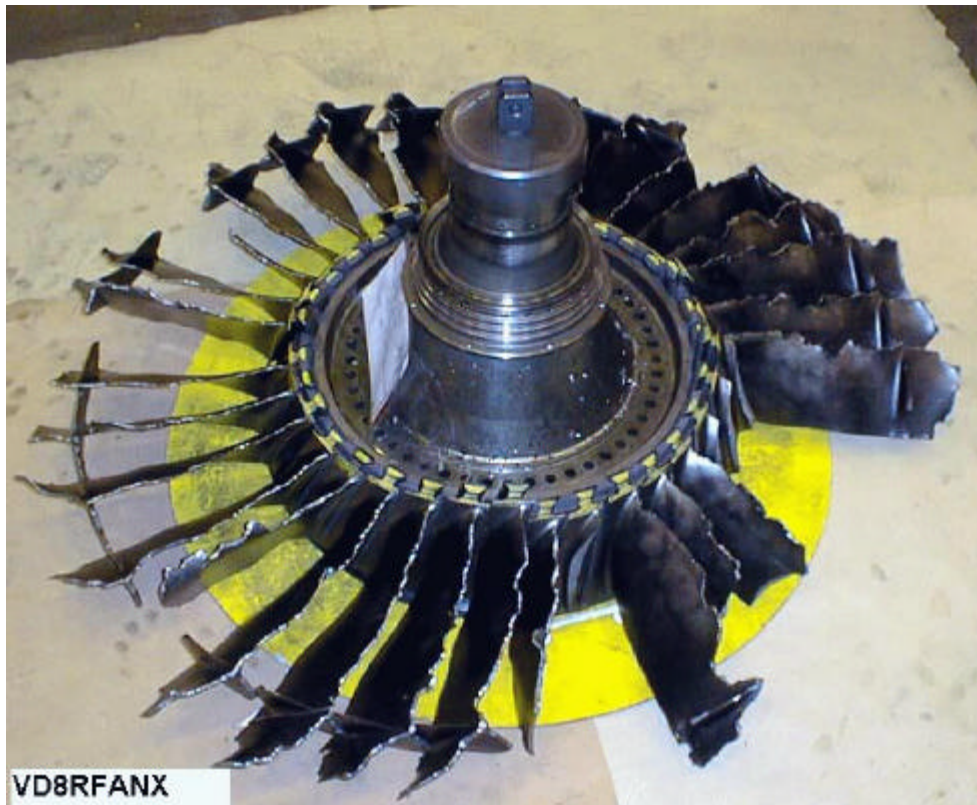
Photo 1 F-GHEI Right Engine
Overall view of the fan blades after disassembly (P&W photo)

Right engine fan blades were missing, destroyed or severely damaged (see appendix 4, plate 1).

- four blades, including three in a row, were broken off at the root,
- seven blades were broken off at the base of the sponsons,
- the leading edges of all of the other blades were damaged.

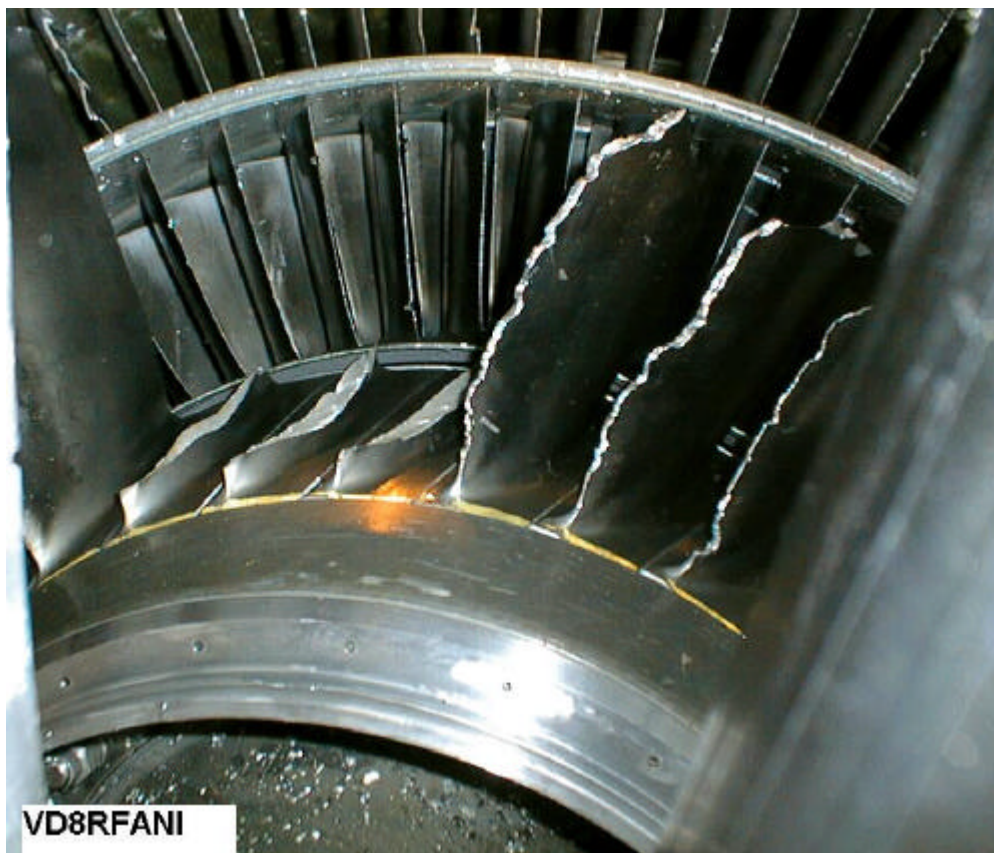
Photo 2 F-GHEI Right Engine
Close-up of the three consecutive blades broken off at the root (P&W photo)

- *a single block was ingested, of twenty pounds or more,*
- *the impact on the fan occurred on the three consecutive blades which were broken off at the root (see photo 2),*
- *the absence of any metallisation of the combustion chambers and the turbine blades as well as the good condition of the high pressure compressor leads to the conclusion that the engine decelerated immediately after the damage to fan*

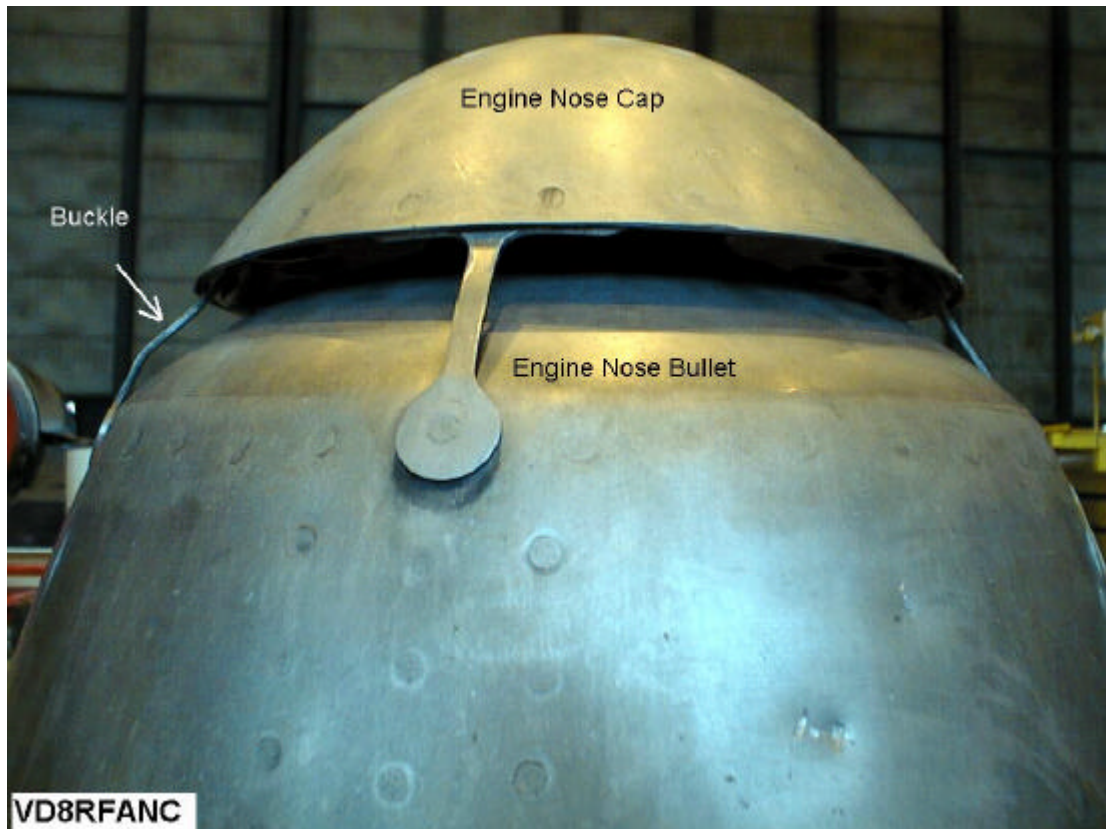
Photo 3 F-GHEI Right Engine

The buckle was distorted by an impact on the engine nose cap (P&W photo)

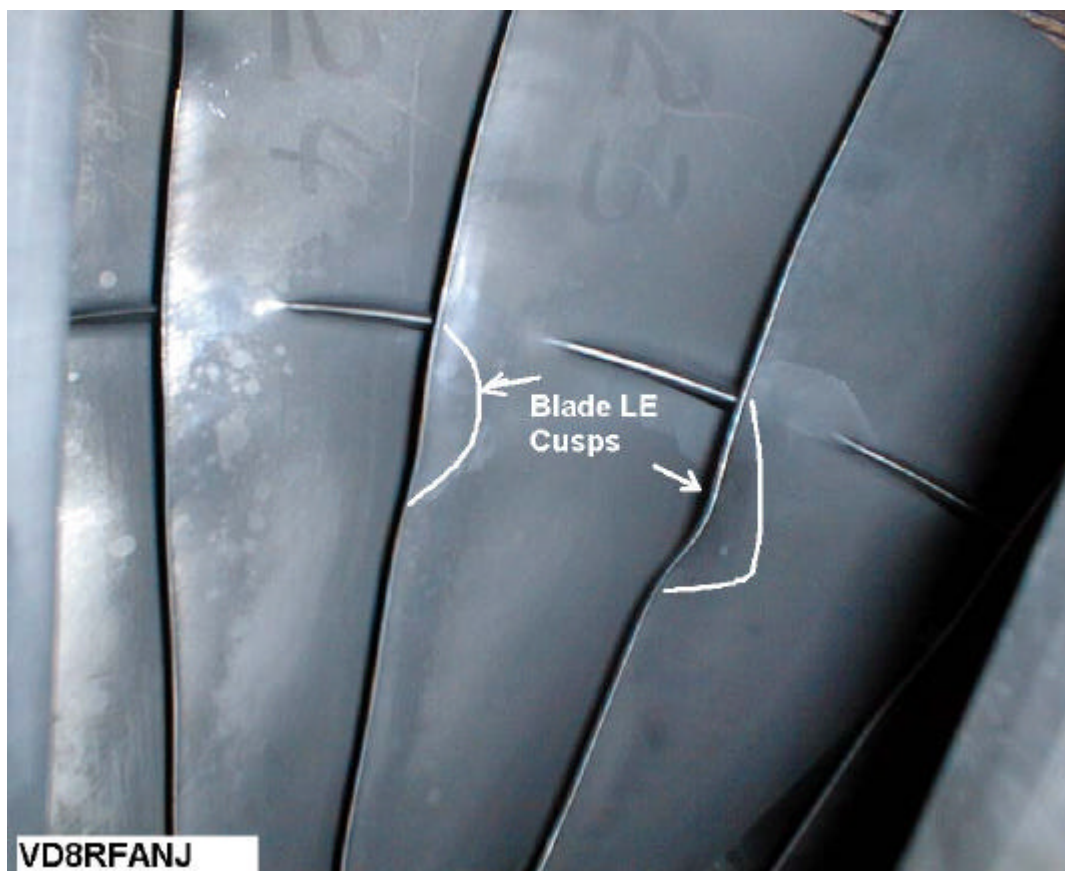
Photo 4 F-GHEI Left Engine

- Two consecutive fan blades were slightly damaged on the leading edge (see photo 4),
- Endoscope examination showed that a high pressure compressor seventh stage blade was twisted.

The minor damage noted on the leading edges of two consecutive fan blades (see photo 4) were caused by a soft body, of the same type as that involved in the right engine damage.

Slight distortion of leading edge of two consecutive fan blades (P&W photo))
