*Serious incident on
23 November 1997
on approach to Orly (94)
to the McDonnell Douglas MD83
registered F-GRMC
operated by AOM Minerve S.A*

REPORT
Translation
f-mc971123a

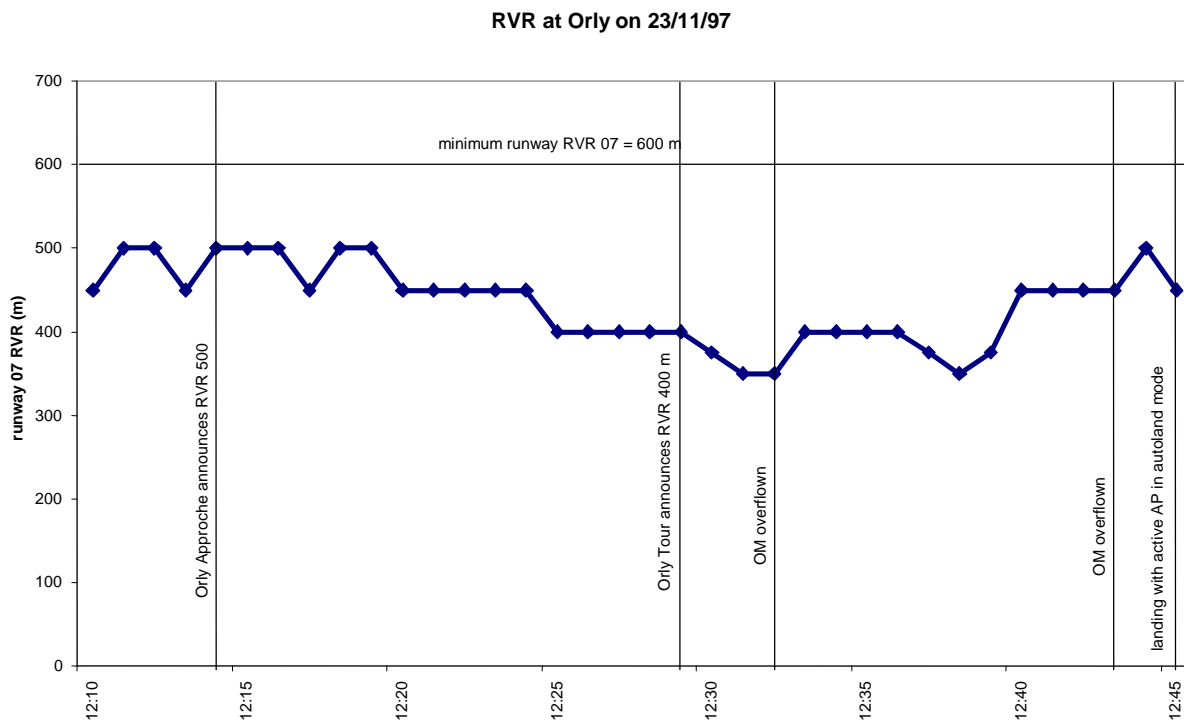
Figure 3

The runway 07 RVR figures are shown in the chart below. The crew's operational minima, overflight time at the Outer Marker and landing time and the times when ATC communicated the RVR figures are also shown.

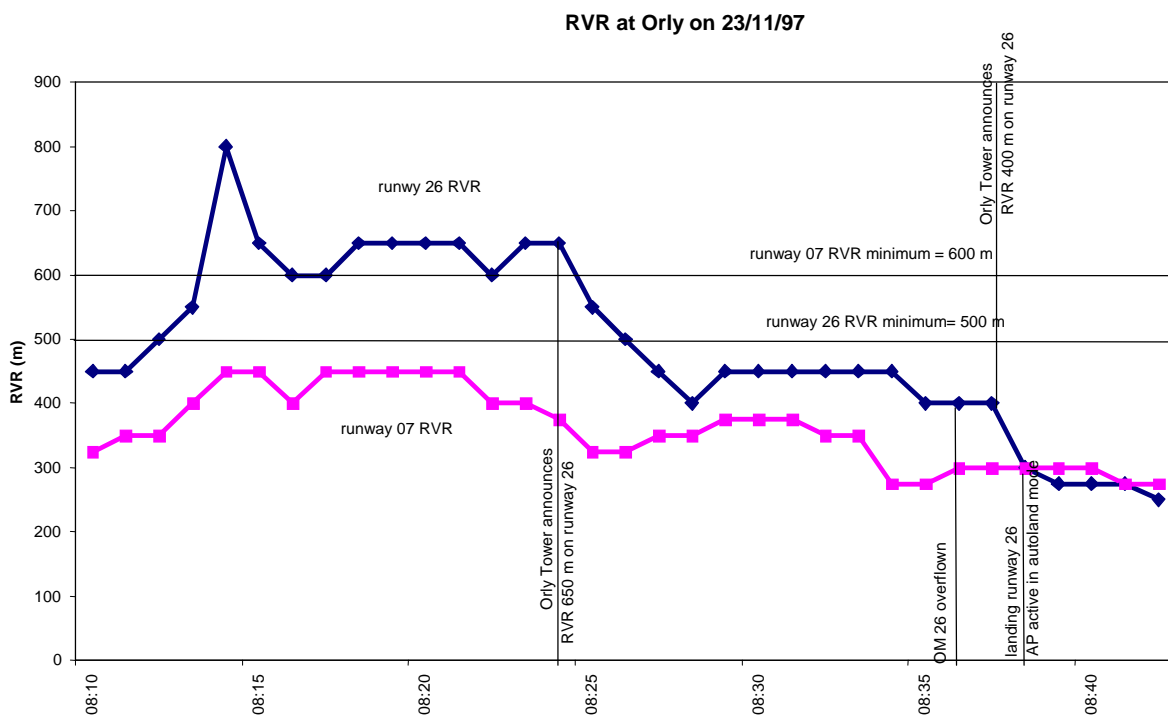
Figure 4

The RVR's recorded at Orly at the time of the morning Toulon-Orly flight are shown in the following chart. The crew's operational minima are also shown.

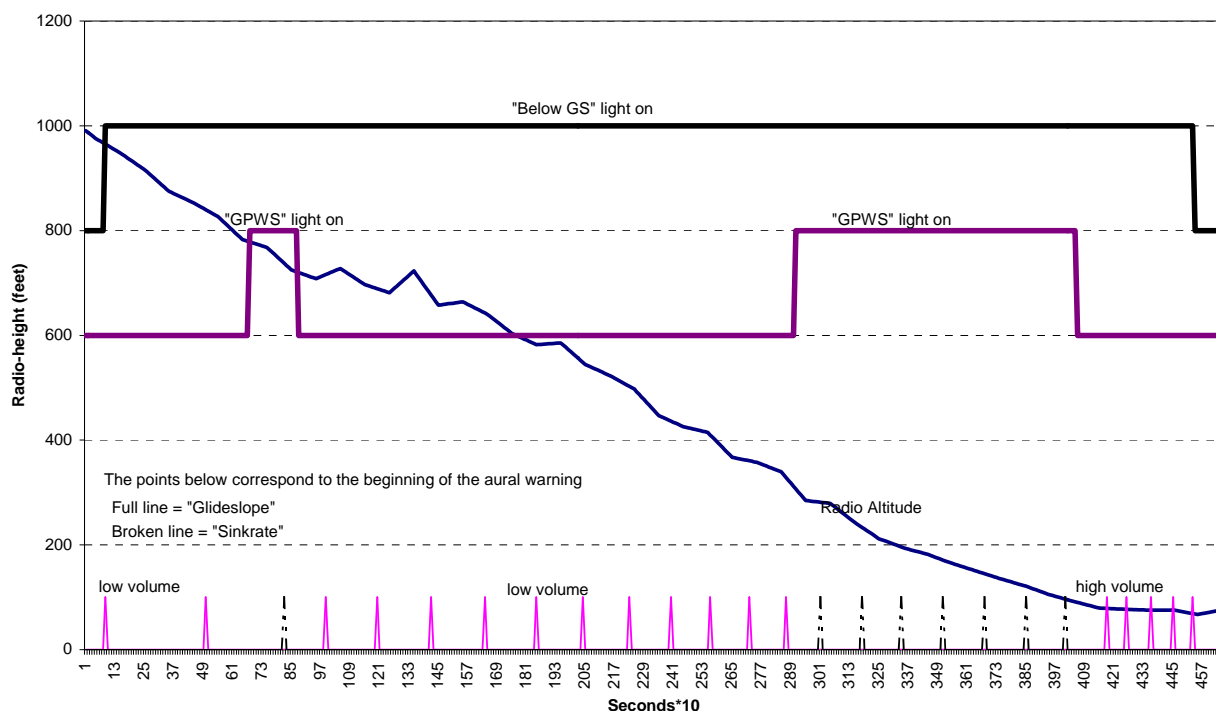
Figure 9

In May 1998 Allied Signal, at the request of the BEA, carried out a simulation of GPWS MK VII warnings using data from the flight. The results of this simulation were as follows:

The warnings which appeared are of the "Low Volume Glideslope", "Sinkrate", and "High Volume Glideslope" type. The times when the "Glideslope" and "Warning" lights came on during the simulation correspond to the respective times when the "Glideslope" and "Terrain" warnings were recorded on the QAR.

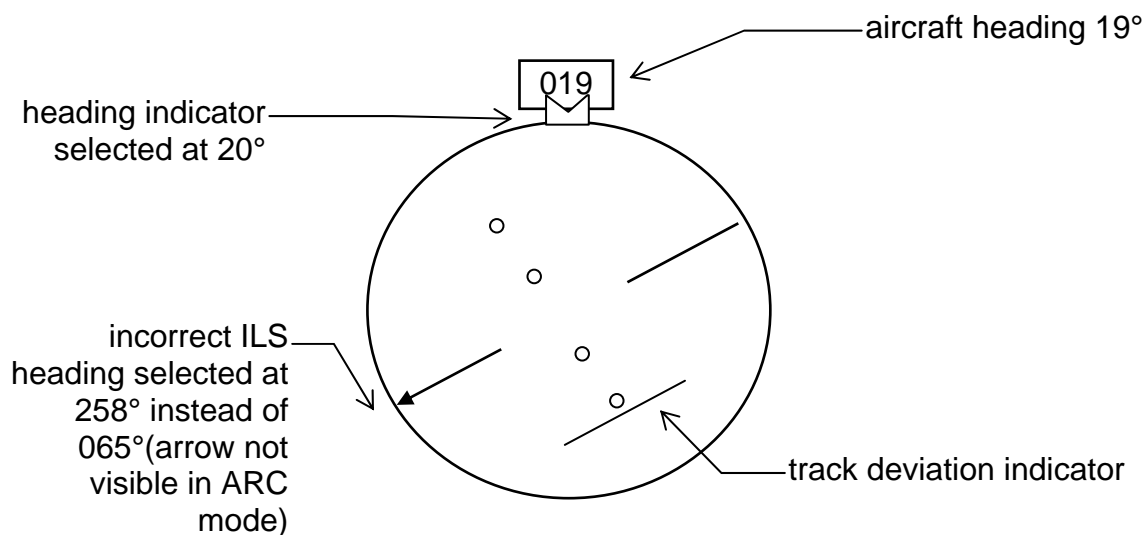
At 12 h 29 min 36s, intercepting the runway 07 ILS, the runway line-up deviation indicator began to move. A simplified representation of the Captain's HSI would show (the HSI is shown throughout in "ROSE" mode for more legibility):

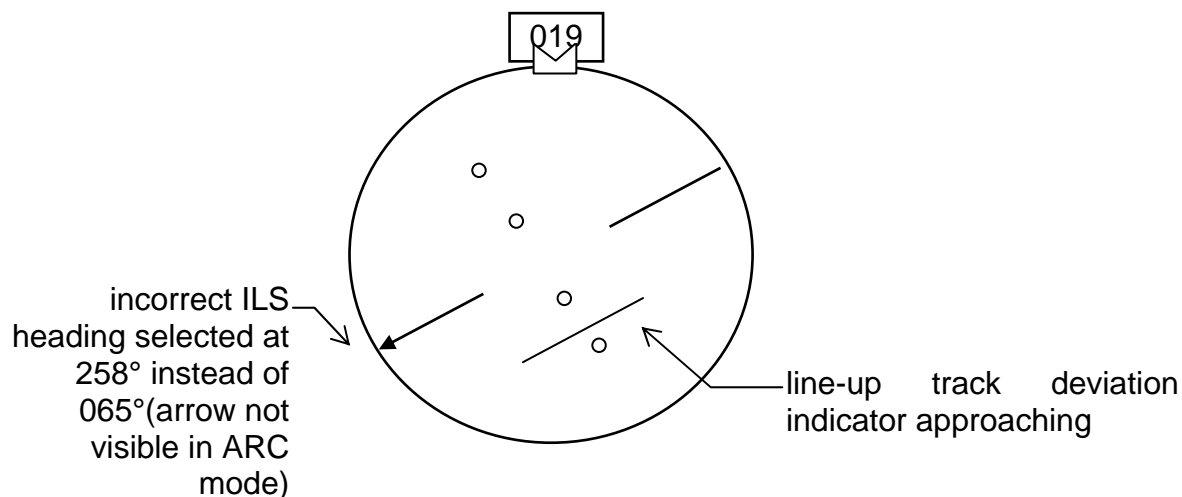
At 12 h 29 min 43 s, the LOC capture mode was displayed on the FMA. At that moment, a simplified representation of the Captain's HSI would show:

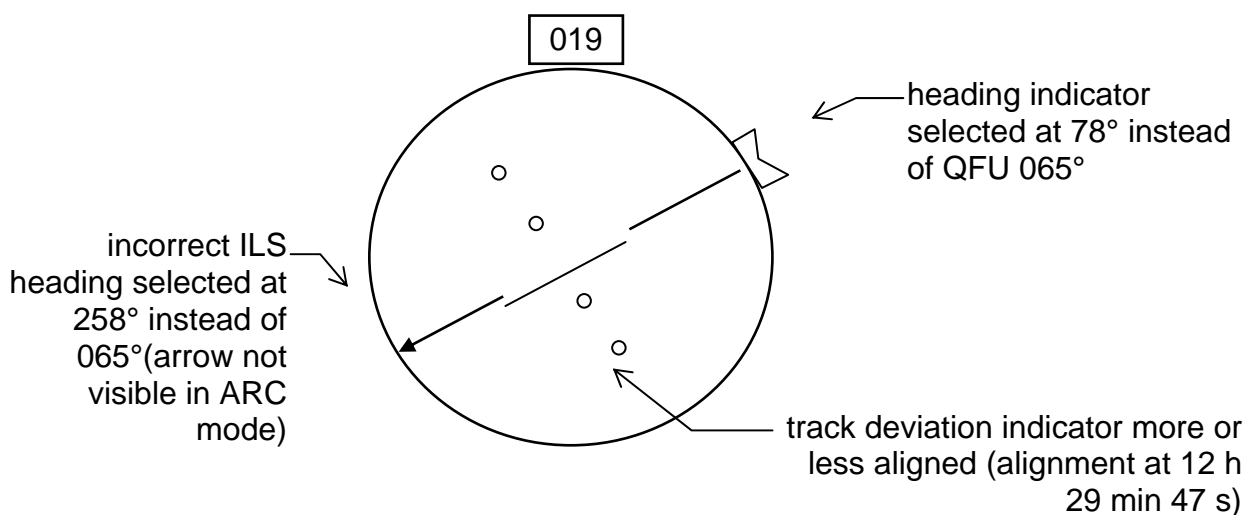
The Captain believed he was bringing the heading indicator up in line with the head of the ILS indicator arrow, but in fact he was bringing it to the tail of the ILS. He then noticed that the heading indicated 78° whereas he expected the QFU of runway 07. He tried to understand the difference between the expected heading and the displayed heading, which increased his workload. From this moment on, he was working alone. The co-pilot, who was no longer informed of the situation, could no longer understand the Captain's actions. A simplified representation of the Captain's HSI would show:

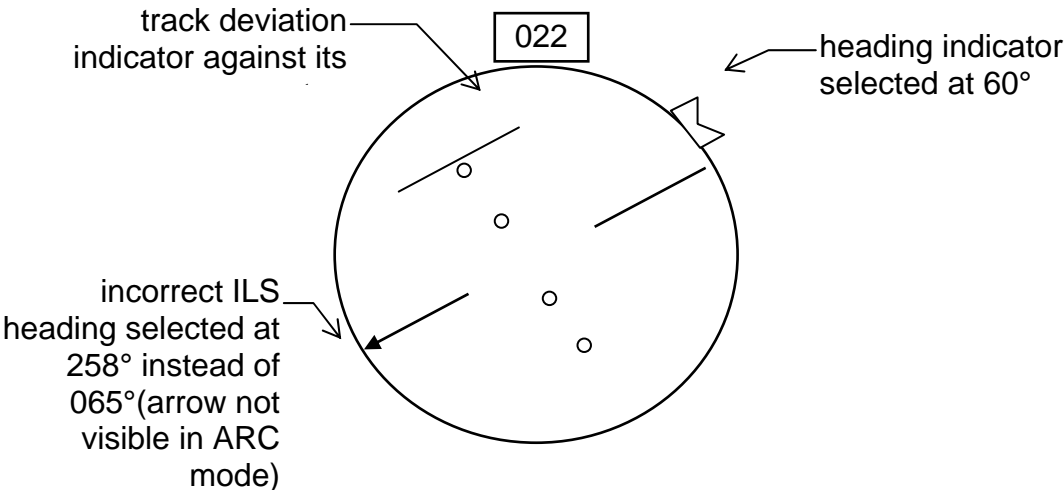
At 12 h 29 min 57 s, the track deviation indicator reached its stop. Two seconds later, the Captain selected a heading of 60° on the DFGS, probably to return

towards the localizer track which he believed to be to the left, with a heading close to the approach track. In fact, he still had not realized that the tip of the ILS heading selection arrow was pointing more or less 180° away from the ILS heading. In this configuration, the localizer track was displayed on the left on the HSI. This selection caused disarming of the "Autoland" mode, and replaced the "LOC CAPTURE" mode with "HEADING" mode. Note that if the Captain had not selected any heading, the airplane would have continued on a constant bearing without ever intercepting the localizer track. A simplified representation of the Captain's HSI would show:

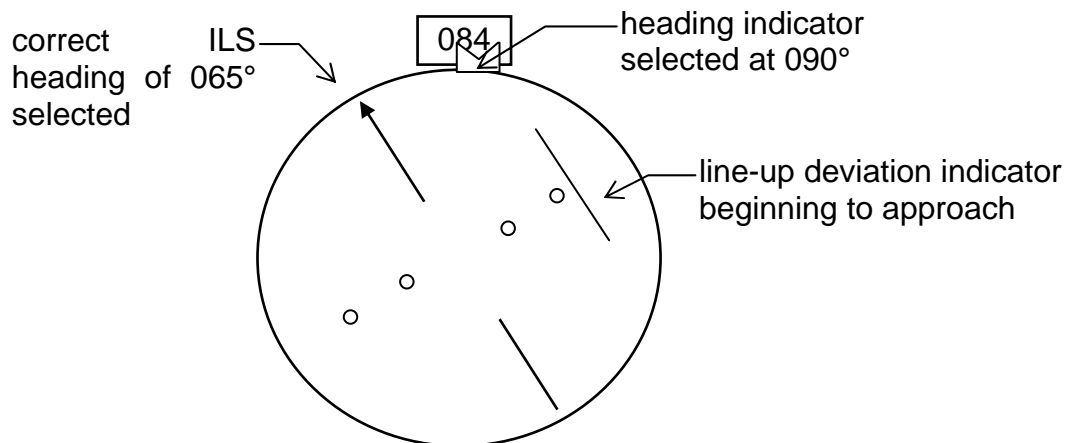
At 12 h 31 min 30 s, the airplane descended through 1,250 feet QNH and the altitude alarm triggered again and was superimposed on the GPWS alarm. It was not cancelled by the crew, and continued to sound until the airplane reached 1 250 feet QNH in climb after the go around. At 12 h 31 min 30 s, the "LOC capture" mode was displayed on the FMA and the localizer beacon indicator, until then at its stop to the right, began to move. The flight director, which was centred until that time, then indicated to the pilot the trajectory to follow to rejoin the localizer track. The Captain turned the airplane left to intercept the approach track:
