ACCIDENT

involving the glider registered D-6223

Event:	Hard landing at an unlisted site.
Identified cause:	Delayed decision to make emergency landing.

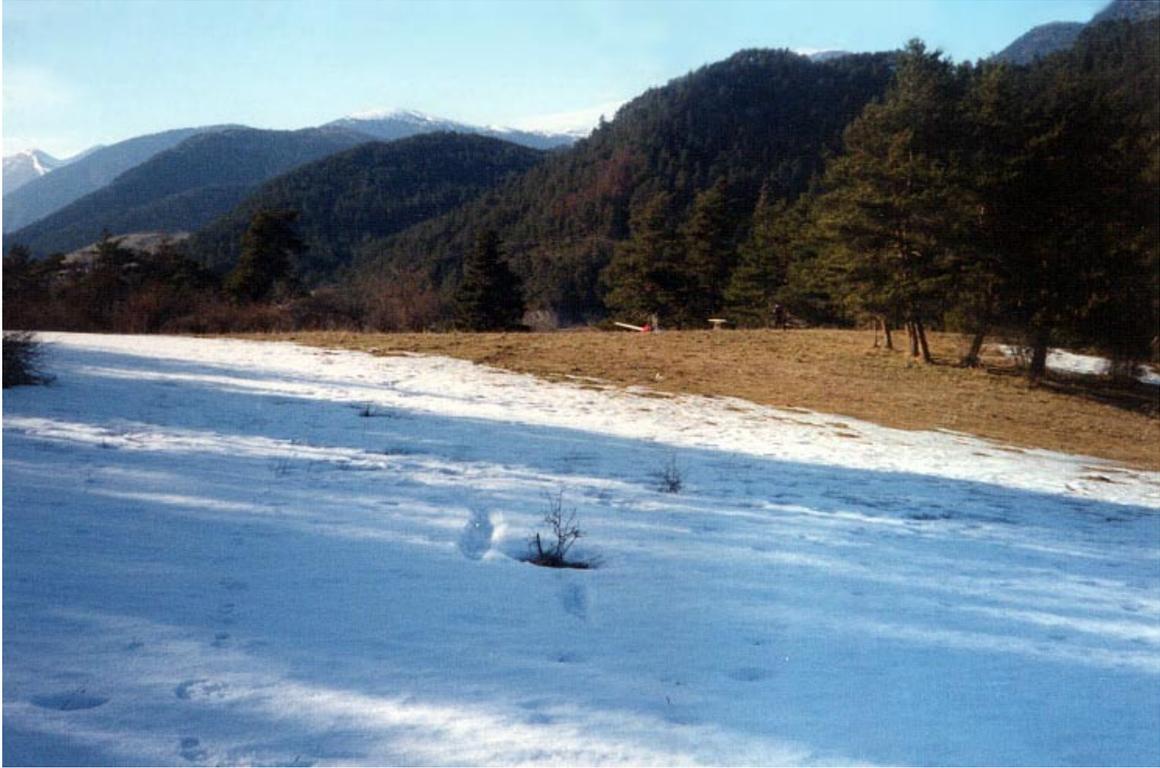
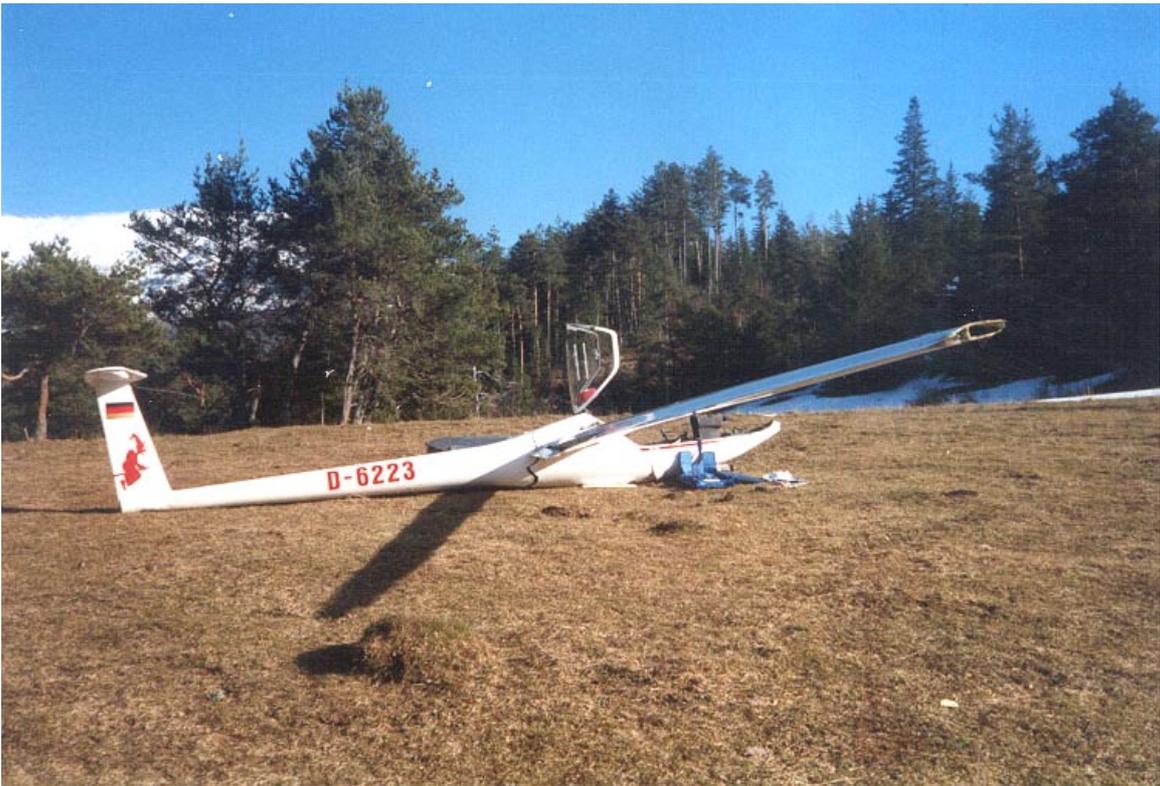
Consequences and damage:	Glider severely damaged.
Type of aircraft:	Glaser Dirks DG-200 glider.
Date and time:	Wednesday 8 March 2000 at 15 h 00.
Owner:	Private.
Place:	Verdaches (04), Labouret Pass.
Type of flight:	Circuit.
Persons on board:	Pilot.
Licenses and experience:	Pilot, 50, VV issued by Germany in June 1998, 900 flying hours on gliders.
Meteorological conditions:	Estimated at site: slight wind, CAVOK.

The pilot took off from Serre La Bâtie AD (05) for a flight bound for Seyne Les Alpes AD (04). In the Labouret Pass sector, the pilot found himself at an altitude too low to continue the flight to the destination AD. He decided to make a forced landing in a clearing about 150 m long by 40 wide. After a first impact in a place which was snow-covered, the glider slipped on the grassy earth for about 80 m, then came to rest. The right wing tip and the rudder were torn off and the fuselage was cracked around the wing roots.
