*Accident
on 25 July 2000
at "La Patte d'Oie"
in Gonesse (95),
to the Concorde,
registered F-BTSC,
operated by Air France*

INTERIM REPORT (15/12/2000)

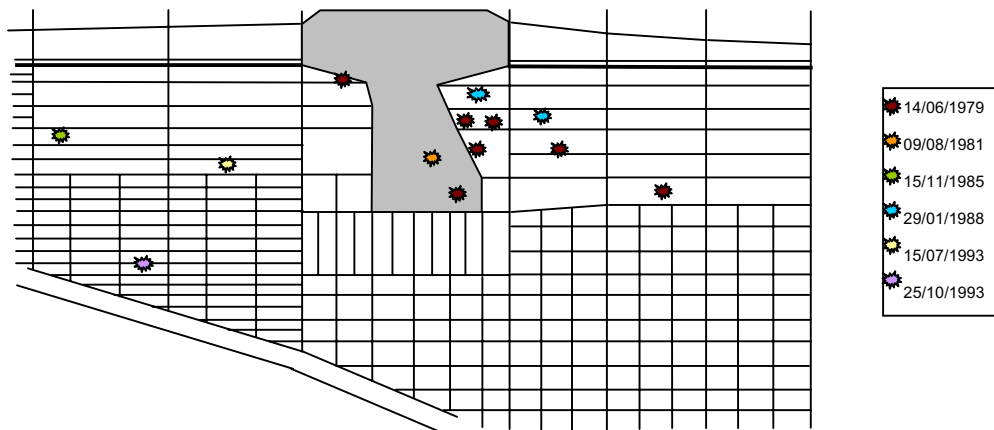
Location of impacts with penetration during the various incidents (right wing and left wing)

15 November 1985: G-BOAB on takeoff from London Heathrow, burst of n° 5 tyre causing damage to the landing gear door. Minor penetration in tank n° 5, probably by a piece of the door mechanism.

15 July 1993: G-BOAF on landing at London Heathrow, burst of n° 4 tyre leading to damage to the gear door mechanism. Tank n° 8 was damaged, probably by a piece of this mechanism.

25 October 1993: G-BOAB during taxiing at London Heathrow, burst of n° 2 tyre leading to damage to the water deflector. Tank n° 1 suffered minor penetration, probably from a piece of the deflector.

Most of the structural damage resulted from impacts from pieces of wheel rim on the wing, aft of the tyres. Three penetrations were also observed in the area of tanks 2, 5 and 6, whose wall thickness is 1.2 mm. One of them was caused by a piece of rubber from a tyre. The resulting fuel leak from all of the penetrations was 4 kg/s.

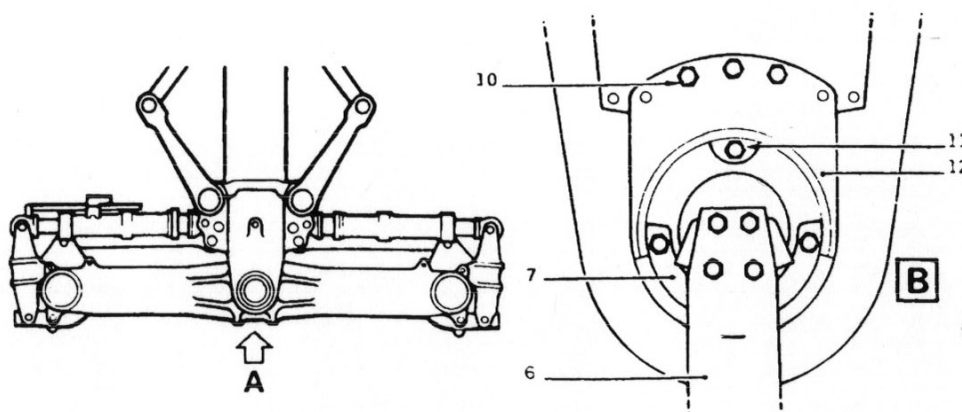
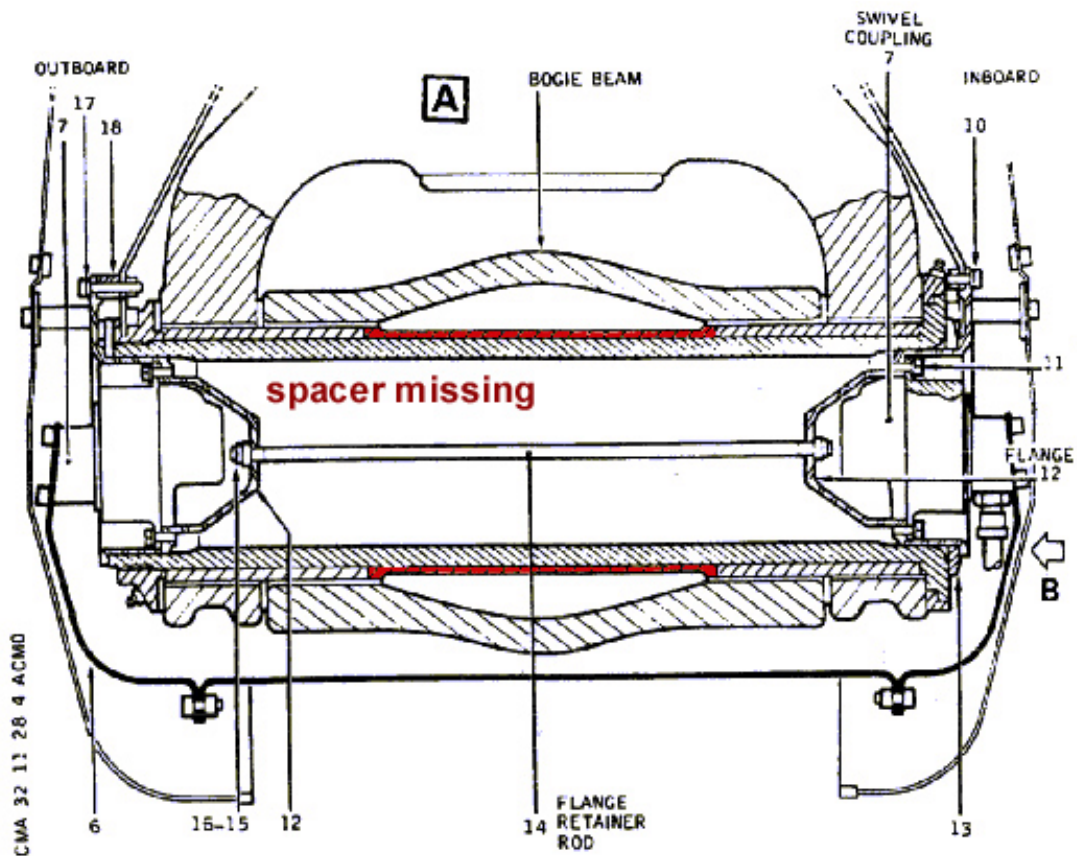
- The left main landing gear was extended and locked at the level of the side-stay. The right main landing gear was severely damaged but clearly identifiable in the extended position. The nose gear was released with its locking pin out.
- The two main landing gear door locks were in the open position.
- The left nose gear door closing actuator was released with movement of 100 mm. The normal course of this actuator is 35 mm when the door is closed and 195 mm when the door is open.
- The main landing gear door closing actuator was broken. An examination of this actuator should allow its movement at the moment of impact to be determined.
- A spacer, which holds two lateral rings in position, is missing from the oleo/bogie coupling on the left main landing gear. This retainer had not been re-installed after the AO1 check performed from the 17 to the 21 July 2000.

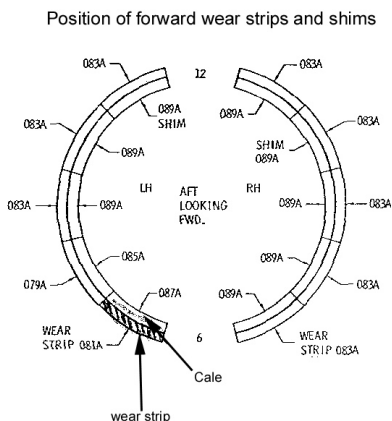
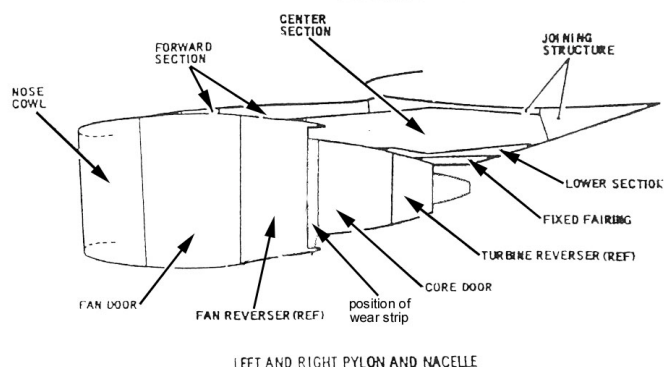
16.6 Metal Strip Found on the Runway

The metal strip found on the runway after the accident (see Preliminary Report, § 12.1.3) appeared to be of a type used in aviation but not belonging to the Concorde. A search was therefore undertaken to identify the aircraft which it could have fallen from. This search was concentrated on the aircraft which had taken off from the same runway after 13 h 00. In addition, work on several types of aircraft led to a belief that the part could be a wear strip from a CF6-50 engine thrust reverser cowl.

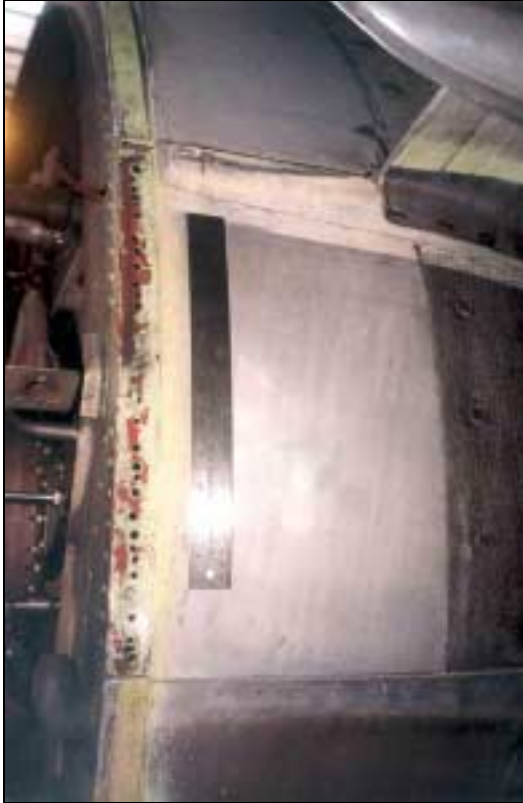
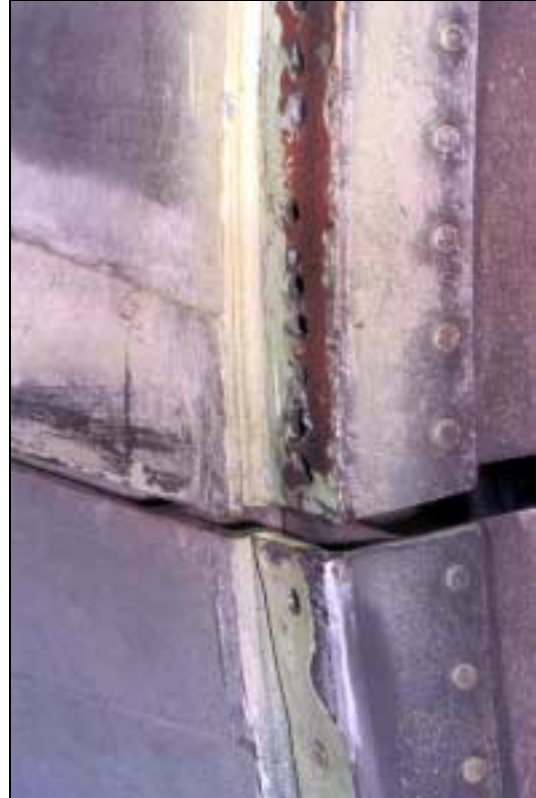
- The lower left wear strip, about 44 cm long, was missing. The closed core cowl door normally rests on the front part of the wear strips ;
- The fitting had been painted with green epoxy primer ;
- In the missing part's position, the fitting had been coated with red type RTV106 mastic ;
- There were no traces of RTV 106 on the other parts of the fitting ;
- There were no traces of RTV 106 on the wear strips still in place ;
- There were numerous paint run marks on the fitting and on the wear strips. The paint partially spread over onto the fan cowl door ;
- In the position of the missing part, the fitting still had several rivets in place;
- the fitting was drilled with thirty-seven holes, some of which had spaces less than twice their diameter between them.

- the right wear strips appeared to be original parts made of stainless steel (extruded profile at the tip)
- the left wear strips had been replaced, and do not appear to be original parts made by the manufacturer;
- the spacing of the rivets on the strips in position and their alignment appeared to be correct ;
- the level of wear on the strip adjacent to the missing strip was greatly in excess of the tolerance permitted by the manufacturer.

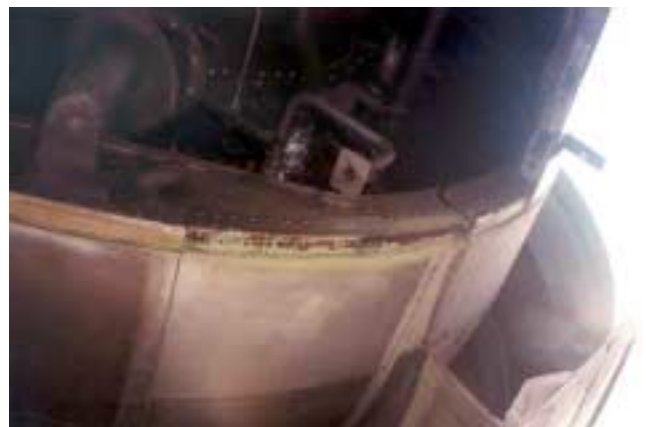
c) Lower right wear strip

- a rivet was missing on the strip. The strip was twisted and allowed play of 6 mm in relation to the fitting ;
- the rivet at the tip was broken off, the part remaining on the fitting prevented the strip from sticking to the fitting, which prevented correct closing of the cowl;
- in comparison with an original part, this strip was too long.

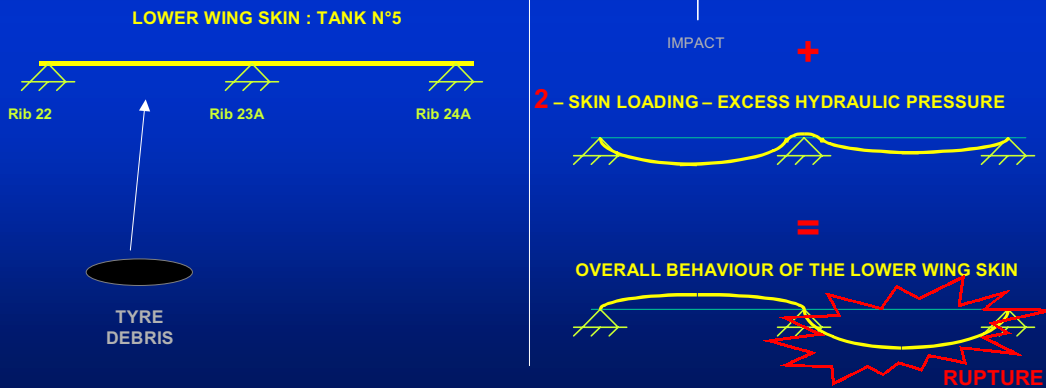
Qualitative approach to the rupture scenario

According to the first results of the simulation performed with the conditions of the 25 July 2000 flight, the rupture of the tank could thus be explained by the conjunction of two phenomena induced by the shock, without penetration, from a large piece of tyre on the tank :

➤ 1st rupture mode : direct penetration by dynamic shearing

➤ 2nd rupture mode : bending effect + excess hydraulic pressure
