*Accident  
on 2 May 2000  
at Lyon-Satolas (69)  
to the Learjet 35A  
registered G-MURI  
operated by  
Northern Executive Aviation Ltd*

**REPORT**  
**g-ri000502a**

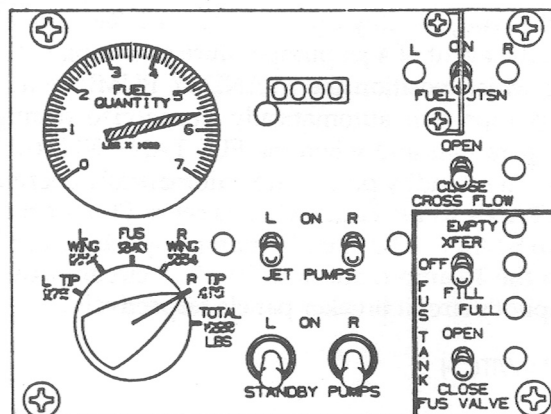
*Illustration of the fuel management panel*

The positions noted on the valves, fuselage transfer open and cross-feed closed, allows two hypotheses to be considered to determine the fuel balance. Either these positions resulted from a malfunction leading to incorrect positioning of the cross-feed valve during the transfer procedure, or the incorrect positioning of this valve resulted from the impact.
