ACCIDENT

Involving the glider registered I-DLEA

Event:	Loss of control, collision with terrain.
Probable cause:	Manoeuvres at low speed and height in highly turbulent atmosphere.

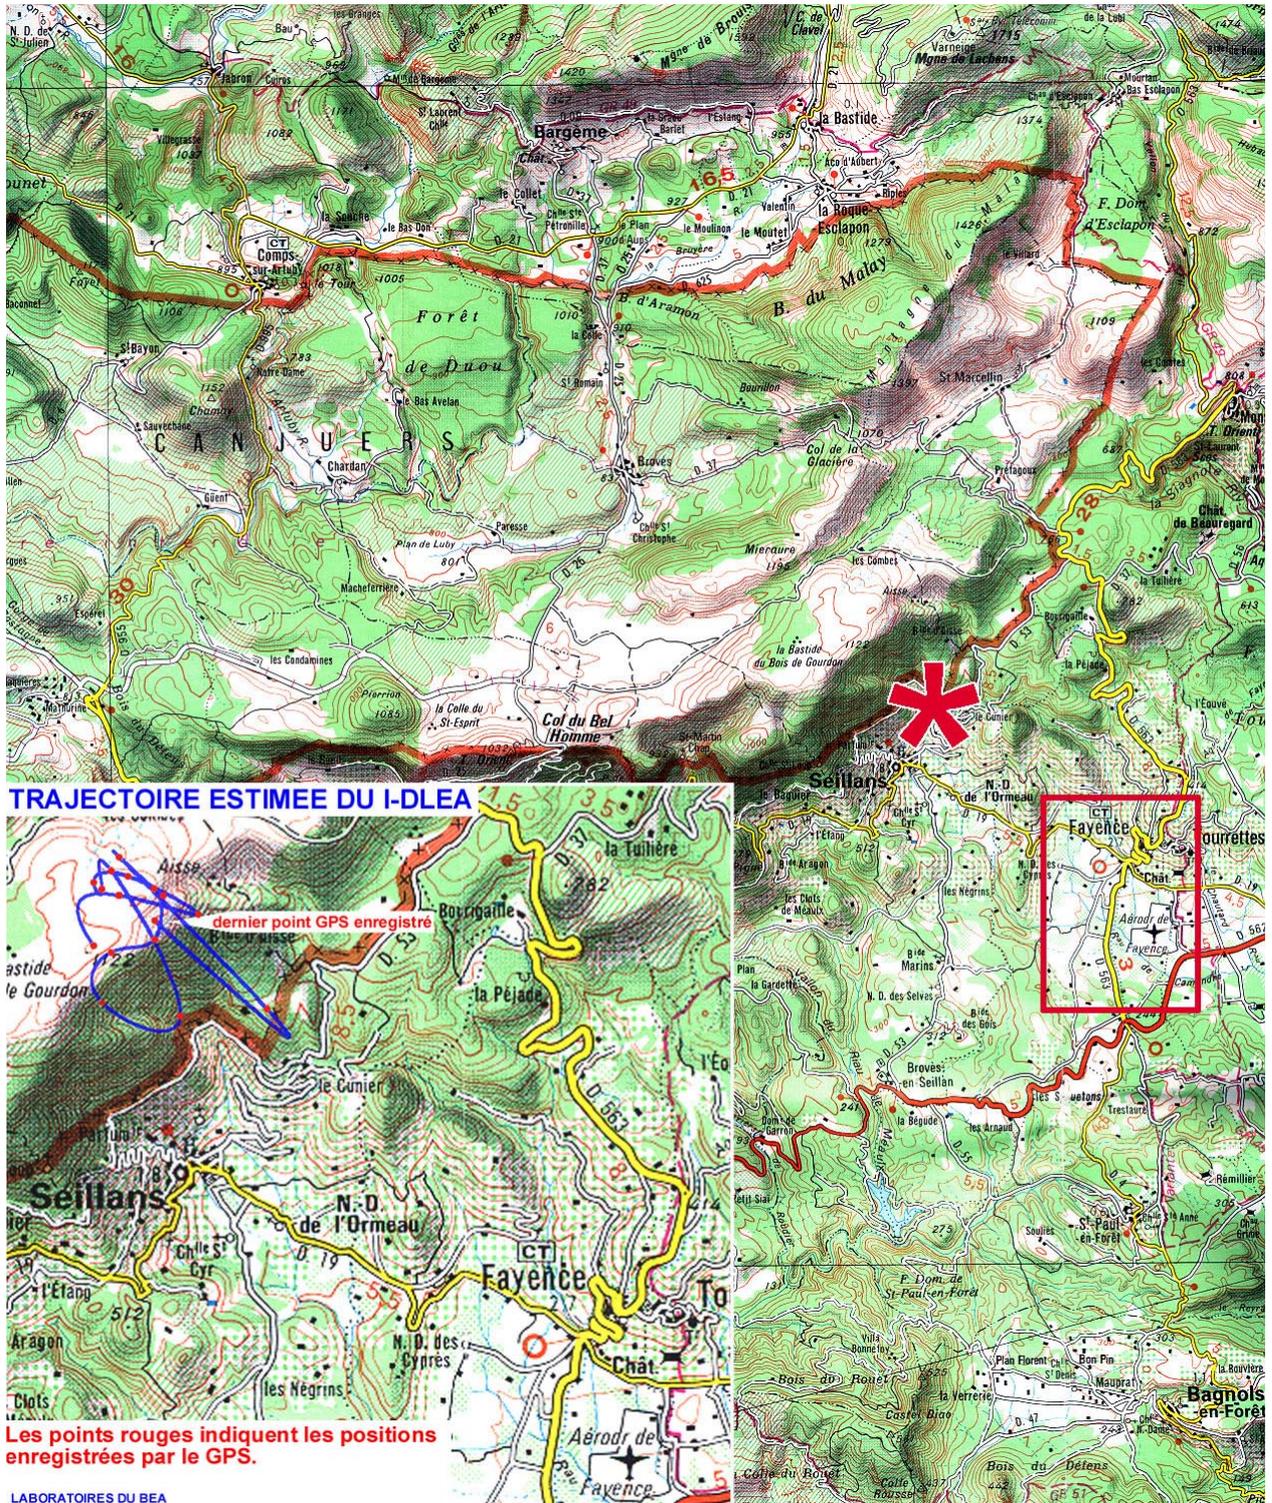
The wreckage was found by the pilot of an aircraft who raised the alarm. The wreckage was not widely dispersed. Examination showed that the glider struck the terrain very near the summit at a relatively high speed while turning right.

The position of the wreckage shows that the pilot turned right near the summit. He probably made the turn at a too low speed which, in association with the turbulence, could have caused a dissymmetrical stall and a loss of control, leading to a collision with the nearby terrain.
