Accident
on 24 December 2000
at Tahiti Faaa Airport
to the DC10-10
registered N132AA
operated by Hawaiian Airlines

REPORT
n-aa001224a

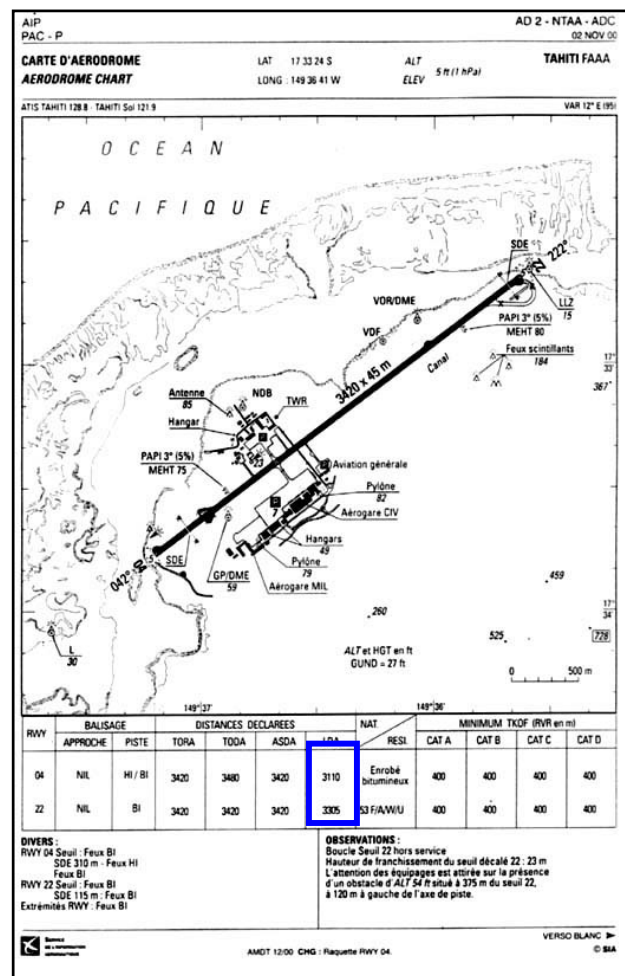
The existence of a displaced threshold on runway 04 was made known to users by AIP / PAC amendment N°10 published in September 2000 that announced an effective in-service date of 5 October 2000. There was an error relating to the landing distance available (LDA) on runway 04 (3,310 m / 10,860 feet instead of 3,110 m / 10,203 feet) in update N°10. This error was corrected on 28 September 2000 by NOTAM and the chart documentation was updated by update N°12 published on 2 November 2000.

On 6 November 2000, the AIP documentation having been updated, the NOTAM was cancelled..

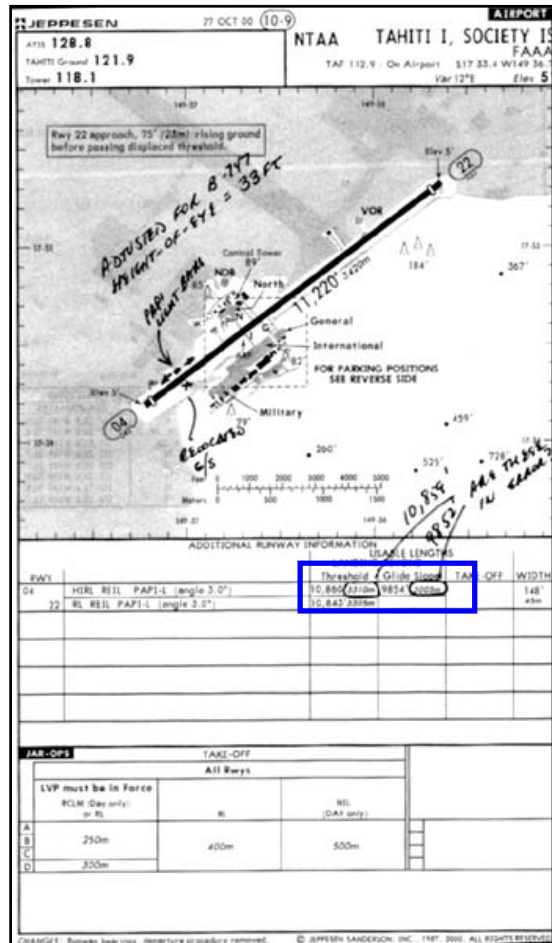
The crew was using Jeppesen charts that did not take into account the various amendments published in September and November in the AIP/PAC.

The Jeppesen “NOTAM chart” for 22 December 2000 did not mention any special points for the aerodrome.

Correction of the Jeppesen documentation was carried out after the event, at the suggestion of the operator.

Most operators use Jeppesen documentation and crews are used to doing so. However, although Jeppesen receives NOTAM's, the chart of the Tahiti airfield had not been updated. Such a failure could lead to dangerous situations for more restricted airfields, since it could lead to erroneous performance calculations during flight preparation.

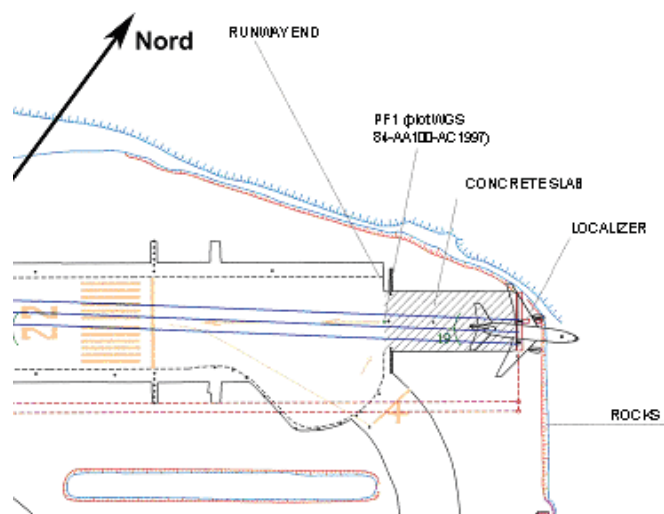
Source: Tahiti Faaa Air Transport Gendarmerie Brigade

The left and right engines were resting on a sea wall made of rocks, eighty meters from the end of the runway. The airplane's nose was in the waters of the lagoon though the nose gear was not touching the bottom. The forward part of the fuselage and the electronics bay were in the water.

- Impact marks between the nose and nose gear.
- The nose gear was marked by the impact with the localizer aerials, one of which was jammed inside. The anti-shimmy was destroyed. No serious structural damage was visible.
- The air intake on the right engine was punctured by a rock and that of the left engine showed signs of scraping along the ground. Some fan blades on the left engine were slightly damaged. The pylons of both on-wing engines were twisted.
- The left main landing gear had struck the localizer installations. Numerous contact marks with the antennae were visible.
- The left inner flap was damaged on its lower part. The right inner slat was deformed by contact with the pylon of engine three.

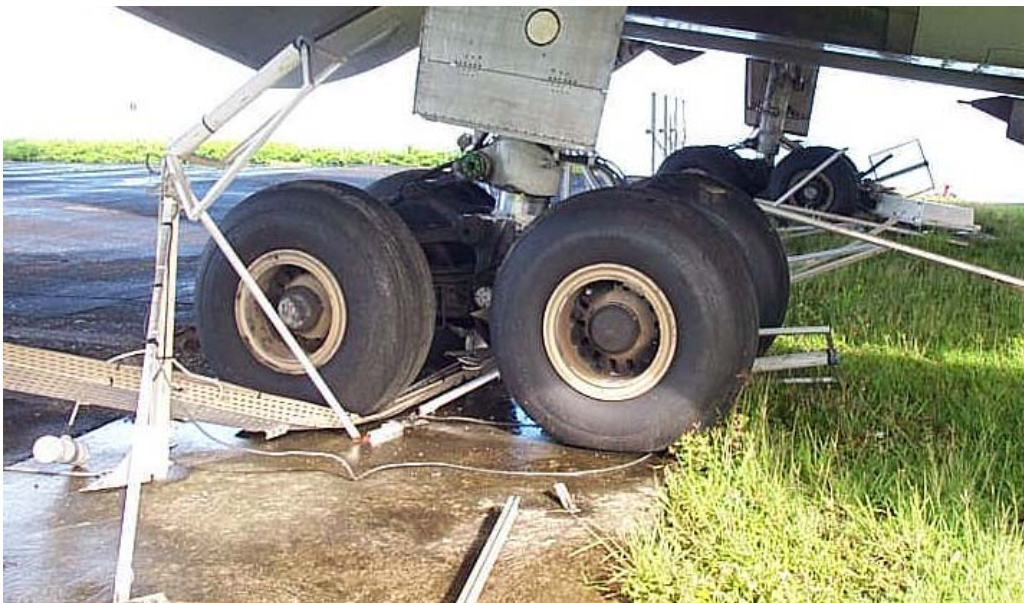
Note: the localizer antennae, located seventy-two meters from the end of the runway, were destroyed.

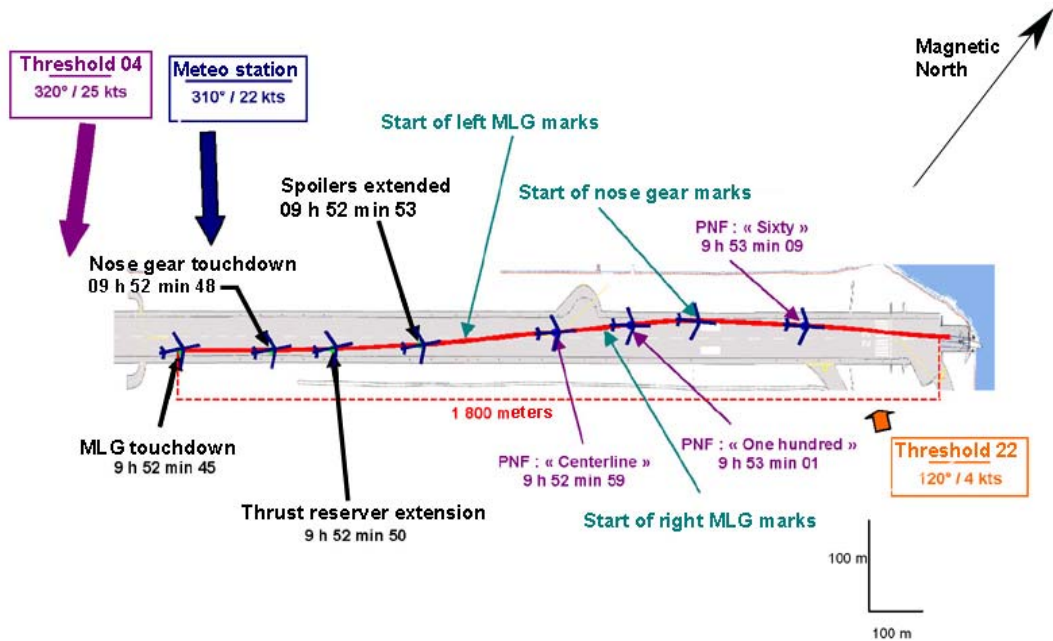
Ground track determined from recorded FDR data

The landing roll, compared with the airplane's magnetic heading, indicates that the airplane started sliding to the right for eleven seconds from touchdown of the main gear, then slid to the left, between 9 h 53 min and 9 h 53 min 13 s.

Note: The winds indicated above correspond to those at 9 h 53 min averaged over the last two minutes at thresholds 04 and 22 and the meteorological station. Threshold 04 is not included due to the scale chosen.
