*Accident  
on 5 November 2000  
at Paris Charles de Gaulle (95)  
to the Boeing 747-200  
registered TJ-CAB  
operated by Cameroon Airlines*

**REPORT**

**tj-b001105**

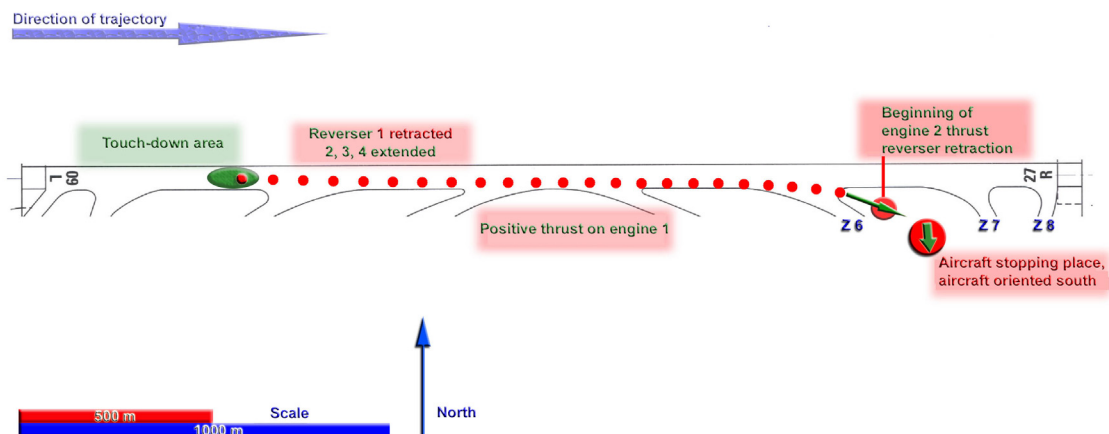
Aircraft trajectory on landing roll:

The points correspond to the aircraft's trajectory sampled every second. The spacing between the points indicates a lack of deceleration.

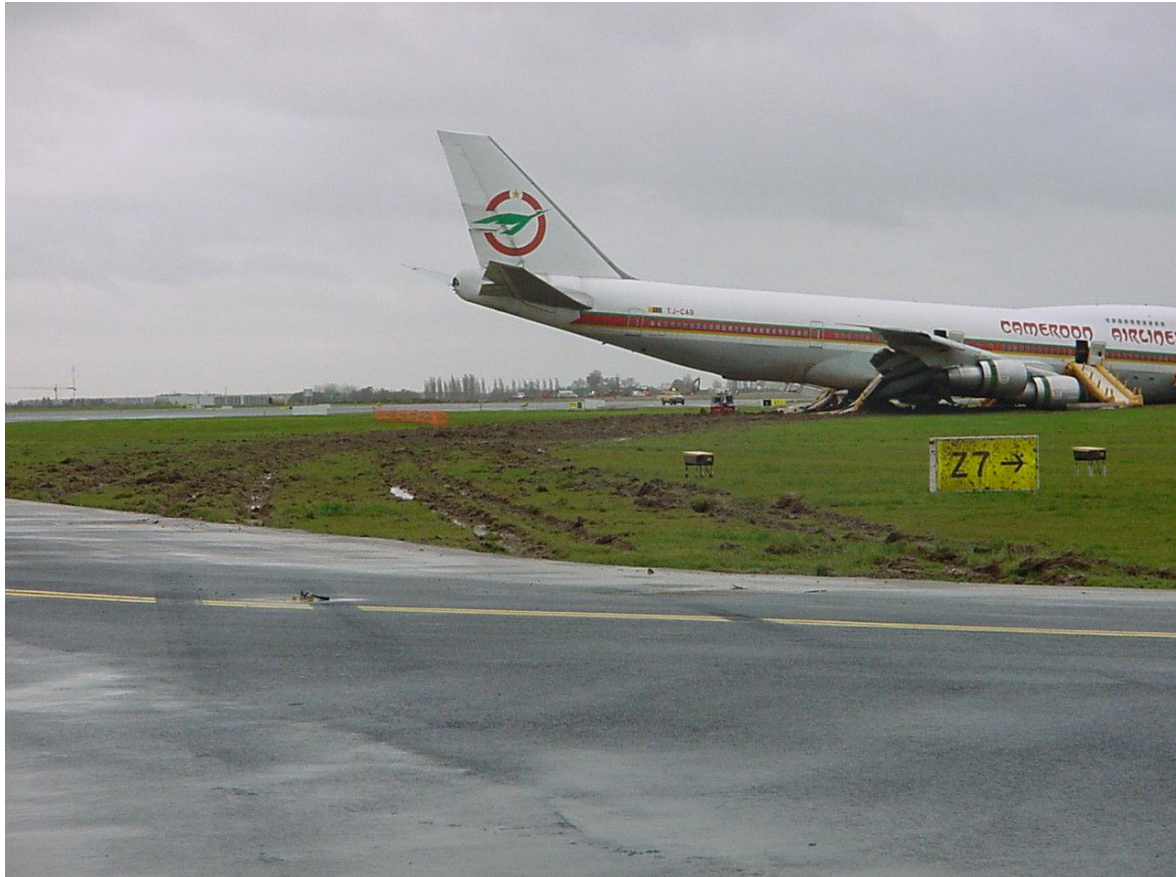
On impact with the concrete structure of the rainwater collector tank, the nose gear, bent backwards, penetrated the airframe at the level of the electronics bay, causing extensive damage to the equipment contained therein.

None of the four engines showed any visible signs of damage.

Three emergency slides were deployed on each side of the aircraft.

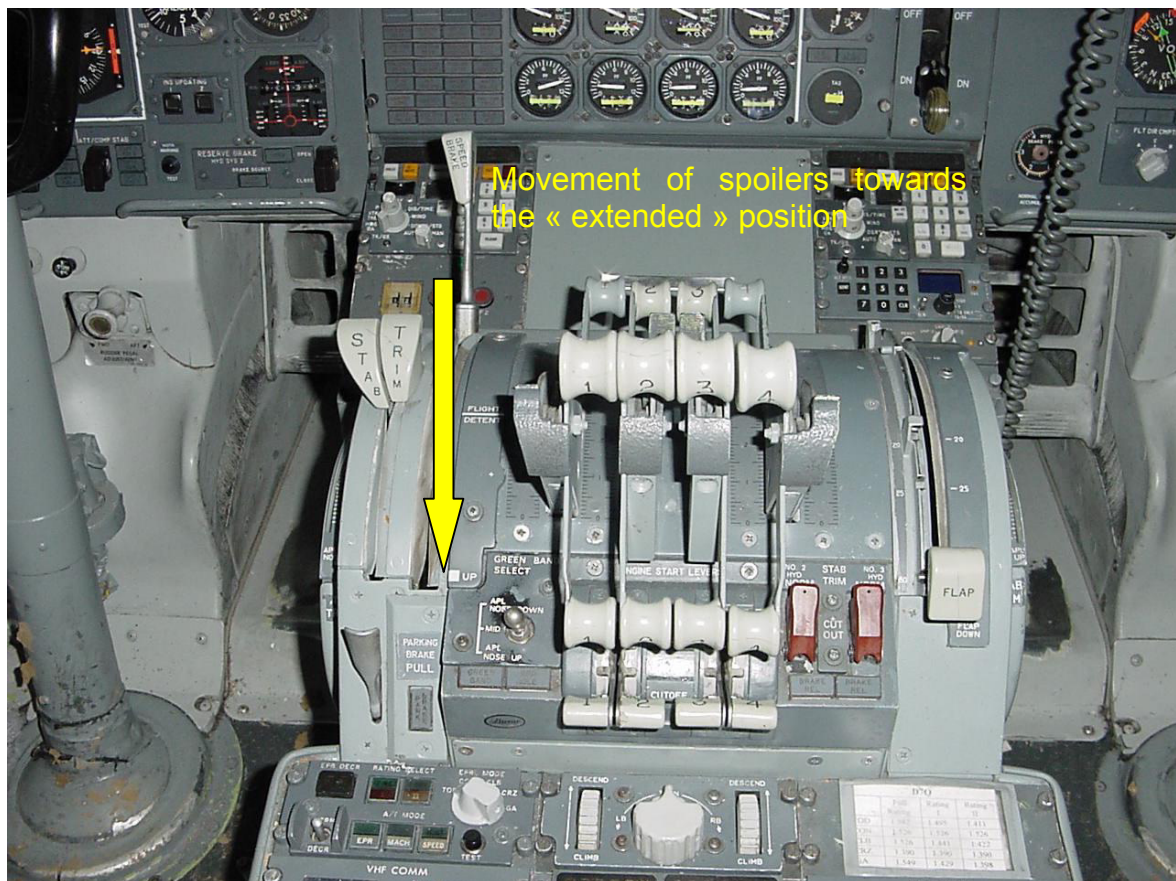
The four thrust levers were found in the idle position. It was noted that the crew had fired the fire extinguishers and the APU. The electric switch for extension of the number 3 slats was found in the "Extend" position.

Note: the position of the buttons and levers in the cockpit should be taken with care, since the implementation of the "Passenger evacuation" check list was carried out at night.

The raisons for the increased thrust on engine 1 remain difficult to explain. It is not impossible that while reaching over to extend the spoilers, which are on the centre console next to the thrust controls (see photo in 1.12.3), the Flight Engineer may inadvertently have moved the n°1 thrust lever towards full positive thrust. A lack of coordination between the Captain and Flight Engineer, as well as an absence of joint control with the co-pilot, may have contributed to the failure to correct the situation.
