Accident
on 17 January 2001
at Quetigny (21)
to the Beechcraft 95-C 55 “Baron”
registered F-BUTZ
operated by Air Bor

REPORT TRANSLATION
f-tz010117a

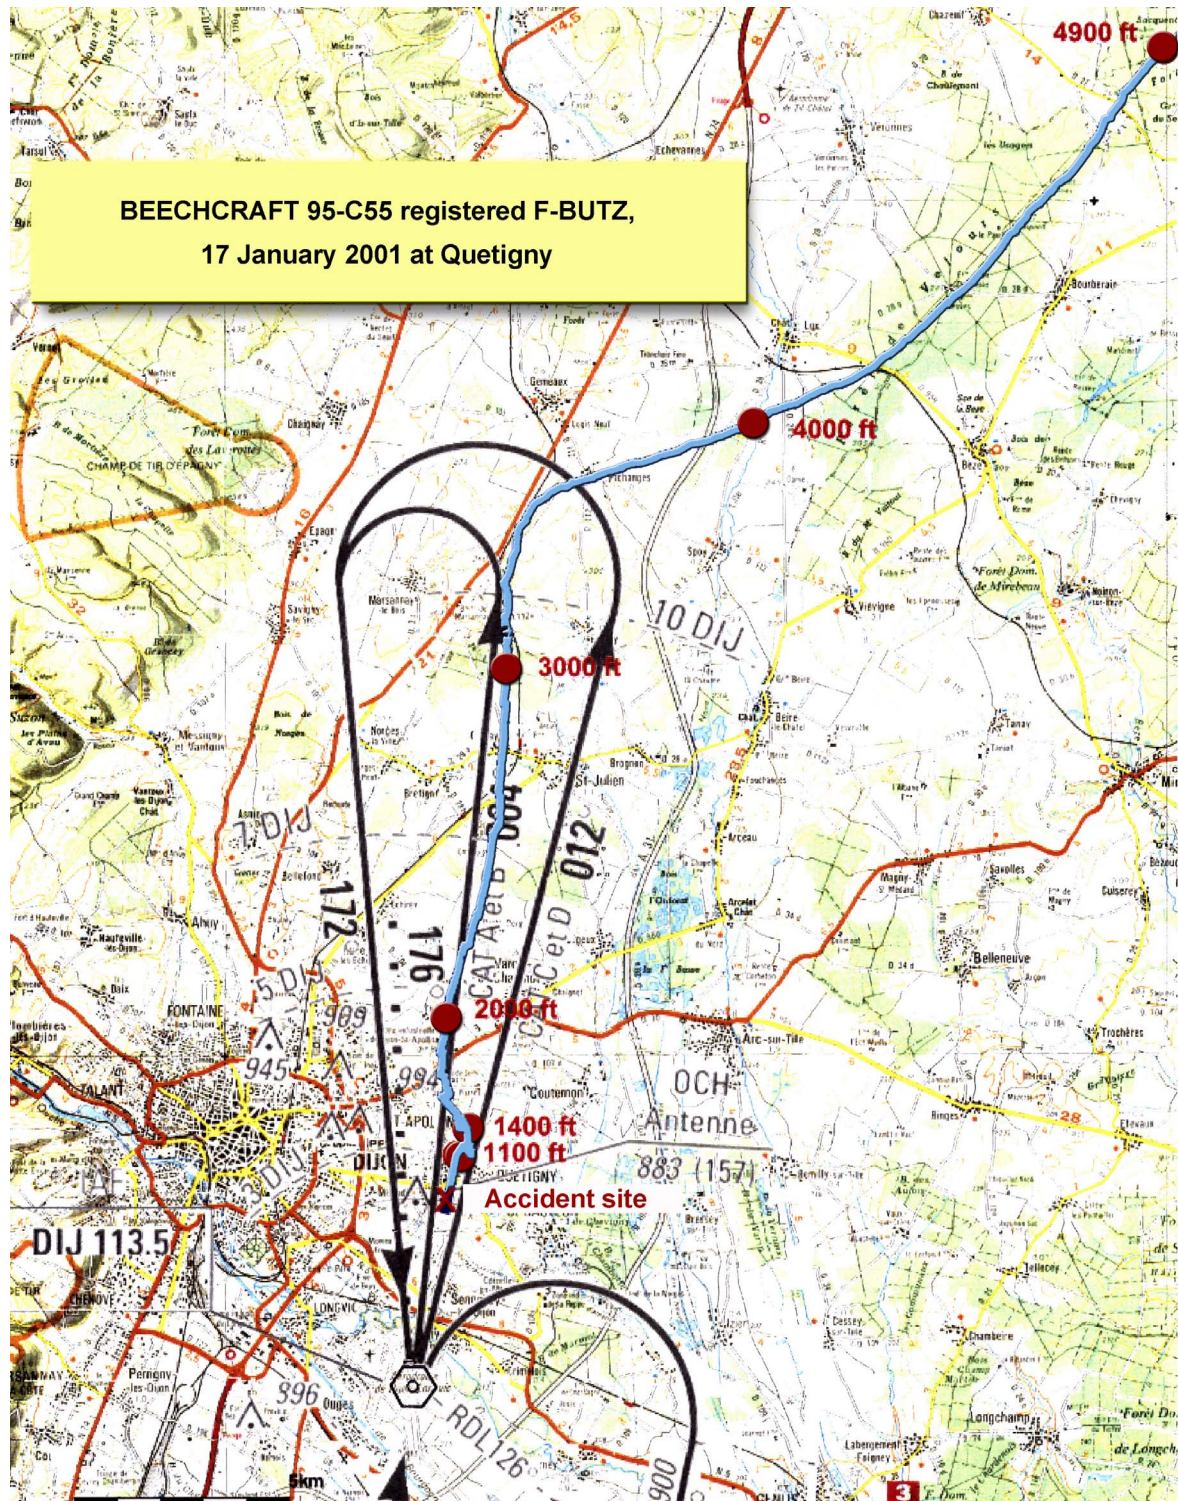
Figure 1: radar track and VORTAC 18 procedure

Distance to TACAN	Aircraft altitude	Nominal altitude (Jeppesen chart)
7 NM	2,600 ft	2,900 ft
5 NM	2,400 ft	2,270 ft
3 NM	1,500 ft	1,640 ft

Seven NM out, the airplane was three hundred feet lower than the nominal slope. Five NM out, the airplane moved to 130 feet above the slope. Three NM out, it again passed under the slope (140 feet) , with a descent rate of 1,000 feet per minute on this segment. Radar data is not usable at less than three NM.

Examination of the radar track shows that the pilot performed the procedure using the 184° path directly (corresponding to the outbound 004° path) instead of the published 172° path. Further, the pilot did not over-fly the IAF to descend under the minimum altitude in the sector to the altitude at the beginning of the procedure and he was not under radar vectoring. The order of 17 July 1992 concerning general air traffic procedures for the use of aerodromes by aircraft specifies that “on arrival, if an instrument approach procedure is published and approved, the aircraft must conform to it unless a visual approach is decided on”. Taking into account the meteorological conditions, the pilot could not have the field in view. Following the incorrect path in addition to the descent under the minimum safety altitude indicates some kind of improvisation, apparently resulting from the change of strategy analyzed in paragraph 2.1.

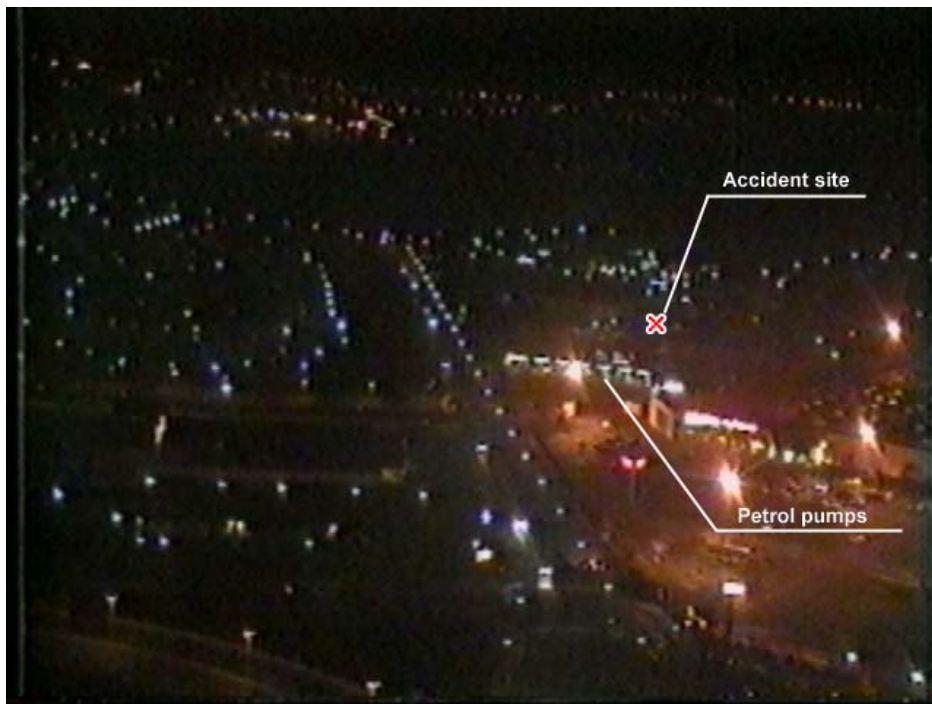
Figure 2: lighting environment near the accident site

The following photograph shows lines of lights corresponding to avenues lined with lampposts, in the vicinity of the accident site.

- performing an approach procedure that was initiated precipitously and incompletely applied,
- the confusion between the luminous references located in an urban area and the runway lighting, at the moment of transition to visual flight.

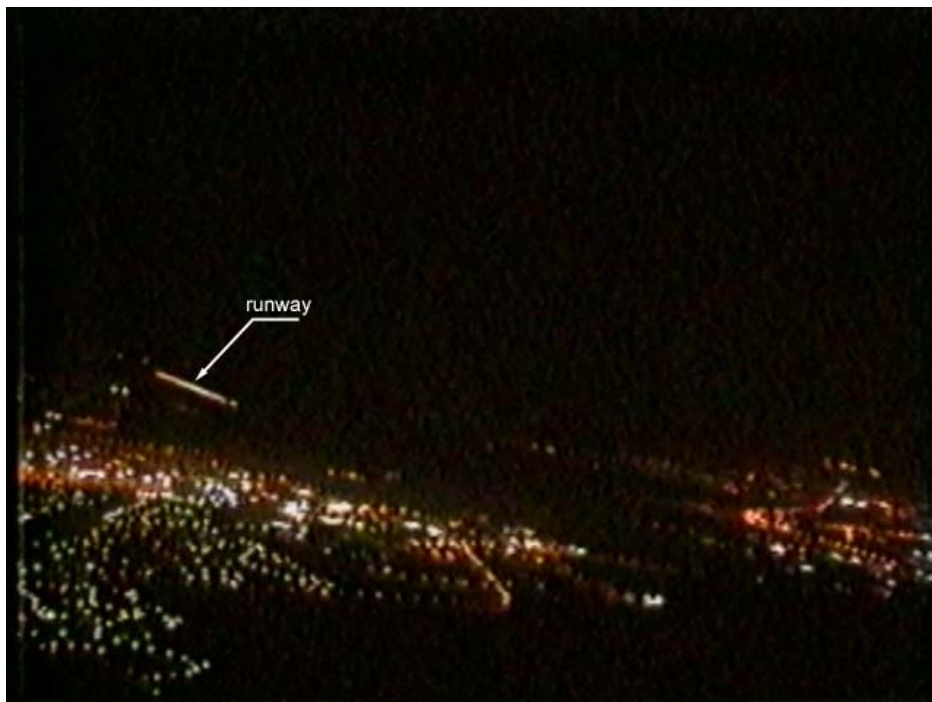
Figure 3: runway position

Varying the intensity of the runway lighting shows the position of runway 18 at Dijon-Longvic. The photo above was taken with the runway lighting at maximum intensity.

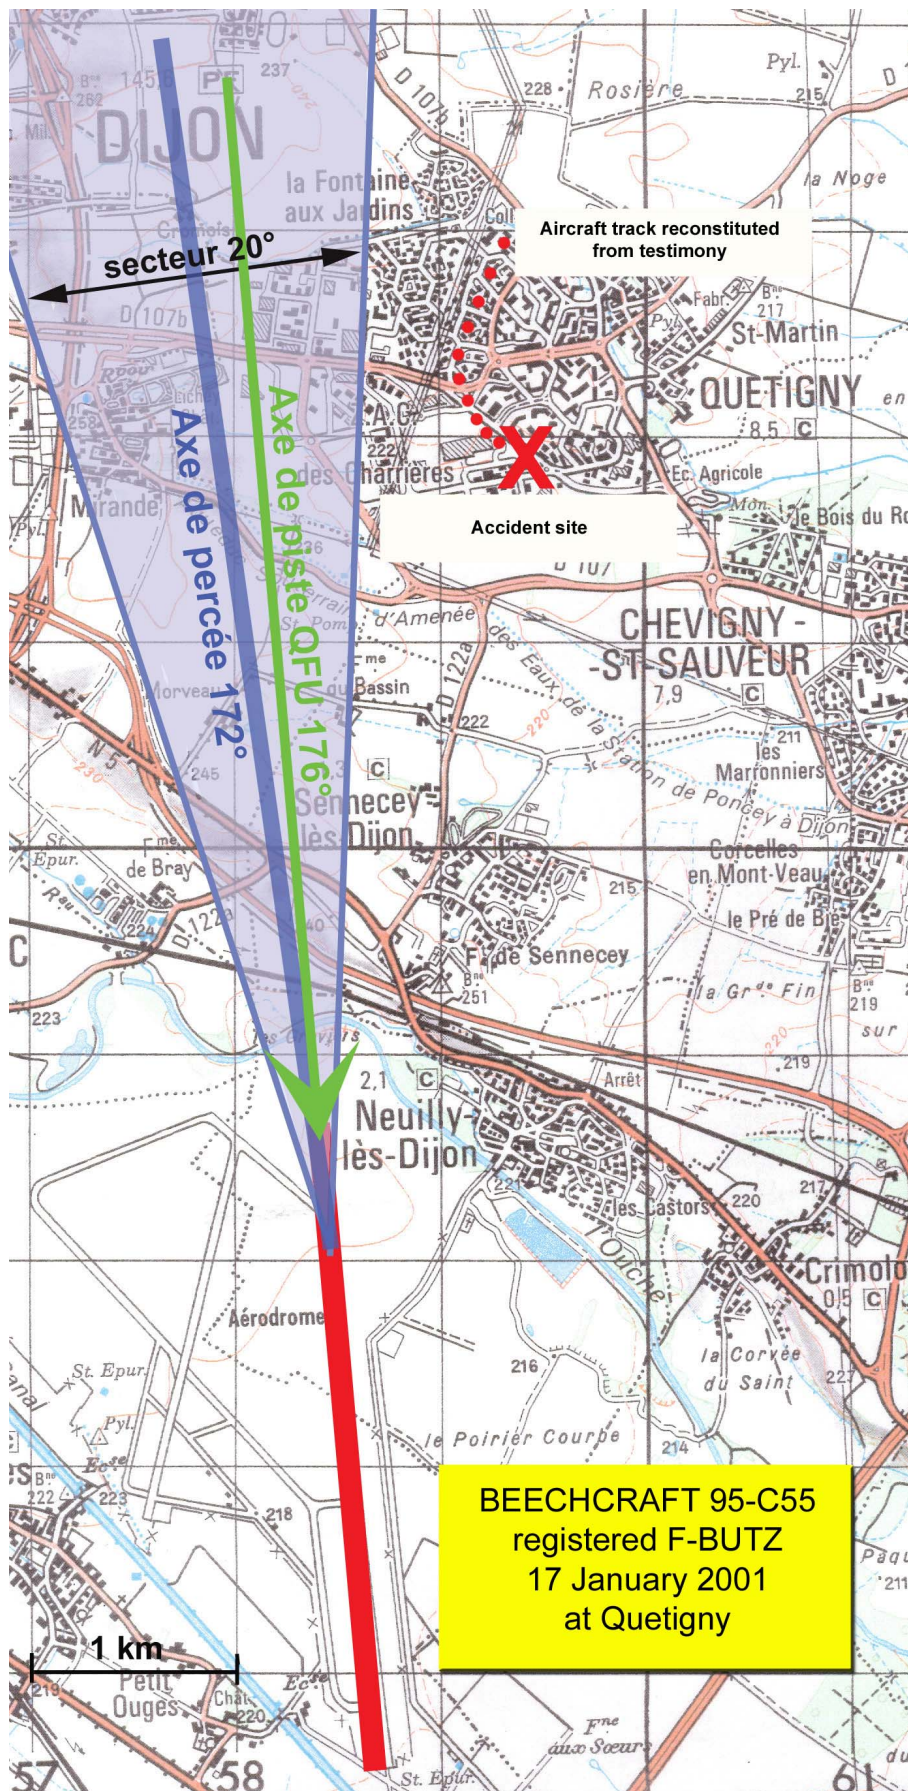
Flight path as re-constituted from witness testimony

Many witnesses saw the airplane perform controlled turns at a low height in the last moments of its flight, then line up parallel to an avenue lined with lampposts, at a height of about thirty meters, as if "the airplane was going to land".
