# Report

Incident on **25 May 2001**  
at **Cayenne-Rochambeau Airport (French Guyana)**  
to the **Airbus A340-311**  
registered **F-GLZC**  
operated by **Air France**

**BEA**

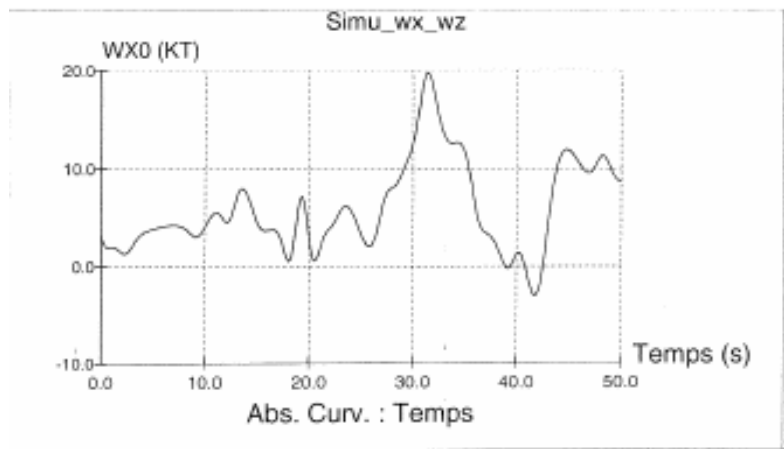
Horizontal wind component (add 3 kt)<sup>(5)</sup>

The effect of the horizontal component was preponderant in the incident. Ten seconds before the first wheel touchdown (corresponding to time 32 on the abscissa), at about 120 ft radio height, the effective headwind was 23 kt then it dropped to practically nothing at touchdown.

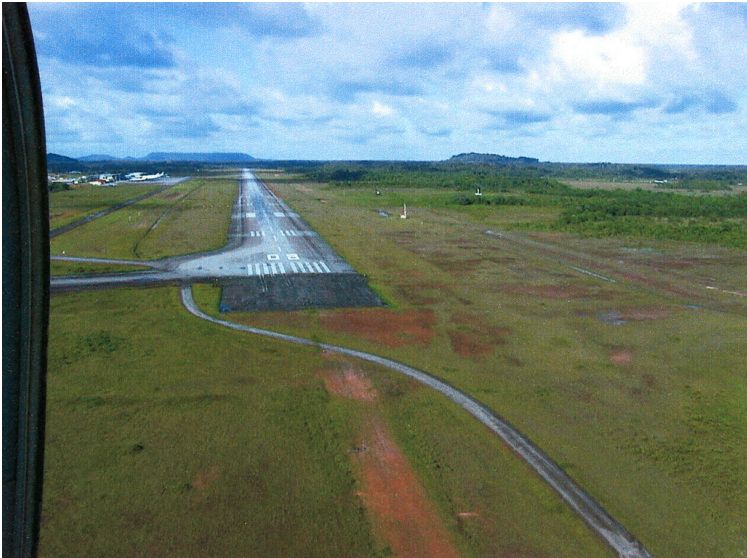
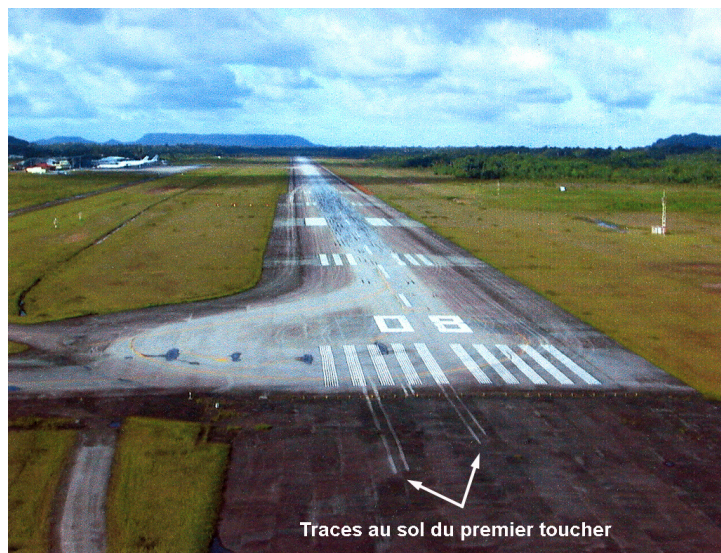
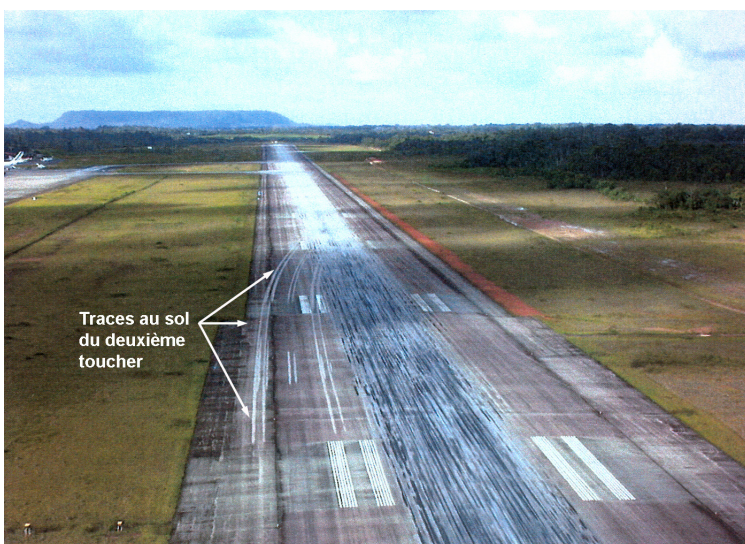
### Photographs of marks on the ground

Two series of marks were noted on the ground (see appendix 4). The first, corresponding to the first touchdown was to the left of the runway centreline. It started on the paved area, about thirty metres before the threshold of runway 08. There were, in order of appearance, a mark forty metres long left by the left main landing gear, a mark of thirty-eight metres left by the right main landing gear and one of three metres left by the central gear. The second series corresponded to the second touchdown and started 480 metres after the first marks. The mark left by the gear was on the paved area, located to the left of the runway, measuring 106 metres and curving to the right at the end to return back onto the runway. The mark left by the central gear was on the runway, consisting of a sixteen-metre long mark followed, twenty metres further, by another mark of about thirty metres. The mark left by the gear was 96 metres long and was to the left of the runway centreline.

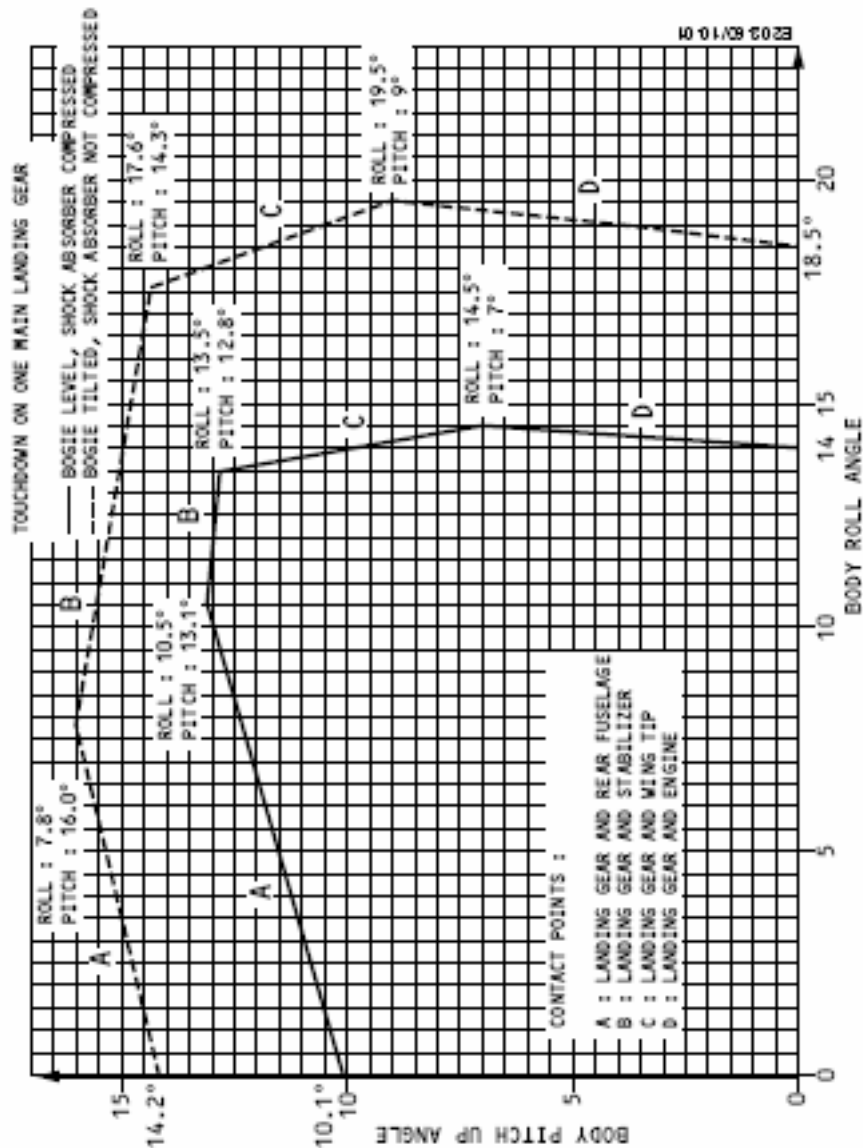
#### GARDE AU SOL (A340)

The airplane's attitude limit is  $10.1^\circ$  with the dampers compressed and the wings flat. Beyond this, the rear section of the fuselage touches the ground (see appendix 6).
