*Accident
on 22 March 2001
at Orléans Saint Denis de l'Hôtel aerodrome (45)
to the Piper PA-31-350
registered PH-ABD
operated by Tulip Air*

REPORT

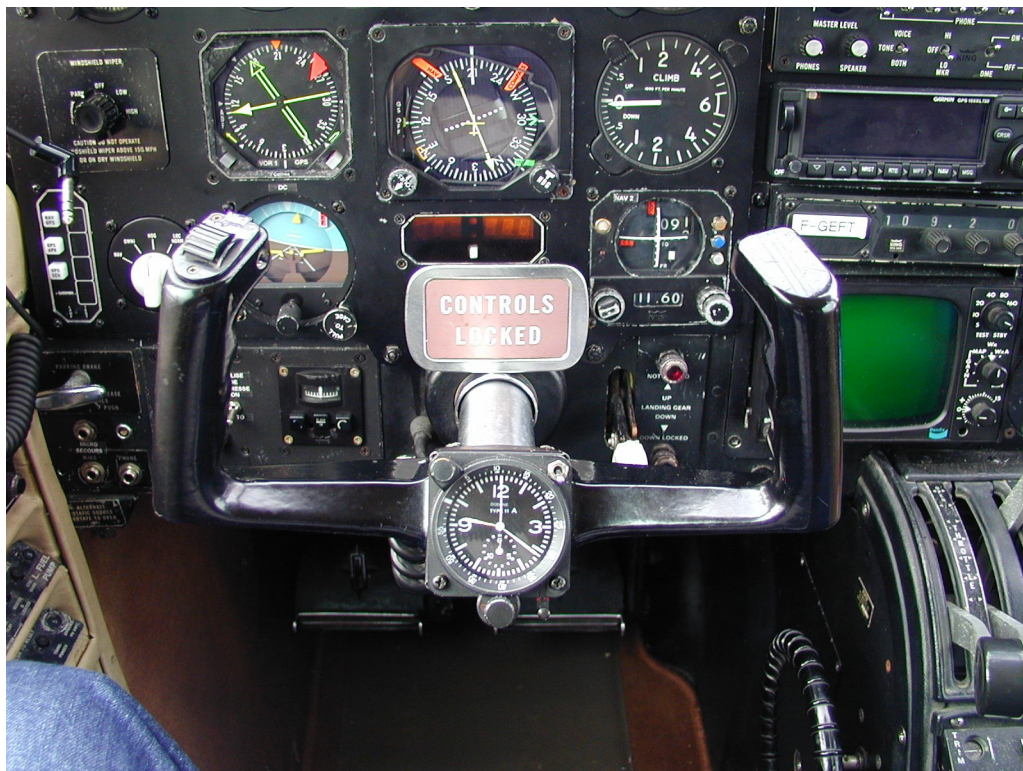
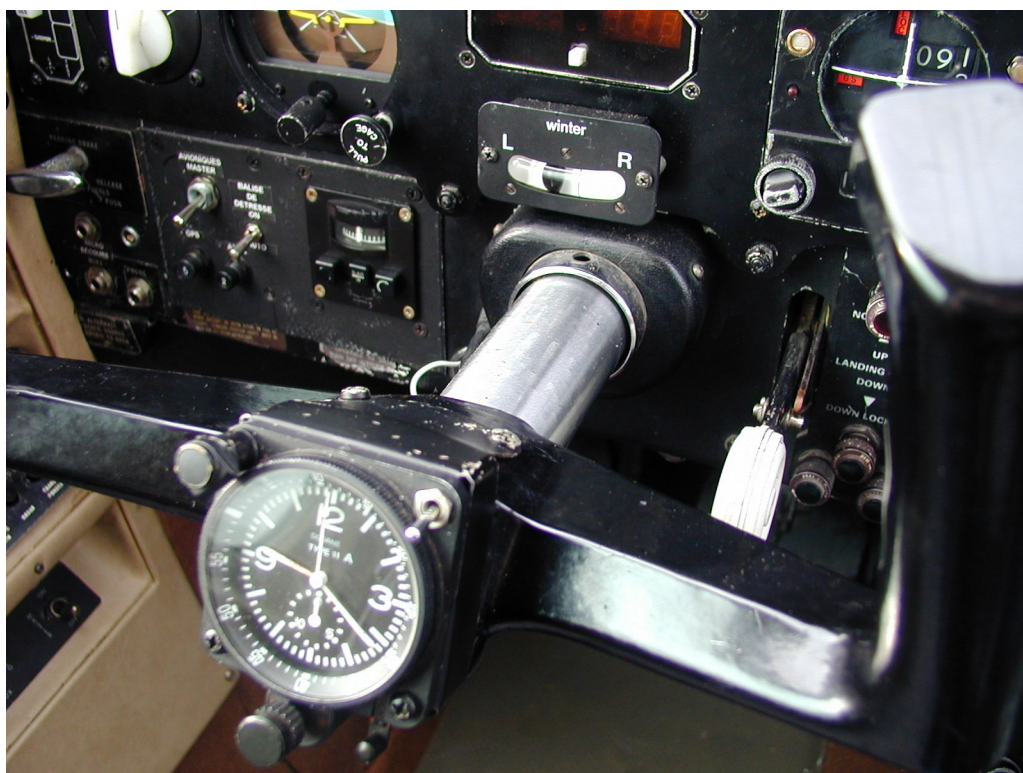
The aircraft is equipped with a flight control locking device for use on the ground installed so as to avoid the flight control surfaces flapping. The system is based on locking the left side control wheel. It consists of a nail-shaped latch pin topped with a rectangular light alloy metal plate that can bear the inscription "Controls Lock" on a red background. The latch pin is inserted into holes drilled into the shoulder to the right of the wheel housing on one side and into the wheel shaft on the other.

Note: the following photos, designed to illustrate the lock, are not of the accident aircraft. The crew took the latch pin away with them.

The wheel is thus maintained in a horizontal position, the ailerons remain in a more or less neutral position and the elevator is deflected down. No use of instruments or vital controls is affected by the presence of the locking device. The wheels on the accident aircraft were equipped with clips designed to hold the takeoff or landing charts. The presence of such a card tends to hide the metal plate. According to the crew's statements, no charts were in this position during

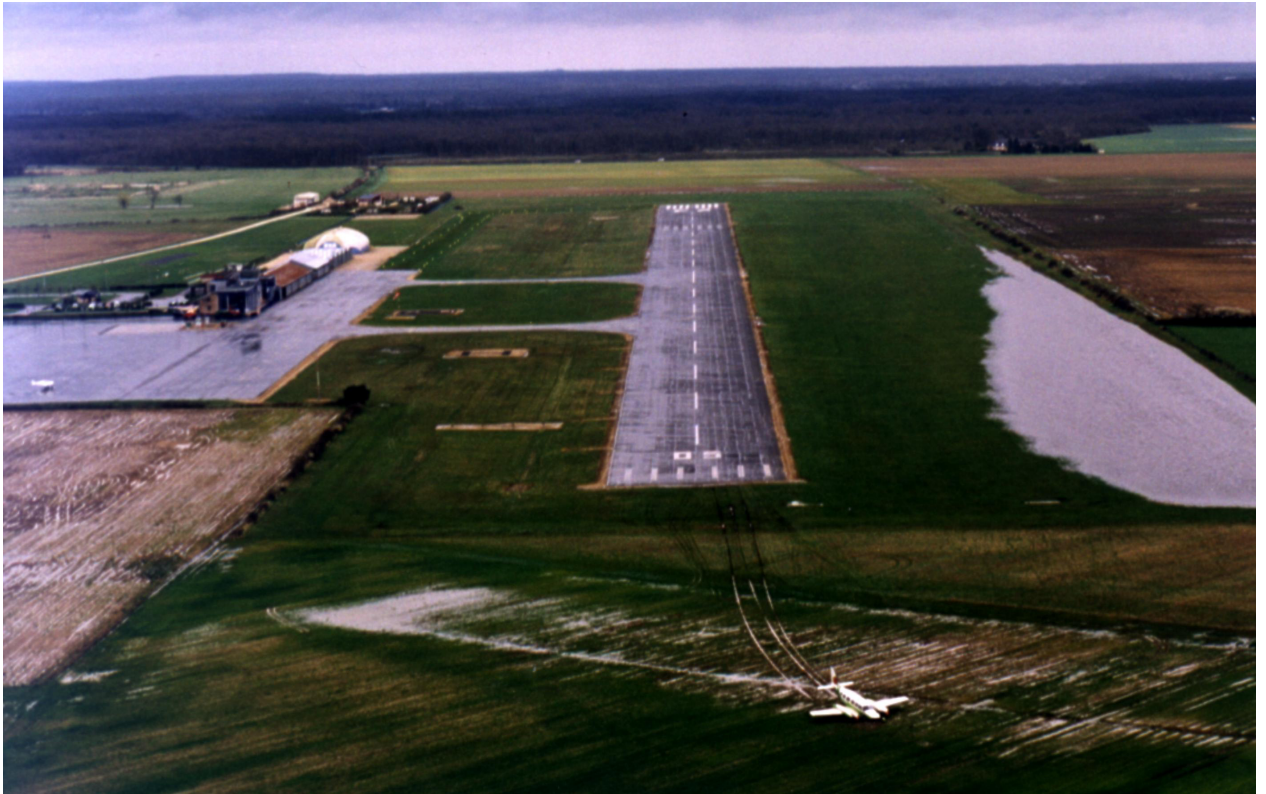
Picture of Site and Aircraft

The crew forgot to remove the flight control locking device before takeoff. At the end of the takeoff run, they could not rotate the aircraft. An attempt to abort the takeoff was undertaken but the aircraft overran the end of the runway after a slight track deviation to the left. It came to a stop on muddy ground in a field about one hundred and eighty-three metres from the end of the runway. The nose gear was broken, the propellers and the aircraft nose were damaged.

The aircraft ran across grass soaked with water. The nose gear broke and the aircraft came to a stop about one hundred and eighty metres after the end of the runway (photo of site and aircraft in appendix 1). The crew had forgotten to remove the flight control locking device.
