## **ACCIDENT**

### ***involving the glider registered D-5580***

<b>Event:</b>	Stall during bank at low height, collision with trees.
<b>Probable cause:</b>	Instructor briefly distracted leading to late perception of the intention of the pilot in the front seat.

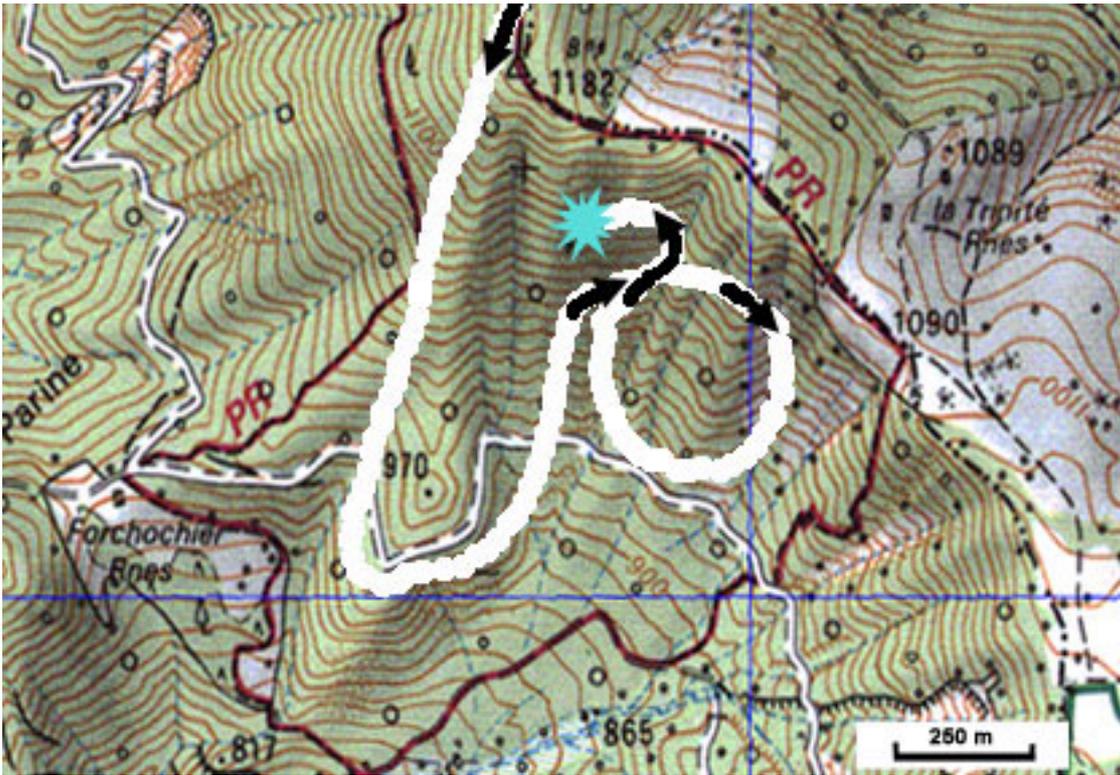
D-5580 on 4 March 2002 – Glider track reconstituted from GPS data
