ACCIDENT

involving the glider registered HB-1932

Event:	Loss of control near high ground.
Probable cause:	Inadequate control of flight parameters.

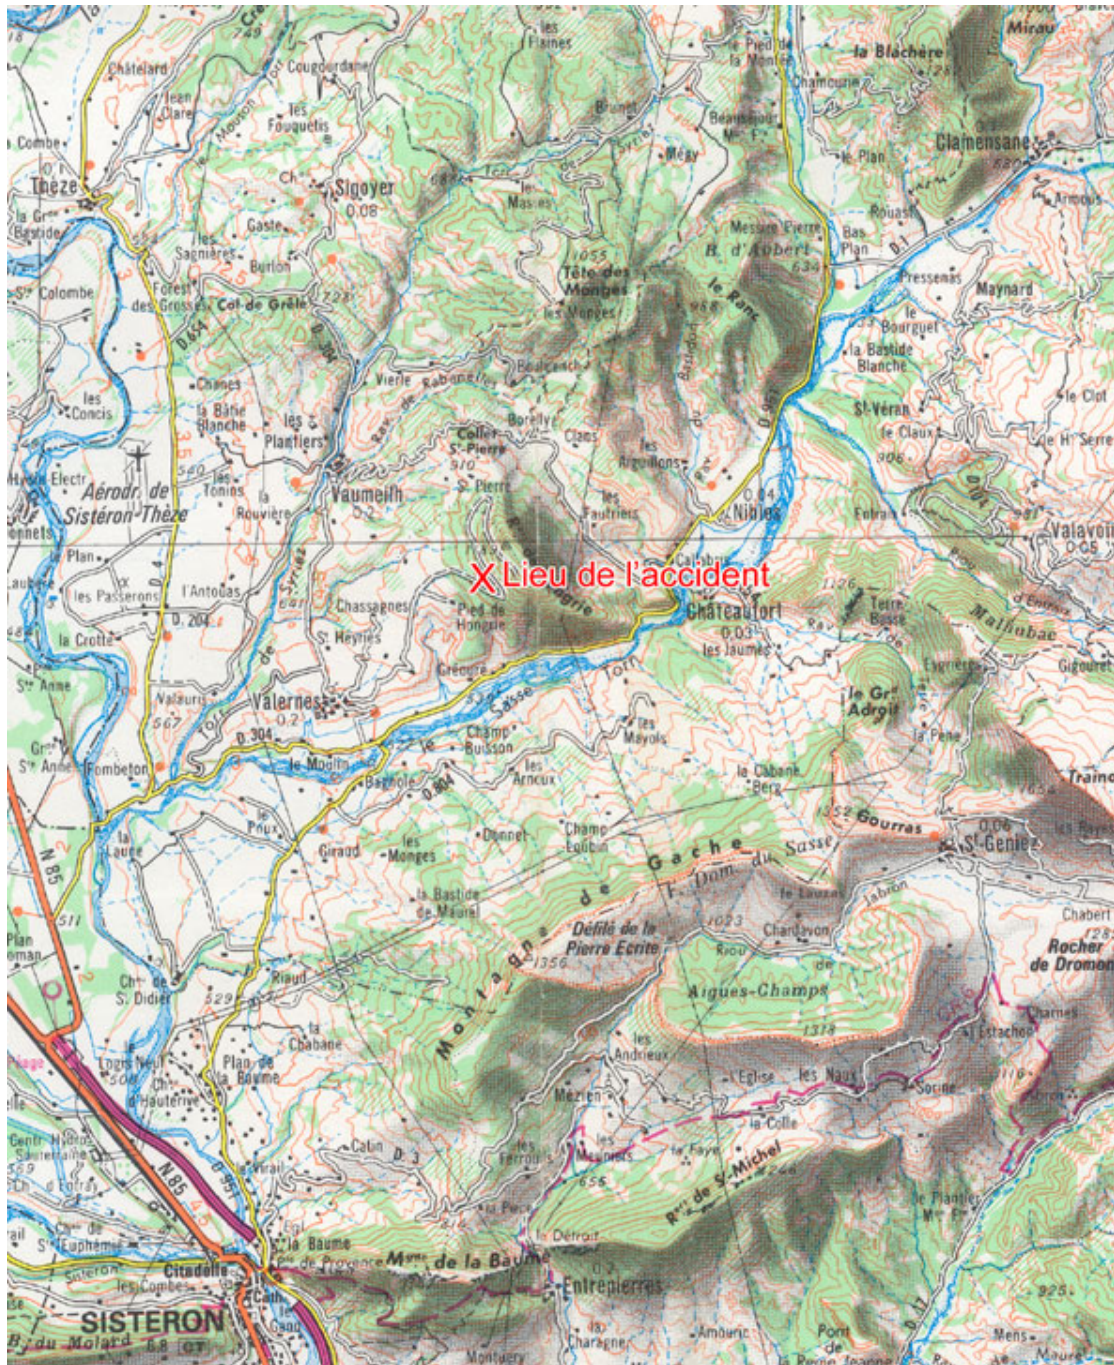
HB-1932 on 2 April 2002

Examination of the site and the wreckage showed that the glider had struck the ground wings levelled at a high vertical speed and a very low horizontal speed.
