REPORT

on the accident
on 6 March 2003
at Tamanrasset
to the Boeing 737-200
registered 7T-VEZ
operated by Air Algérie

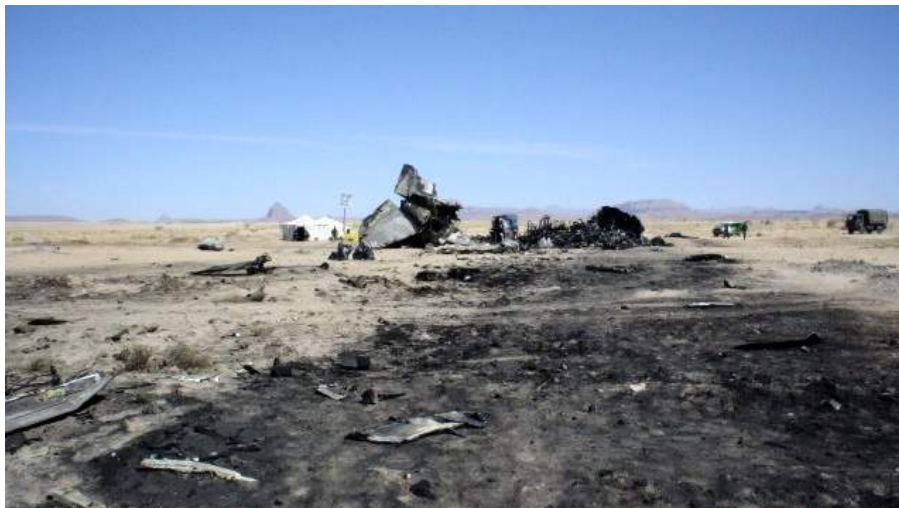
The take-off area is estimated to be abeam the Tower, just after the taxiway. Practically from this point onwards, engine debris was found. Around six hundred meters before the end of the runway, the debris was scattered to the left of the centerline, showing a track roughly fifteen degrees from the centerline. The first point of impact is at 1,645 m from the takeoff area. From this point on, a strip of land showing the marks of an intense fire shows the right of the track (see photo), roughly in line with the right wing. A lot of debris was found, including the engines. The airplane then crashed into the aerodrome perimeter fence and crossed the road. Beyond the road, the right main landing gear was found (without the wheels) then the main wreckage, which had pivoted towards the right.

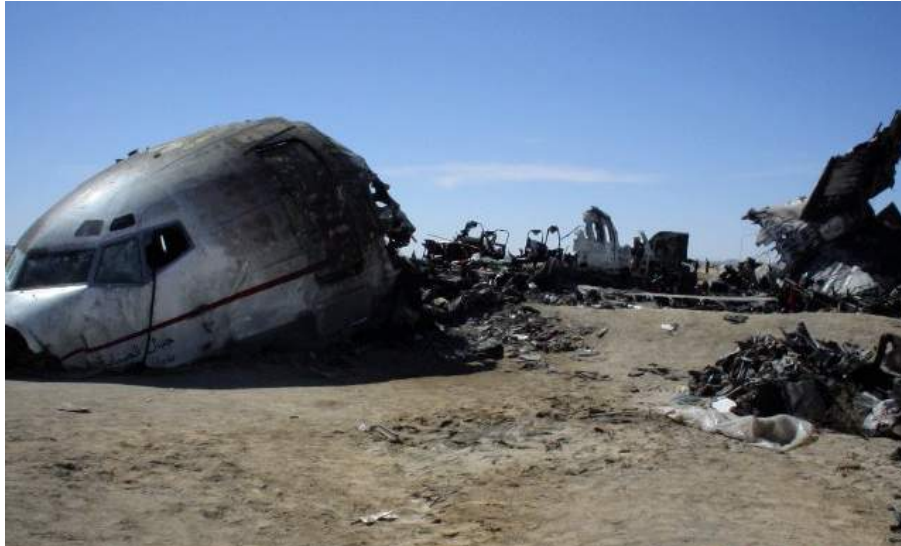
The main wreckage was practically in one single piece, had been destroyed by fire, the right wing was folded back along the fuselage and the rear section was detached and tipped over. The wheels of the two main landing gears were found there.

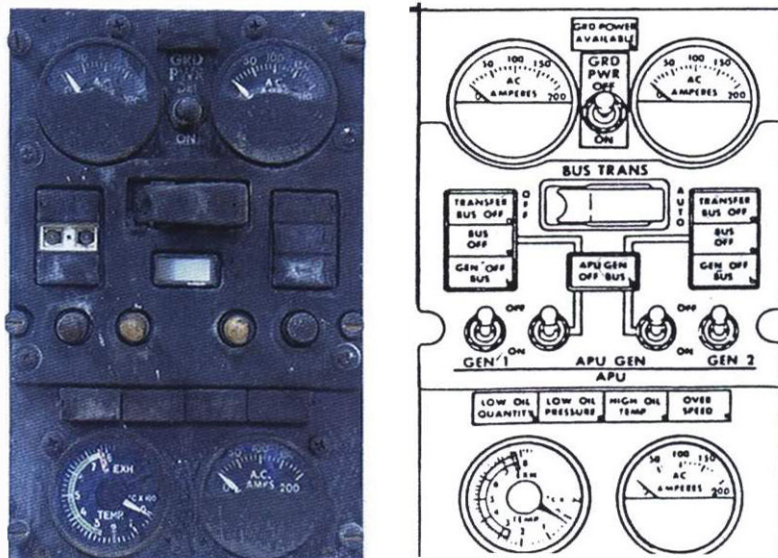
Examination of the electrical power system did not bring to light any malfunction. The photo below, accompanied by the graphic from the airplane manual, shows the module related to electrical power generating systems linked to the two generators and to the APU.

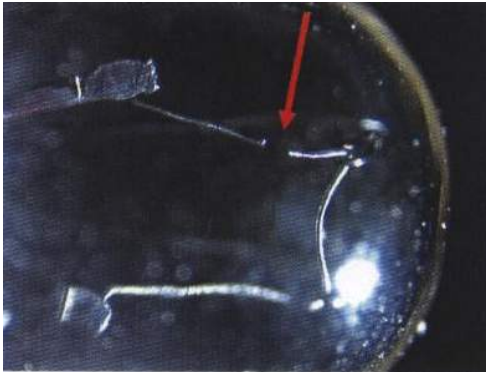
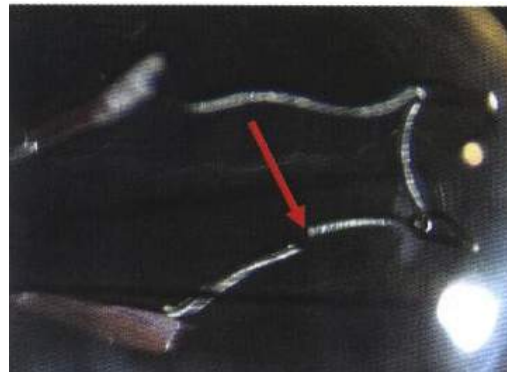
Warning lights GEN #1 TRANSFER BUS OFF and GEN #2 TRANSFER BUS OFF

The bulbs of several warning lights, including the TRANSFER BUS OFF, BUS OFF, GEN OFF BUS and APU GEN OFF BUS, were examined as the following photos illustrate. Their examination showed that most of the filaments were broken on impact.

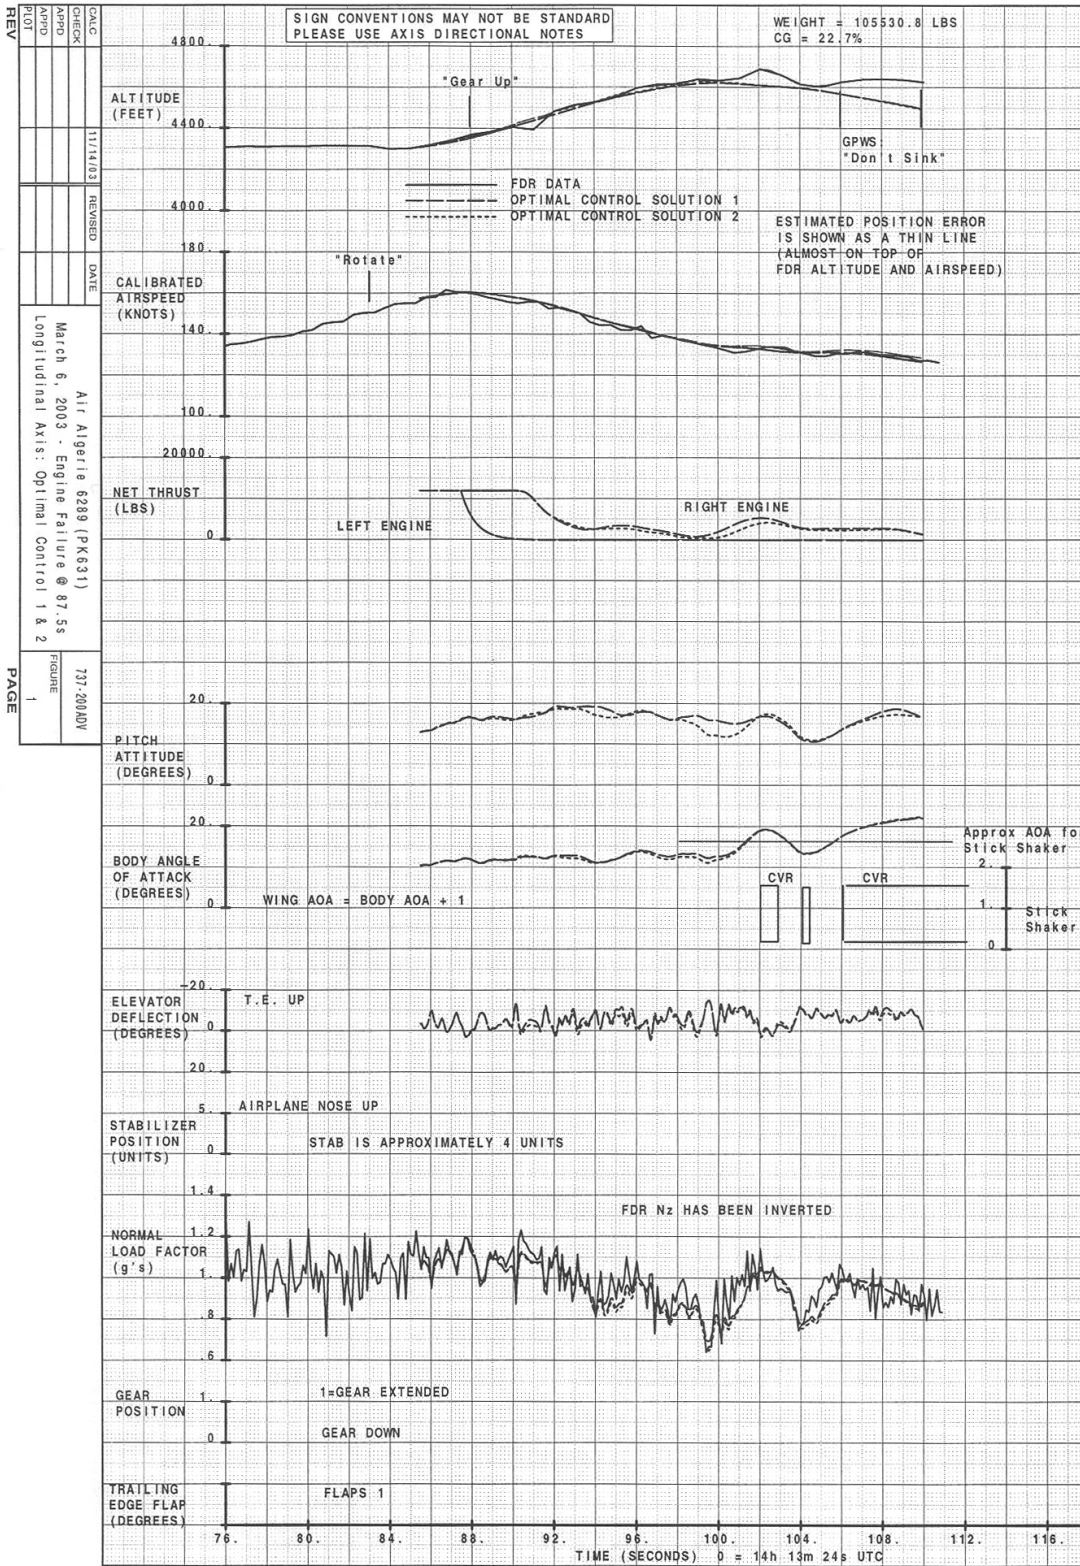
737-200ADV
 FIGURE 1
 Air Algerie 6289 (PK831)
 March 6, 2003 - Engine Failure @ 87.5s
 Longitudinal Axis: Optimal Control 1 & 2

The airspeed decreased on the airplane to the point that a stall condition was encountered. In addition, our analysis of the FDR and CVR data concludes that a significant reduction in thrust on the right engine occurred after the failure of the left engine.

The re-creation provides a good representation of the FDR data, CVR information, and the impact sites and impact attitude. Note that it takes a significant reduction in airplane performance, provided by the significant reduction of thrust on the right engine (in addition to the left engine failure), to achieve these results. In addition, the airspeed decreased on the airplane to the point that a stall condition was encountered.

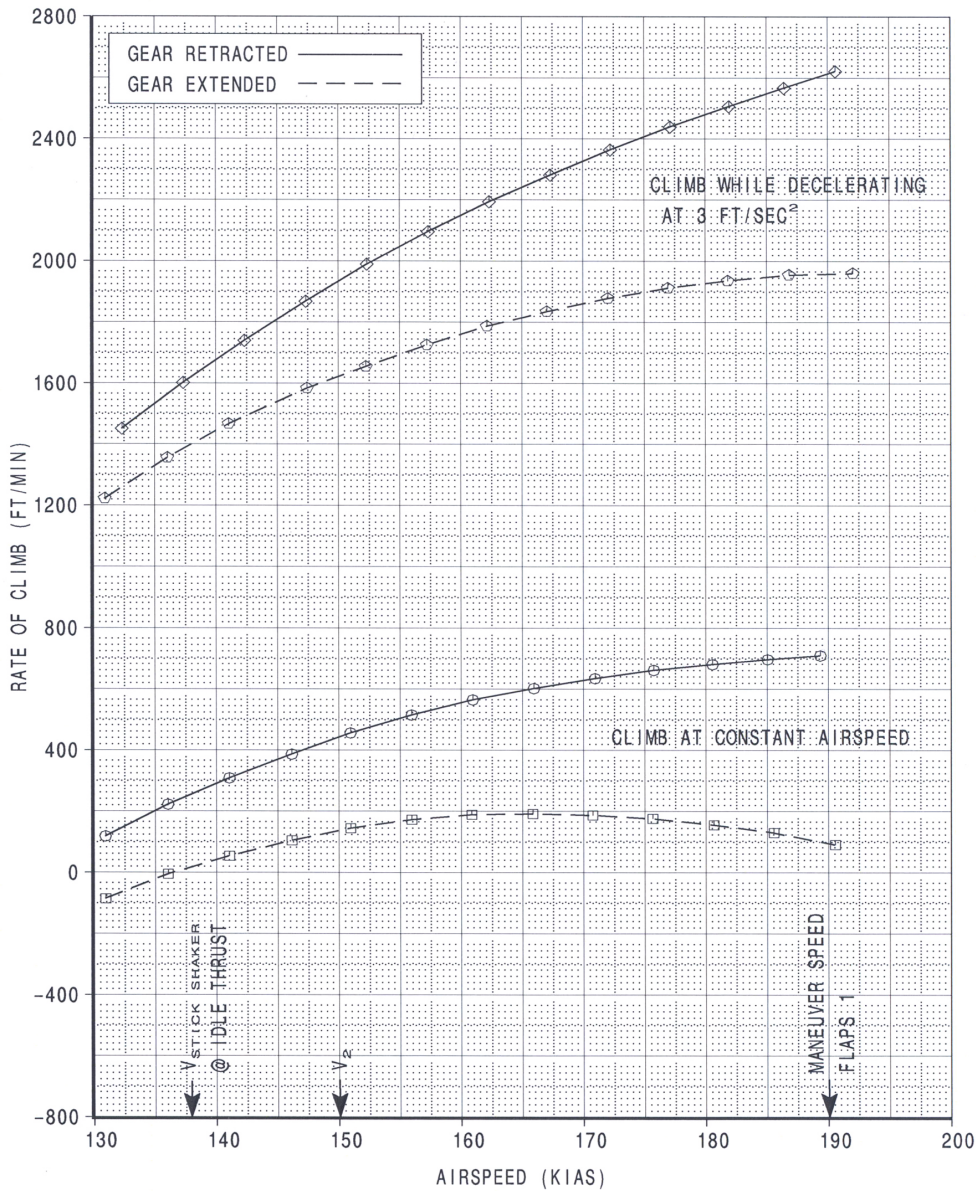
CLIMB CAPABILITY

- FLAPS 1
- ONE ENGINE INOPERATIVE
- GW = 107381 LB
- TEMP = ISA+16.5 DEG C (23 C)
- 150 FT ABOVE AIRPORT (4454 FT)
