Incident
on 18 January 2003
at Paris Charles de Gaulle airport
to the Boeing 747-412F
registered 9V-SFH
operated by Singapore Airlines Cargo

REPORT
9v-h030118a

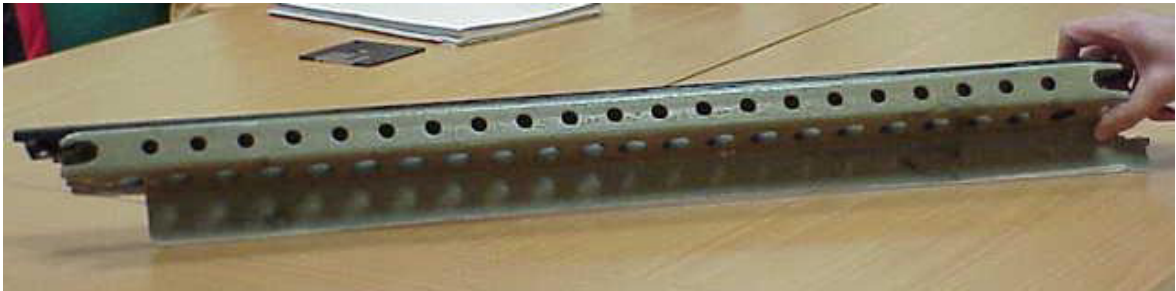
The airplane was damaged at the level of leading edge flap ⁽³⁾ 26 E on the right wing ⁽⁴⁾. The wing leading edge was also slightly damaged.

A part of flap 26 E was found on the northern edge of runway 26 right between taxiways S4 and S3.

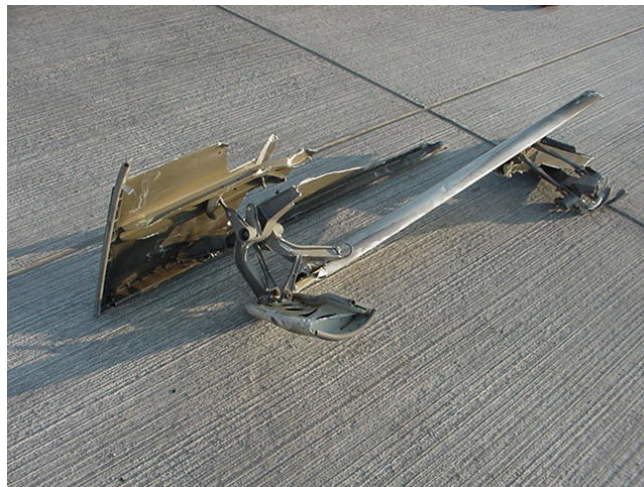
The main damaged part of flap 26 E was found at Dubai.

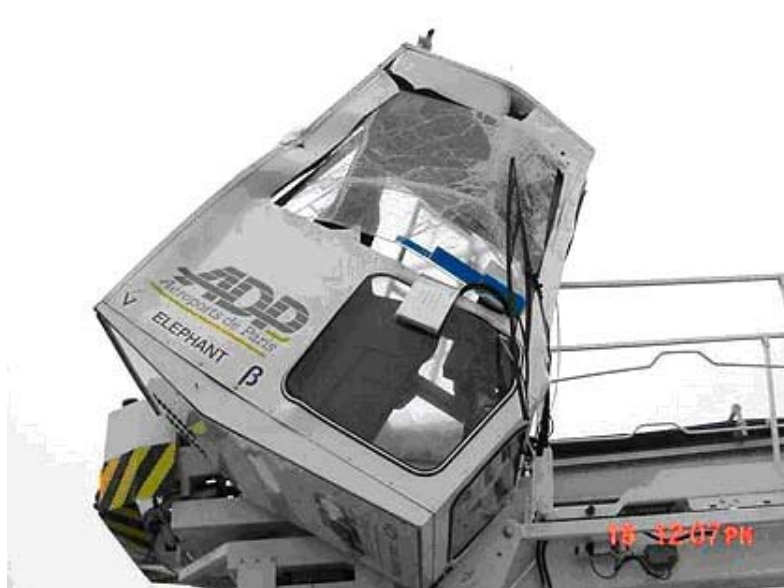
The operator's control cabin on the de-icing vehicle was damaged.

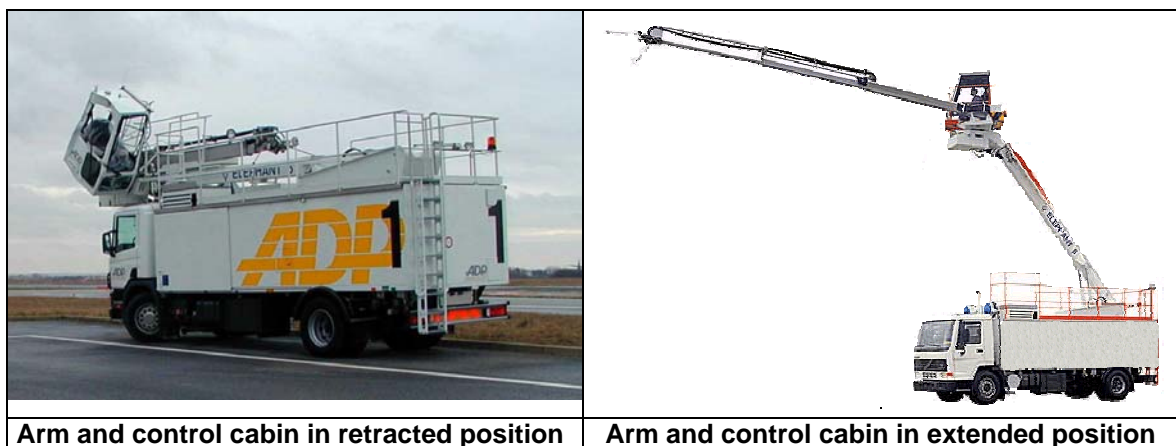
These autonomous vehicles allow heated de-icing liquids to be sprayed via a rotating cannon located at the end of the telescopic boom. The operator gets into the rotating cabin. There is a flashing light at a height of 4.10 m.

When the arm is retracted, the cabin can be in a high position (during use) or in a low position (during vehicle movements). The overall height of the vehicle is then 5.20 m and 4.10 m respectively. At the time of the collision, the cabin was in the high position, with the arm retracted.

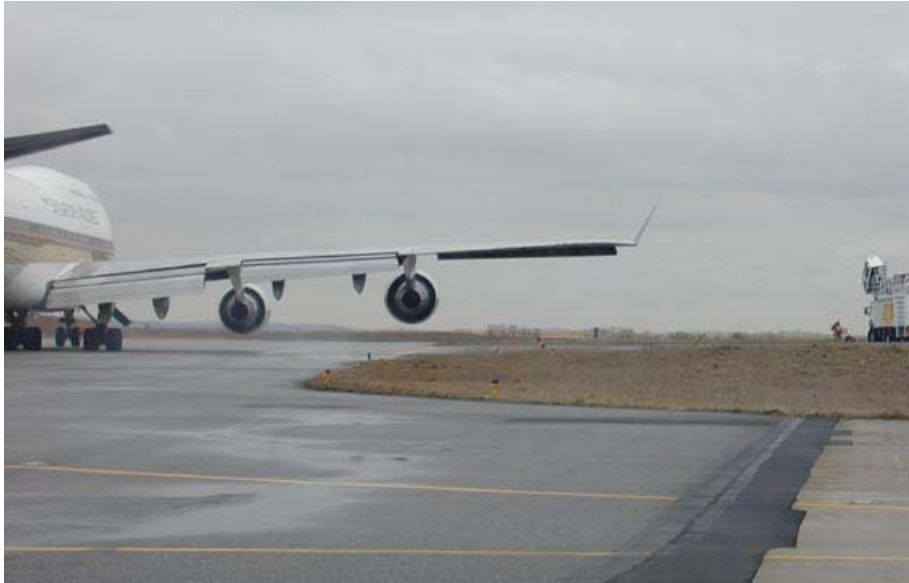
The dissymmetry between the surfaces defined by the painted lines should be noted: the surface to the north of the area is clearly larger than that to the south. As a result, the vehicle has to be parked parallel to the taxiway in order to remain within the defined area whereas to the north it can be oriented in any direction.

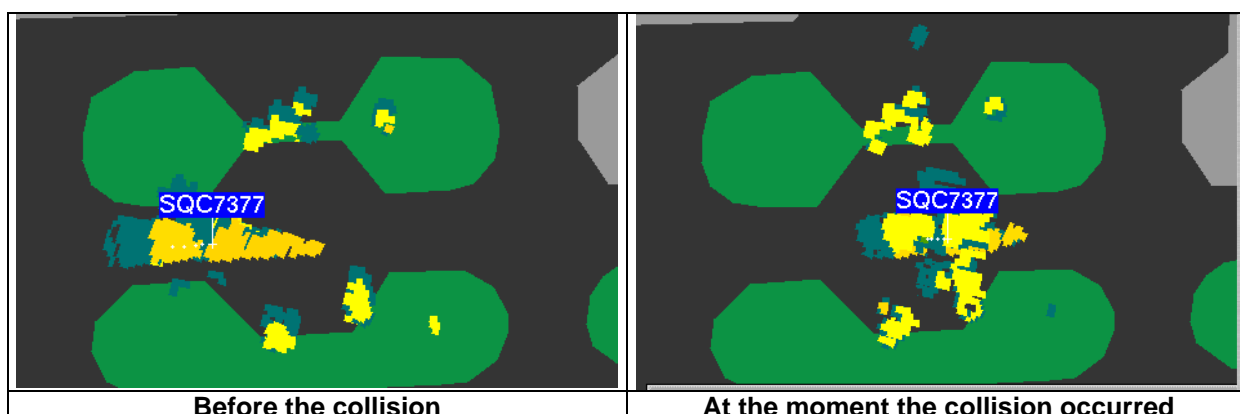
The ground radar recorded the airplane's movements from taxiing to take-off. The following photos are taken from the recorded images. They show the situation just before and during the collision. The surrounding area is shown in various colors: black is for the taxiways (the hexagonal shape of SE1 included), green is for the verges and orange or yellow for radar returns from fixed or mobile objects. The precision and sampling rate do not allow the outlines of the various vehicles to be defined exactly. The group of yellow and orange dots at the center of the area, moving from west to east, corresponds to the airplane. The tag indicating the flight number is superimposed on the radar return of the airplane.

These images show that the de-icing vehicle parked to the south-east is positioned differently than the three others, in a more withdrawn position (group of yellow dots).

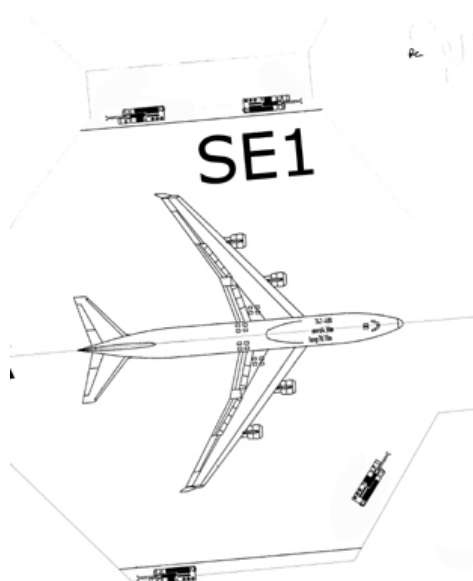
This radar data and on-site observations after the collision showed the approximate position of the vehicles on the de-icing zone a few seconds before the collision:
