Accident
on 22 June 2003
at Guipavas (21)
to the Bombardier Canadair
CL-600 2B 19
registered F-GRJS
operated by Brit Air

REPORT TRANSLATION
[f-js030622a](#)

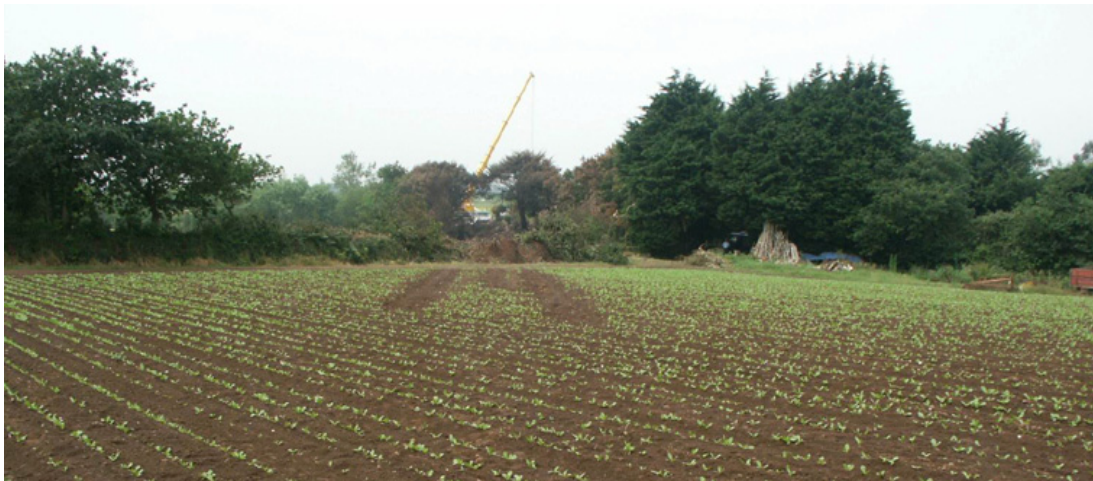
Marks left by the main landing gear wheels

First contact with the ground occurred in a mud field with a slight slope (about 3%). The main landing gear wheels left marks oriented along a 281° heading, without any marked furrowing, which indicates that the contact was not violent, with a low vertical speed.
