Report

Incident on **4 July 2005**
at **Paris Charles de Gaulle (95)**
to the **Lockheed 1011-385-3**
registered **A6-BSM**
chartered by **Olympic Airlines (Flight OA202)**
and operated by **Star Jet**

BEA

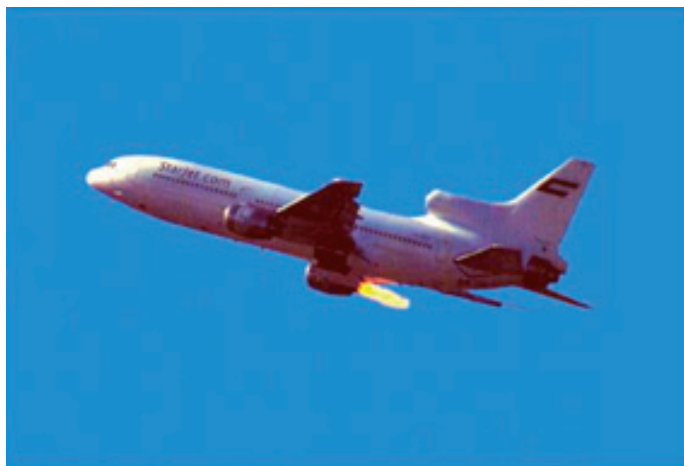
(Source Le Parisien)

The incident, an engine surge after takeoff, stirred great emotions, which were heightened by the publication of a photo of the airplane in flight, with a large flame trailing behind one engine. Questions asked by the passengers and by those from the airport's neighbouring area were widely spread via the media.

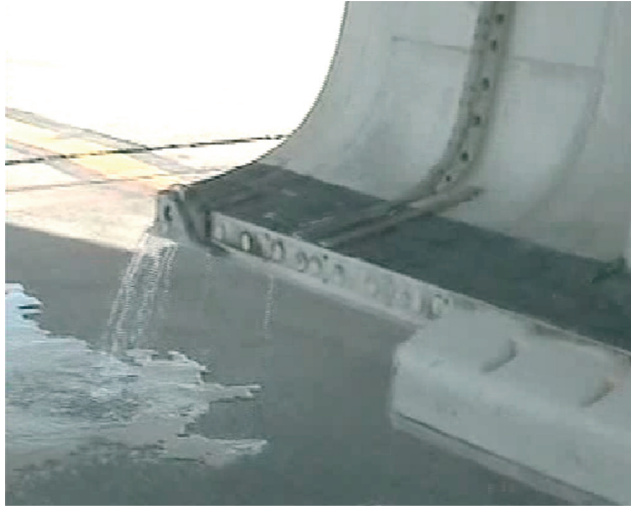
Fuel leak detected on opening a landing gear door

- ❑ A serious fuel leak outside of safety limits under the right wing. The liquid was flowing onto the brake block of the right L/G. A service bulletin had been issued for this fuel circuit and this seems to have been applied. Damage to the paintwork on the starboard wing seemed to indicate that this leak was not recent ⁽⁸⁾.

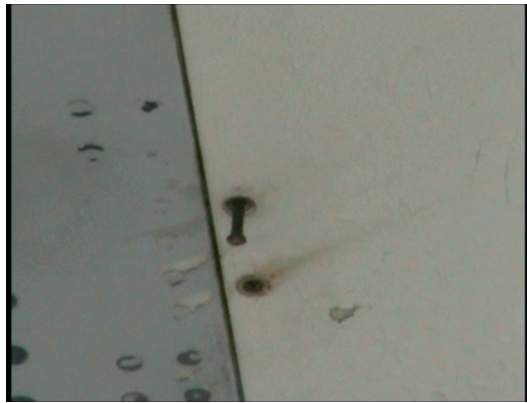
Example of a loose screw on a lower wing panel

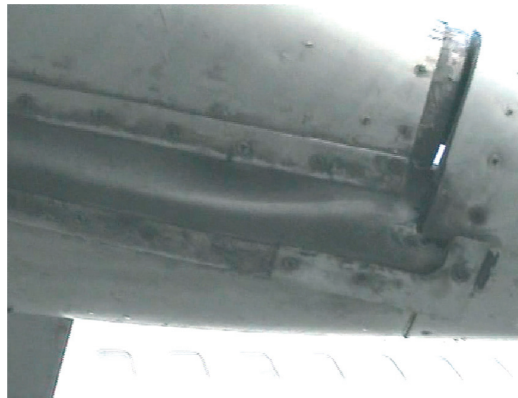
There was serious corrosion on several mechanisms, in particular on the flaps and slats (flap guide rails). Several rivets were missing from the lower left wing. A seal had been added in accordance with a service bulletin, but had been fitted in a makeshift way.

Example of the fairing of a flap guide rail that had come loose because certain rivets were missing

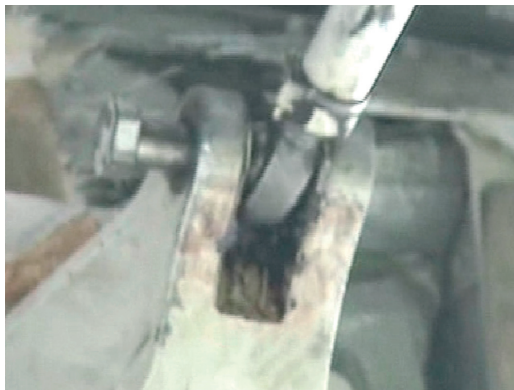
The cargo door actuator was ripped off and the support provided for opening did not ensure the safety of the personnel handling the door. The lower nut on the actuator was missing and the screw was almost out of its fitting. An electric cable had been crushed by the closing of the door. The electric motor actuating the door was no longer attached to the airframe. The pressure seal fitted on the door frame was rotten and part of the upper door frame was broken. In view of the condition of this door, the specialists were sceptical as to the potential consequences of performing any new pressurisation cycles.

Off-centre cargo door actuator

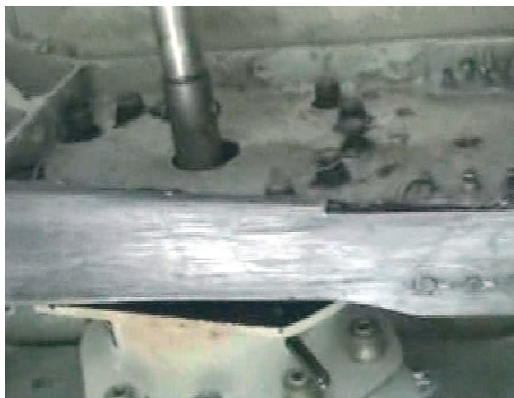
Actuator motor separated from the airframe

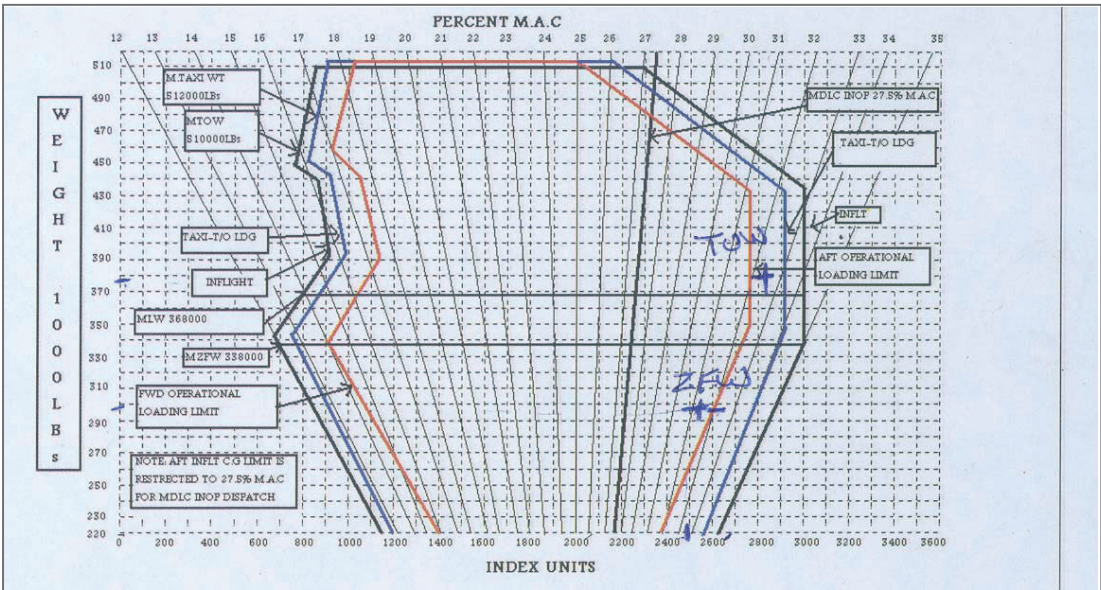
These three different empty weight equipped indices had been used randomly by the crews on the weight and balance sheets found on board.

Note: The maximum permitted index range calculated for loading is 2,300. This must be compared with the range of uncertainty of 621 between the indices used.

Excerpt from the load sheet filled in for a CDG-ATH flight on 2 July 2005 (using the index given on the weight report issued by GAMCO, i.e. 2,161). The index of 2,782 given in the table provided by the operator for airplane 9L-LED made takeoff impossible.
