# Rapport

Accident survenu le **9 septembre 2006**  
à **Ferrières-en-Brie (77)**  
à l'**avion Robin R 2120 U**  
immatriculé **F-HAPC**

**BEA**

Bureau d'Enquêtes et d'Analyses  
pour la sécurité de l'aviation civile

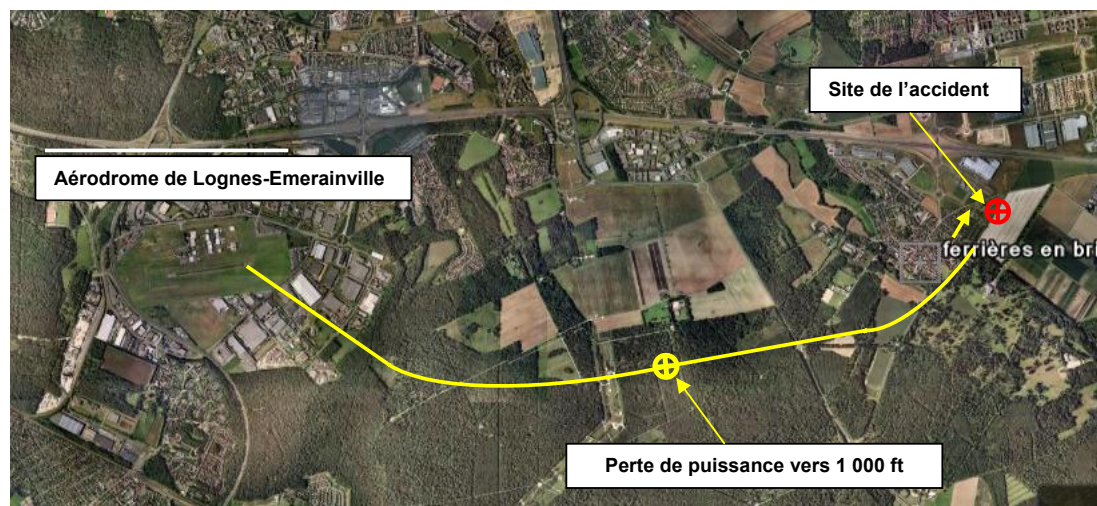
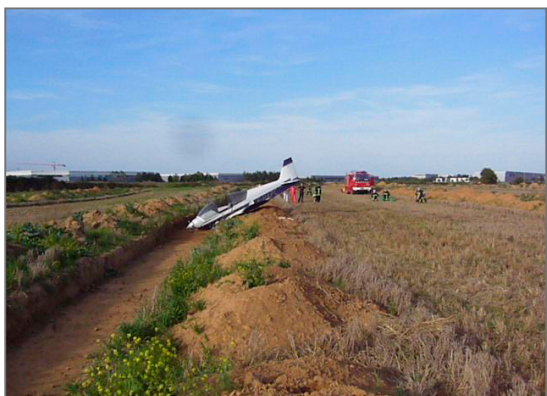
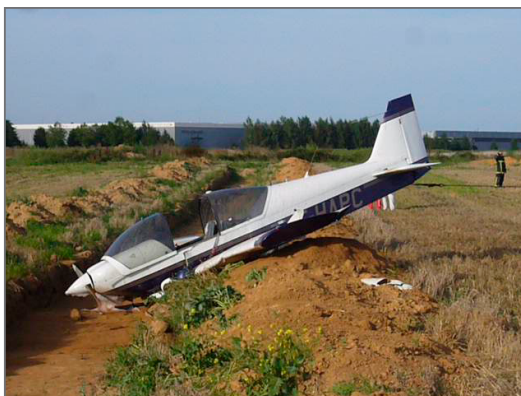
Lors du roulement, le train d'atterrissage s'efface et l'avion s'immobilise dans une tranchée.

La cellule et les ailes présentent de nombreuses déformations dues à l'impact. Le réservoir d'essence contient du carburant. Le moteur et l'hélice sont retrouvés intacts.

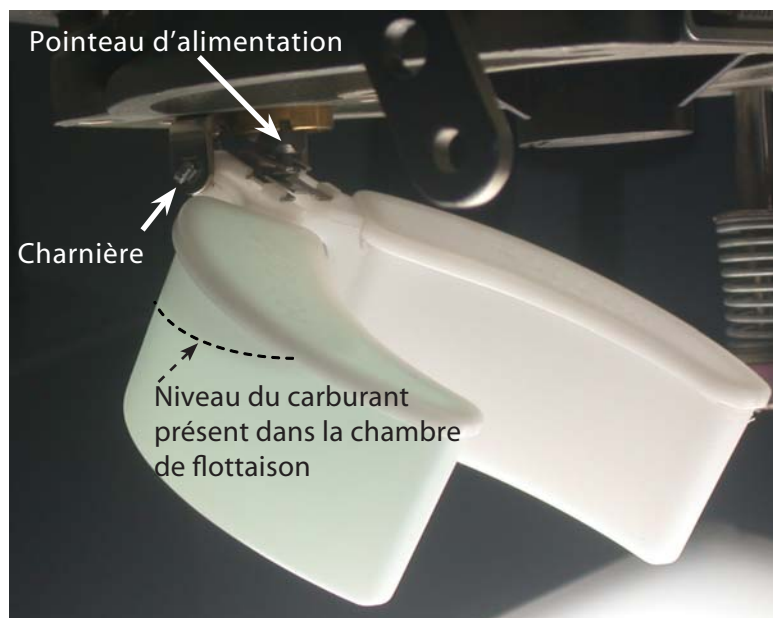
Un examen du carburateur a été effectué. Il a montré une anomalie au niveau du flotteur. Ce flotteur, en forme de fer à cheval, comporte deux chambres de flottaison creuses indépendantes en polymère. Le mouvement du flotteur autour d'une charnière est transmis au pointeau d'alimentation et permet ainsi la régulation du niveau de carburant dans la cuve du carburateur. De l'essence avait presque entièrement rempli une des deux chambres de flottaison normalement étanches et vides de carburant.

La présence d'essence dans l'une des chambres du flotteur du carburateur altère la flottabilité ainsi que l'équilibre de ce flotteur. Ce déséquilibre engendre des forces dissymétriques sur la charnière. Il peut entraver le libre mouvement du flotteur, celui du pointeau d'alimentation et, par conséquent, une variation du niveau d'essence dans la cuve modifiant la richesse du mélange carburé.

Cela est susceptible d'entraîner des modifications de puissance plus ou moins importantes. C'est ce dysfonctionnement qui paraît être à l'origine de la perte de puissance en vol du F-HAPC.
