REPORT A-042/2007

Date and time	Monday, 24 September 2007; 17:07 local time ¹
Place	Dalias (Almeria)

Registration	F-BTVI
Type and model	Morane Saulnier MS 893 E

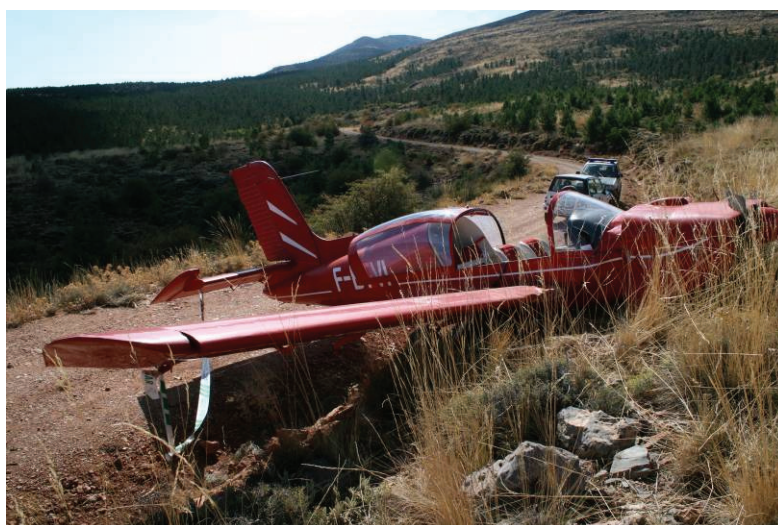
Figure 1. Condition of the aircraft after the accident

The aircraft was found in a southwesterly orientation, resting on its lower fuselage and perpendicular to a slightly inclined hill, with the front end pointing uphill. It appeared intact save for damage to the underside, the engine, the landing gear, which had bent backwards, the wing roots and the propeller.

Photographs taken of the cockpit after the accident indicated the following settings: rich mixture, maximum throttle, right fuel tank selected, horizontal stabilizer trim tab in neutral, altimeter at 5450 feet. The magnetos, carburetor heat, battery, alternator and fuel pump were disconnected.

There were no signs of any fluid leaks in the aircraft. The amount of fuel left in the tanks, as indicated by the gauges, was $\frac{1}{4}$ in the left tank and $\frac{1}{2}$ in the right.

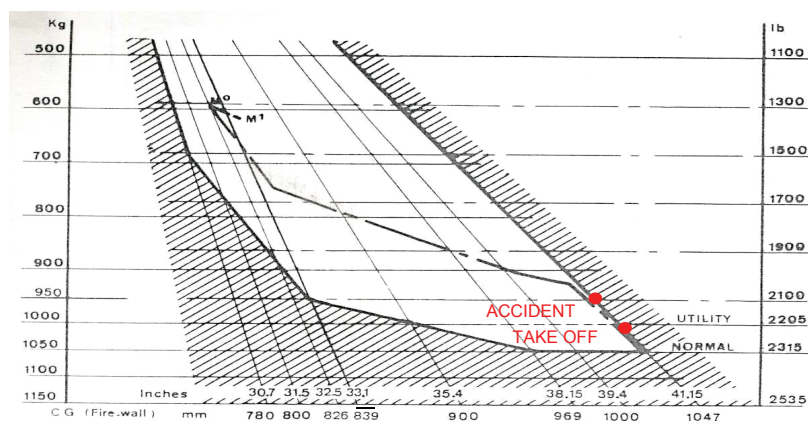
These values yield weights of 1011 kg at takeoff and 951 kg at the time of the accident. The center of gravity in both cases was located at its aftermost limit.

Figure 2. Position of CG during takeoff and accident

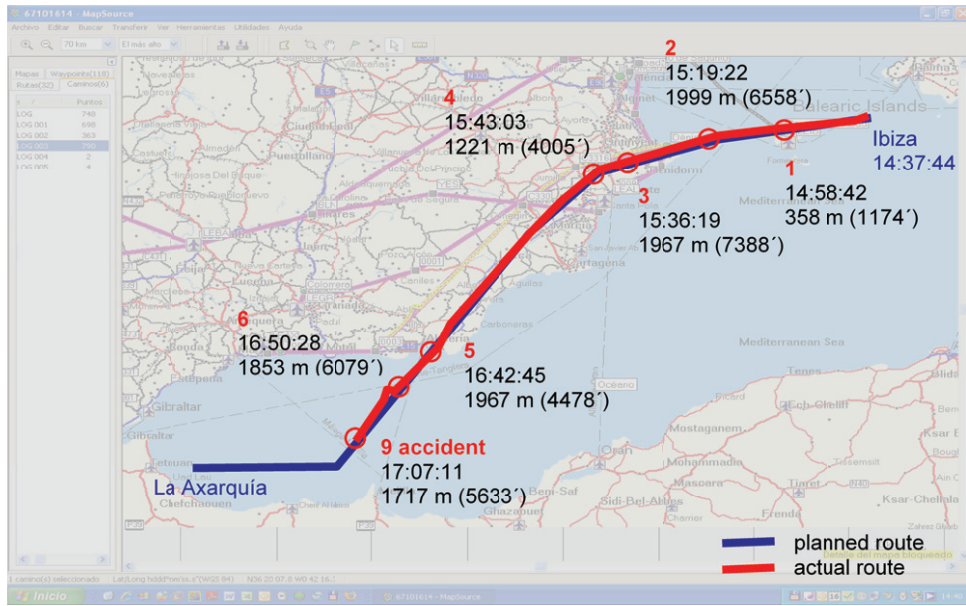
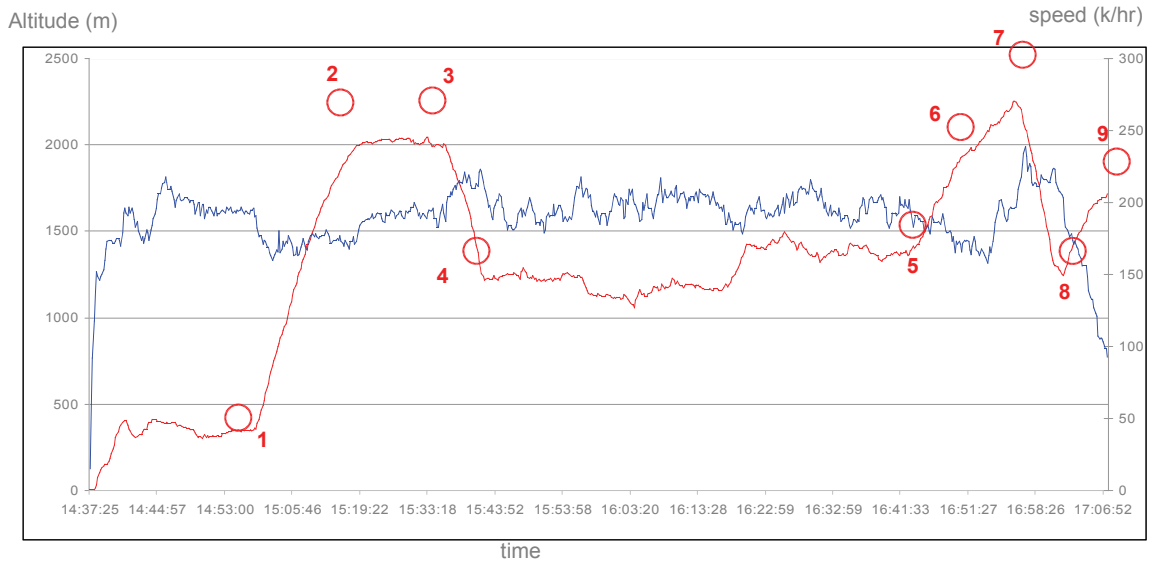
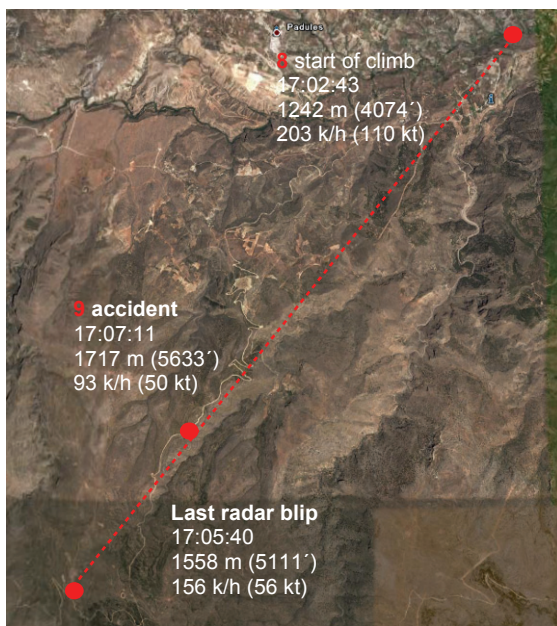
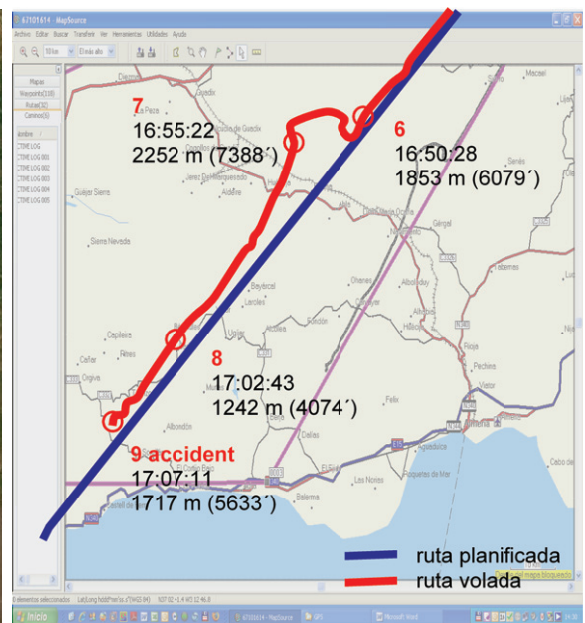
The pilot had a Garmin GPS receiver onboard which was undamaged by the accident, and which allowed for data from the accident flight to be downloaded. Among these data were the planned route from Ibiza to La Axarquia made the day prior to the flight. The data included waypoints along the route, but not altitudes, save for those associated with the departure and destination airports. As shown in Figure 3, the flight followed the planned route at an average speed of 200 k/hr. After taking off from Ibiza at 14:37:44, the aircraft climbed to 6500-7500 feet to enter the mainland over Denia (point 2). Once past the mountainous area, it descended to an altitude of 4000 feet (point 4), which was maintained for one hour. At 16:42:45 (point 5), the aircraft initiated a climb and later a 10-minute detour so as to clear a mountainous area with elevations of 6500 feet. The maximum altitude reached was 7388 feet (point 7). After flying over this peak, the aircraft resumed the planned track and initiated a descent to 4074 feet, reaching that altitude 7 minutes before the accident. At that moment (point 8), the aircraft was in the vicinity of Padules at an altitude of 4074 feet and an airspeed of 203 k/hr (110 kt). The final 5 minutes of the flight (points 8 and 9) took place in the increasingly mountainous region of the Gador Mountains, with elevations going from 700-800 meters up to 1730 meters. The aircraft climbed from 4074 feet to the 1717 meters at which the accident took place as it decelerated from 110 kt to 50 kt. The final course was 226° and the altitude indicated on the GPS was 1717 meters, matching the actual elevation of the terrain.

Figure 3. Aircraft trajectory

Based on the pilot's statement and the GPS data, it seems the pilot planned the course without taking into account the elevation. This could explain the events of the final 25 minutes of the flight, during which he had to deviate from his route to clear a mountain before deciding to descend to 4000 feet while crossing over irregular terrain. After the
