Report

Accident on **2 January 2009**
at **Molesmes (89)**
to the **Eurocopter EC135**
registered **F-HBMA**
operated by **Regourd Aviation**

BEA

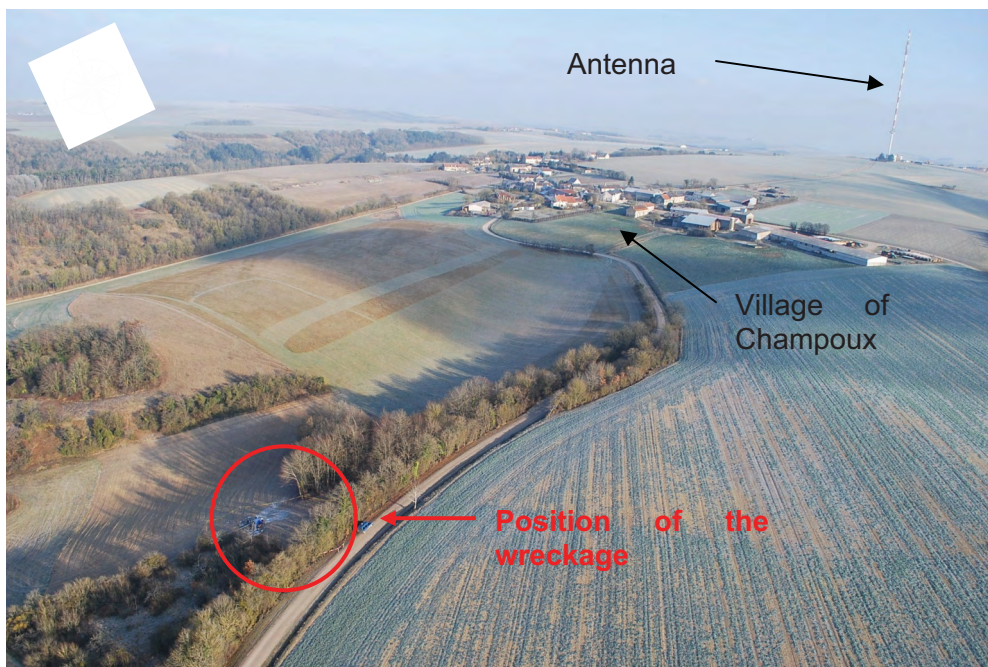
The wreckage of the helicopter was located on the edge of the road, 500 metres south of the village of Champoux (89). The area of the accident is very hilly, and includes alternating woodlands and fields. The area in which the wreckage was found was on a slope down from the road. The trees around the accident area were covered with ice but showed no marks from a collision with the helicopter.

A tethered antenna 656 feet high is located near the accident site, at the summit of a hill at 1,864 feet. A thorough inspection of the high and medium voltage cables around the antenna and its tether did not indicate any contact with the helicopter.

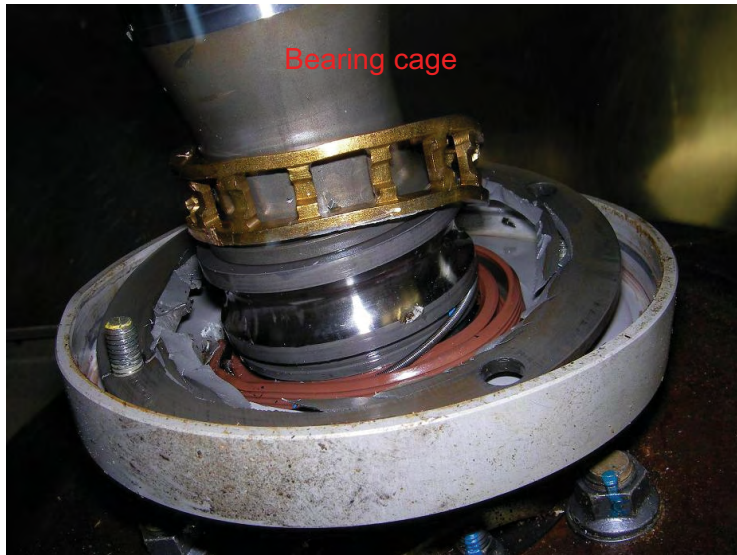
Only the bearing corresponding to the transmission of the tail rotor was found to be damaged. The bearing cage was somewhat distorted but not fractured, which suggests low rotation energy of the MGB at the time of impact (a bearing cage is completely destroyed when rotation is blocked at normal operating speed).

Bearing located on the MGB, where the drive shaft exits from the tail rotor

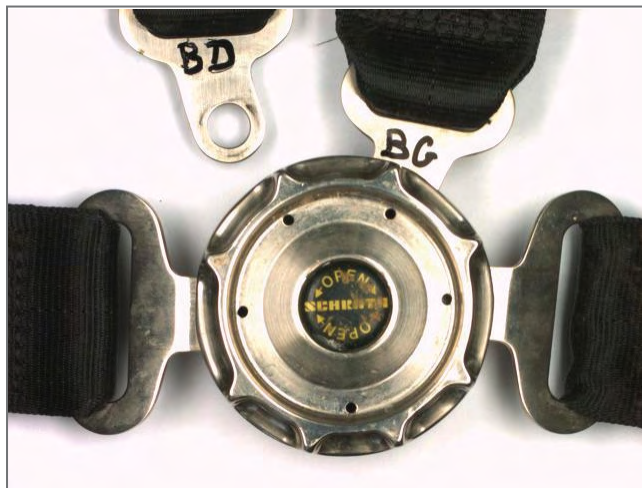
An initial examination showed that one of the fasteners (right shoulder strap) did not lock in the buckle.

No locking of the fastener of the right shoulder strap

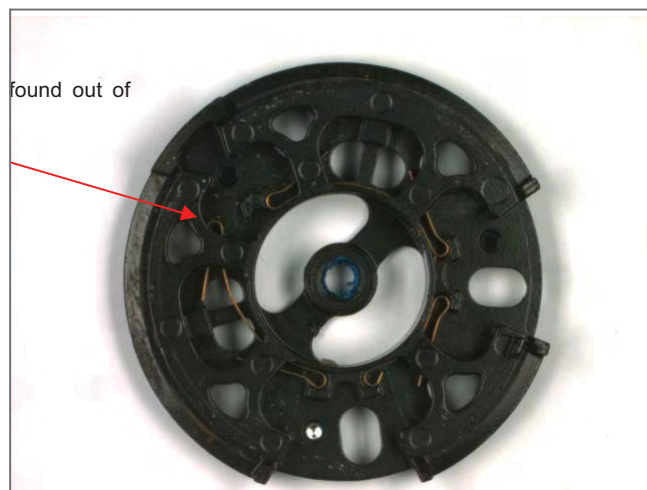
Each fastener is locked by a slug. When it is unlocked, each fastener is released by the expansion of a pin, which is compressed in the locked position. The buckle consists of three pins, two double pins (to release the two fasteners) and a single pin. One of the double pins was found outside its seat on the locking side of the fastener of the right shoulder strap.

Pins used to release the fasteners

In this position, the pin prevents the fastener from being positioned and locking.
