Investigation Report on the Accident to

Ethiopian 409 – Boeing 737-800

Registration ET-ANB

25th January 2010

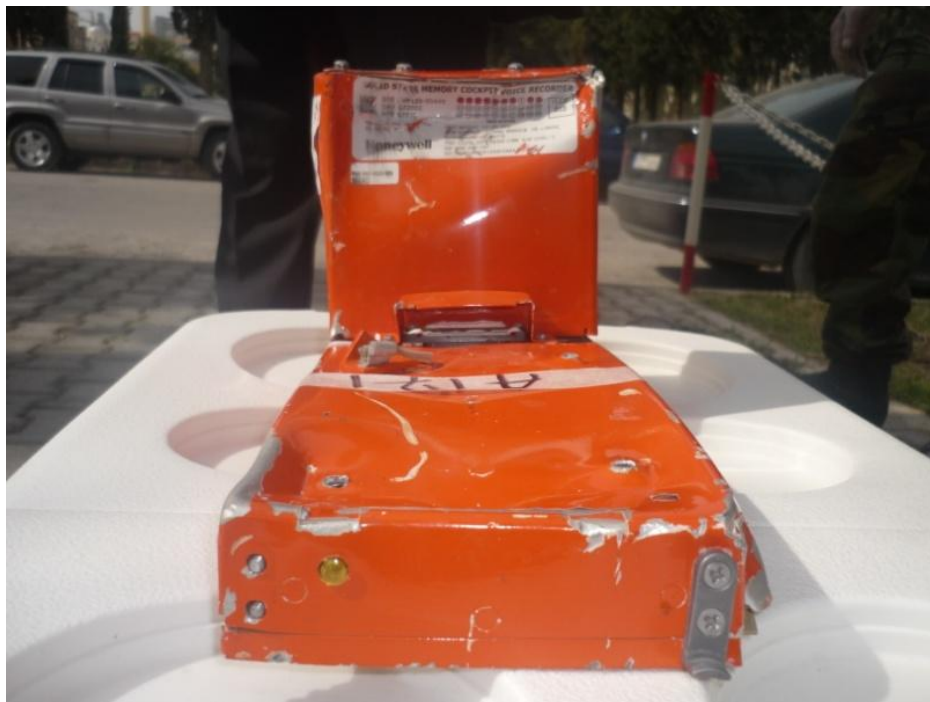
Figure 4: CVR Chassis

The CVR unit chassis exhibited external and internal structural damage with the CSMU detached from the chassis; the CSMU was in good condition. The opening, extraction of the double memory board from the CSMU and the read-out operations were performed following BEA procedures and Honeywell “*Reference Procedure for SSCVR Data Recovery after an*

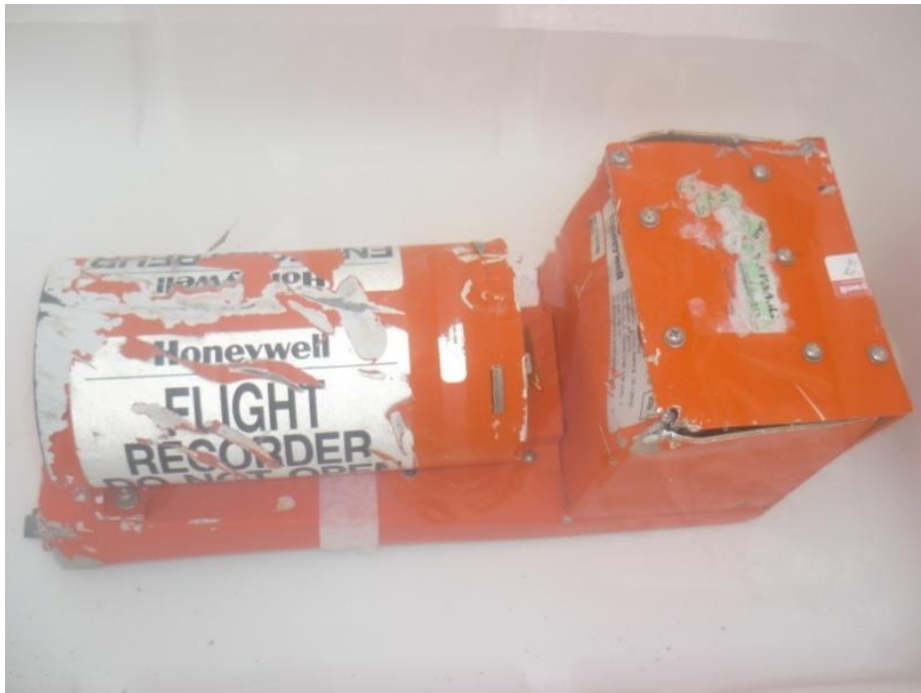
Figure 5: CVR chassis with CSMU

The CSMU was attached to the chassis. The chassis was damaged but the CSMU was in good condition. A complete set of accident flight data, from take-off through the last recorded DFDR parameters was prepared. There were 1000+ parameters available for the analysis.

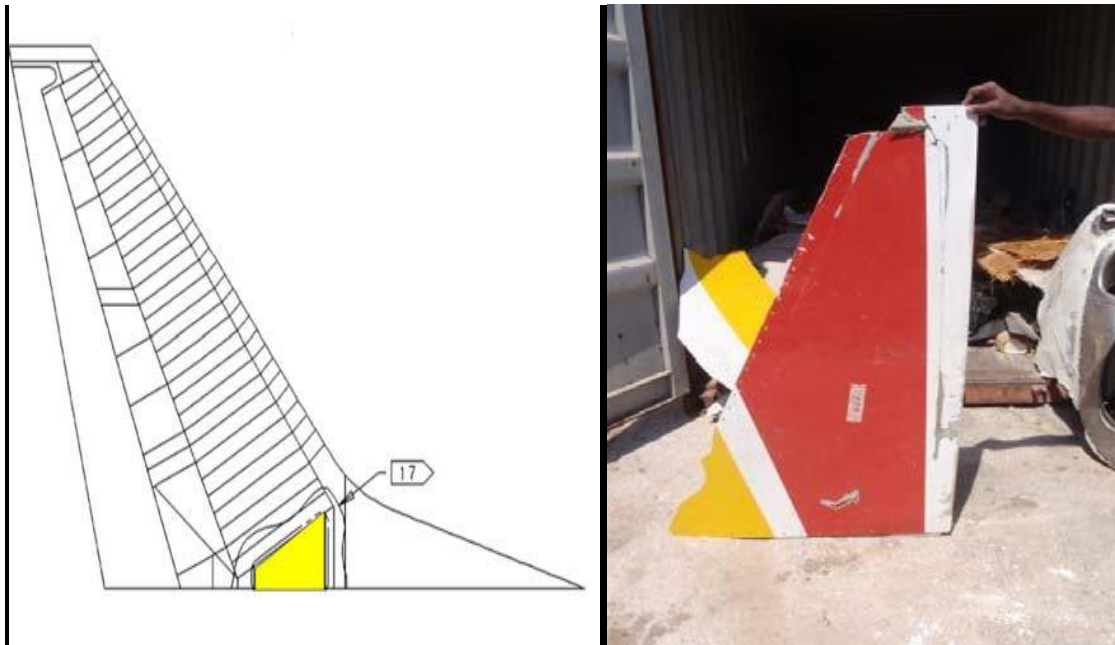
Figure 6: Winglet Panel and its installed location

A number of pieces of floating wreckage were recovered from the water's surface near to the last recorded radar point and to various distances north east of that point. One of these pieces was the winglet panel that was identified by the logo paint scheme and by the part number located on the interior surface. This panel was from the side lower closeout panel at the wingtip as shown in figure 6. That part is of composite material. It was found floating near the beach of Beirut, about 8 NM NE of the impact site.

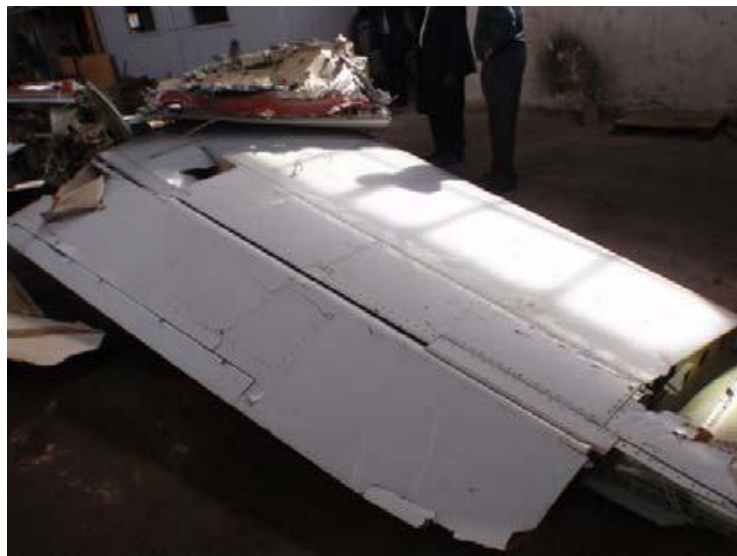
Figure 7: Left Elevator

Many evaluation visits to examine the wreckage were conducted by the Airworthiness Group. They included a thorough examination of the left and right elevators shown in figures 7 and 8. As a result of these visits, the Group also recommended to the IC to further evaluate the

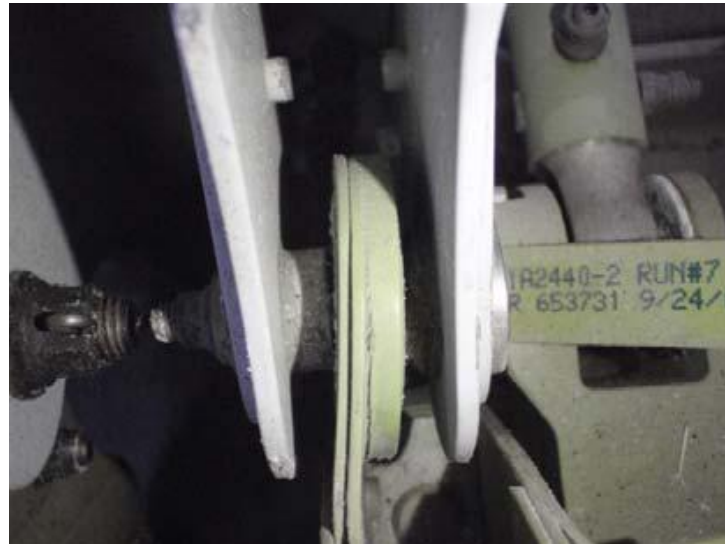
Figure 13: Left Outboard Lugs & Spacer

On the accident aircraft, both sides of the horizontal stabilizer were accessed and the inspections revealed no discrepancies for the inspected components. The spacers were tight and could not be rotated by hand pressure. Although a feeler gage was not available, there were no observed gaps in between the lugs or the lug and the spacer. A fingernail could not be inserted between the pieces inspected.

The inspection also noted that the left mechanism inboard attach point could be displaced 0.25 inches laterally and vertically using hand force and that the inner race of the bearing appears to be damaged. However, the tab hinges (three hinges on the right tab; all hinges on the left tab), tab rods and their connections were inspected and found to have all hardware present. All hinge points move freely and without noticeable play or looseness.

In order to clear that issue and to verify consistency with the DFDR recorded data, which showed no uncommanded movement or oscillation of the elevator or horizontal stabilizer surfaces, the Airworthiness Group recommended the removal of the mechanism for further evaluation. The IC approved that recommendation and decided to send the Trim Tabs of flight ET 409 Boeing 737-800 aircraft to the NTSB for analysis in order to verify consistency with DFDR recorded data.

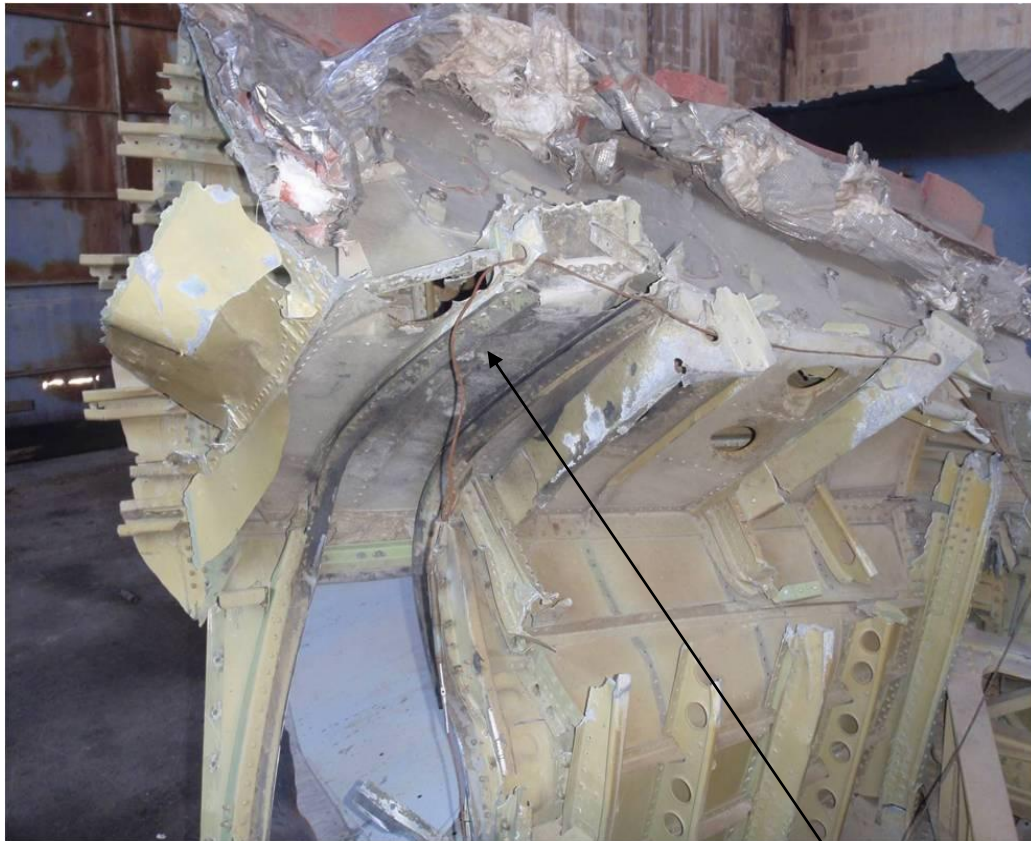
Figure 14: The APU Exhaust area showing the Black Soot

The NTSB report was received from the US Accredited Representative on July 29, 2011. The report specified that “*There was no discoloration to the primer paint and the surface was uniformly covered with a light coating of sand or dirt. Zinc chromate primer paint changes color when exposed to heat.*” It goes to conclude that “*Since there was no change in the color of the paint on the primer side, there was no indication that this section of fuselage was exposed to heat/high temperatures.*”

As for the origin of the black soot it determines after examining the material associated with the black soot that *“The spectrum obtained from the submitted unknown sample suggests that the material was organic as evidenced by the presence of characteristic carbon-hydrogen bonding peaks between ~3000 cm-1 and ~2800 cm-1 as well as a small group of peaks between 2300 and 1400 cm-1. This peak configuration is indicative of a straight chained, aliphatic hydrocarbon. When compared to the spectra of known materials, the unknown material most closely matched spectra from lubricating oils.”*

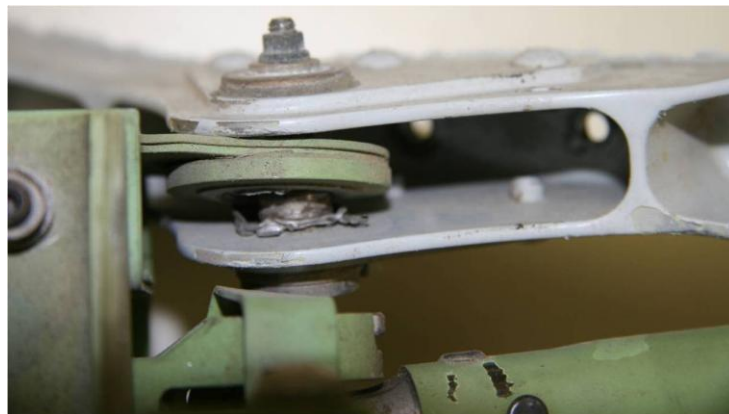
Figure 17: Left Inner Attachment Bearing

A few months after the accident, the FAA issued an AD not related to that accident requiring a periodic on-going inspection of the bearing retention for a secure swage on all Boeing NG airplanes. Therefore, the IC decided to send the trim tab mechanism to the NTSB for analysis, especially that inboard attach bearing of the left side tab mechanism was found with all of the bearing balls missing. Refer to Figure 17 below.

The reason behind issuing the AD was two reports of unusual airframe vibration involving Boeing 737 NG airplanes. Despite airframe vibration, neither airplane suffered from “loss of integrity” to their flight control systems; both airplanes continued safe flight and landings. Post flight examination of both airplanes revealed that the elevator tab mechanism on one side had become completely detached (both inboard and outboard lugs) from its mountings on the front spar of the elevator. Analysis attributed these fractures to the loss of the attach point bearing retention and subsequent fracture of the attach tab. However, the DFDR of the two airplanes that diverted as a result of the vibration oscillation triggering the issue of the AD showed significant oscillatory movement of the elevator following its final fracture.

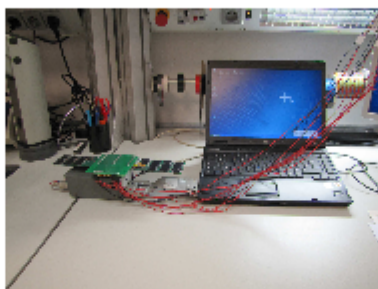
CVR boards connected to BEA memory reader

The CVR boards were connected to the BEA memory reader and each memory chip was individually selected and read out. All the memory chips were correctly read out except U16 (also referred as CE#19 memory chip in Honeywell documentation) which could not be read out at all. The read-out data was saved.

The assumption based on the visual inspection performed in February 17th, 2010 is confirmed: U16, the memory chip with the crack, is the non-functioning memory chip.
