Report

Accident on **31 May 2010**
at "**Col des Bœufs**" (974)
to **the Robinson R22 helicopter**
registered **F-ORGB**

BEA

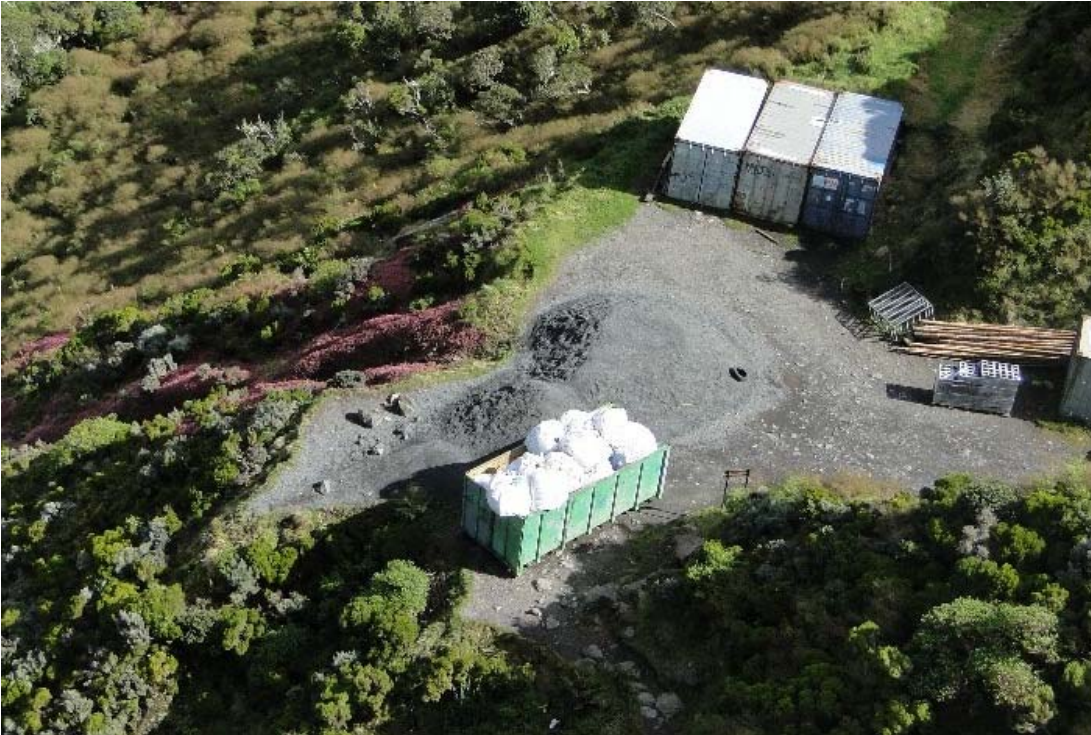
Helipad at "Col des boeufs"- altitude 1,940 metres

The site of the accident was at 1,887 metres, below the "Col des boeufs" helipad, in very steep terrain in the Mafate cirque. This helipad was located at 1,940 metres on the west slope of the mountain. There were a variety of objects (containers) items deposited on the ground (Sand heaps, bigbag transport bags) which reduced the dimensions of the zone usable for helicopters to land.

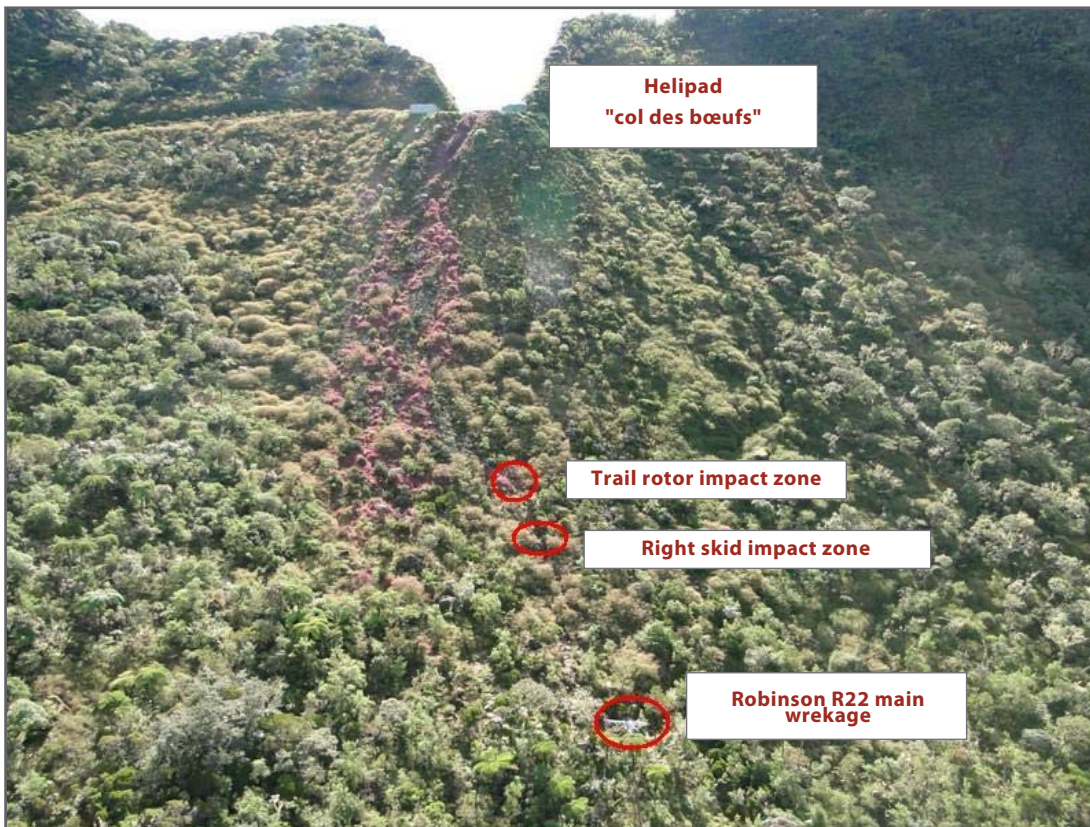
Examination of the site showed 3 distinct zones:

- the zone where the tail boom and tail rotor touched, about 35 metres below the helipad;
- a second zone, where the forward part of the helicopter's right skid was found stuck under a rock and numerous pieces of the canopy were found nearby on the left. The instrument panel was detached and thrown to the left;
- the main zone around 53 metres below the helipad where the main wreckage of the helicopter was found.

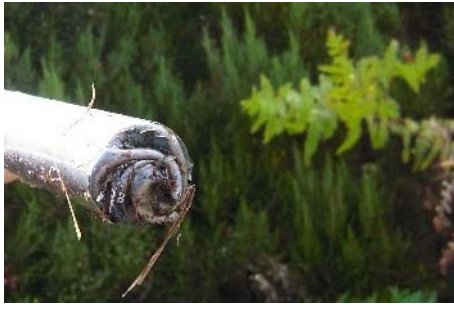
Drive shaft on the TGB side

The end of the tail rotor drive shaft failed in torsion and showed that there was rotation during the first impact and contact between the tail rotor blades and the ground. The "Flex plate" that links the tail rotor drive shaft with the freewheel was distorted and squashed, which indicates that there was little power and low rotation speed.

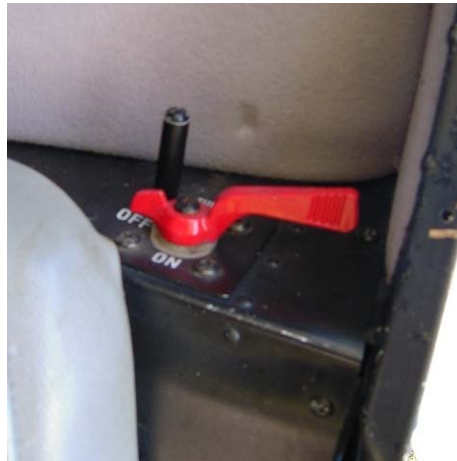
Position of the fuel cock observed in the wreckage

The fuel cock was observed to be in an almost closed position.

The carburettor was disassembled and an absence of fuel noted. A sample was taken from the fuel pipe between the petrol filter and the carburettor and less than a millilitre of petrol was recovered.

The accident was caused by the engine stopping during the takeoff phase. This shut down was caused by the accidental closing of the fuel cock by the passenger, unnoticed by the pilot, during boarding with the rotor turning, followed by a rapid takeoff.

- **EASA and the FAA make mandatory the installation of a fuel cock with a selector as modified since July 2007 on R22 type helicopters in order to avoid any accidental manoeuvres.**

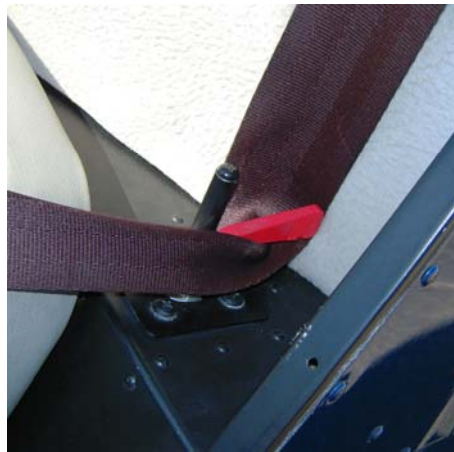
A test simulating passing the passenger seat belt strap under the fuel cock made it possible to determine that when the passenger tried to put on the seat belt, it blocked and the traction exerted by the passenger did not make it possible to move the fuel cock.

The manoeuvring tests performed on the R22 in the tests and on the accident aircraft showed that rotation of the fuel cock was too hard, thus preventing any accidental movement during impact or through vibrations.

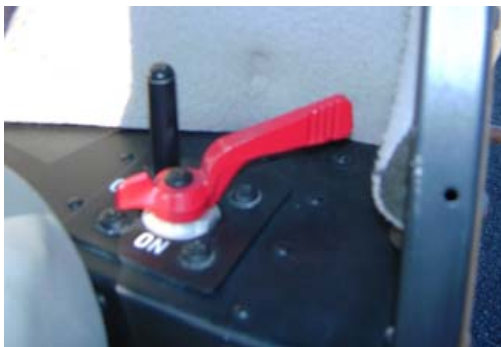
Old type

Case n°3: the seat belt was caught in the handle of the fuel cock and when the passenger fastened his belt, he closed the fuel cock. A protective device to prevent the belt catching the fuel cock handle was installed.

The supplier of the fuel cock made a modification in its shape and use following these three events. This modification was to replace the handle by a selector with a safety notch to move from the ON position to the OFF position as well as a return towards the ON position.

- the fuel cock installed that was of an old type (with a handle);
- The decision to undertake boarding and a takeoff with the rotor turning without previous checks;
- decision to use a helipad whose topographical situation provided no safeguards in case of a failure during takeoff;

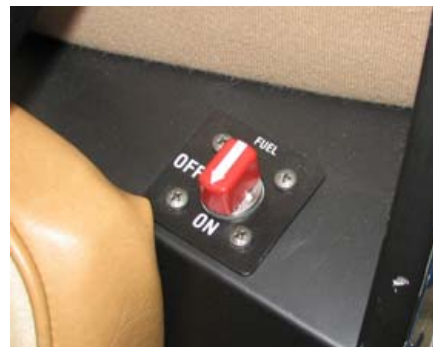
New type

Note: Robinson took the decision from July 2007 to equip the new R22 with this new fuel selector. However, this modification was not the subject of a service bulletin, or of a mandatory replacement.

The new model of the fuel cock installed on the R22 since July 2007 prevents, according to the manufacturer, any accidental manoeuvring of, as well as partial closing of, the fuel cock.
