## In-flight failure of a drag damper, loss of control, collision with trees

<b>Aircraft</b>	Schweizer 269 C helicopter registered F-GJGQ
<b>Date and time</b>	Sunday 25 July 2010 at 10 h 00 <sup>(1)</sup>
<b>Operator</b>	Aerial work company
<b>Place</b>	Coullons (45)
<b>Consequences</b>	Pilot and passenger killed, aircraft destroyed

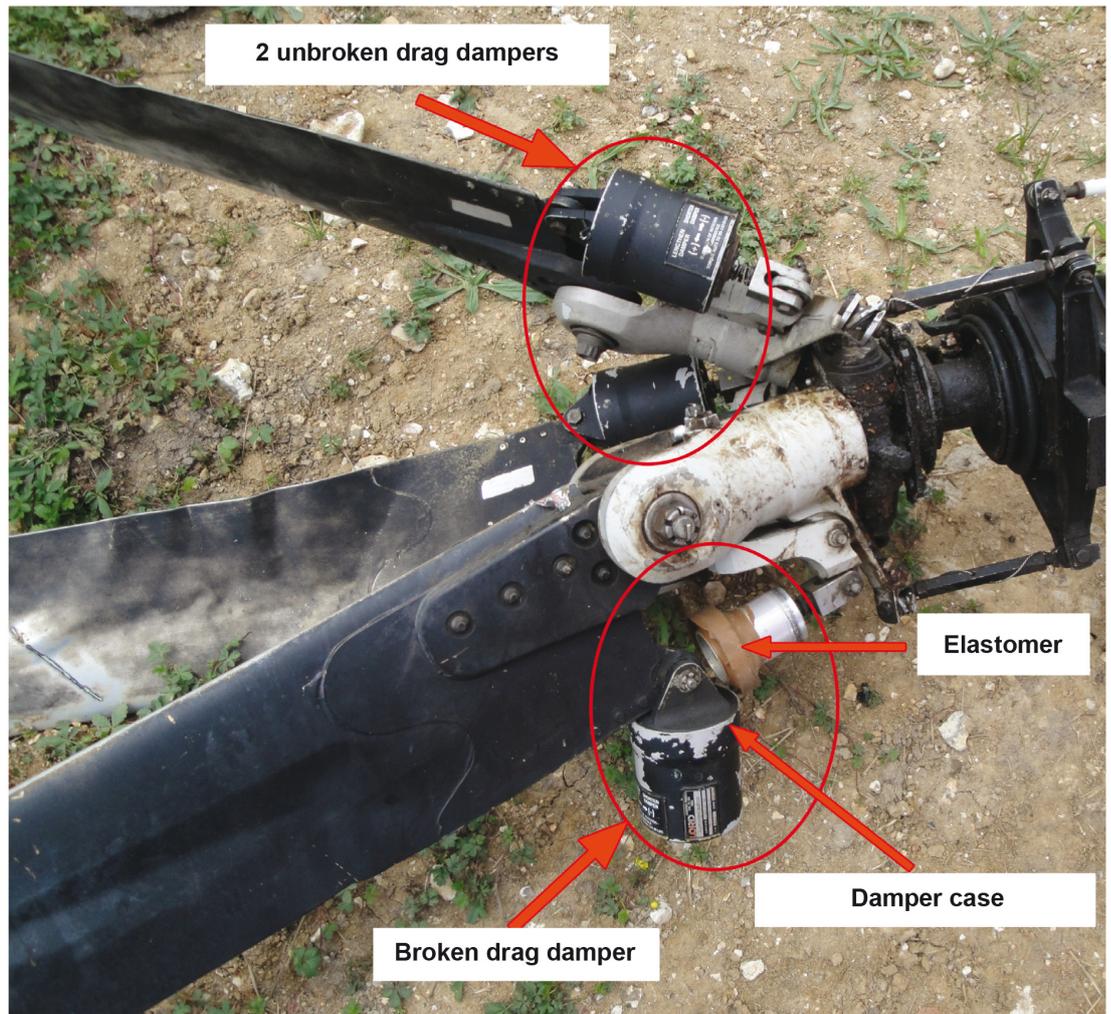
Observations on the wreckage showed that one of the three drag dampers had broken (see photo below).

- ❑ The first, found broken after the accident, showed partial degraded adhesion prior to the accident between the elastomer and the damper case, as well as traces of internal corrosion.
- ❑ An aqueous liquid was found in the second damper. This is incompatible with the sealing performed on a new damper. In addition, it had some adhesion and corrosion characteristics that were identical to those on the first one.
- ❑ During the tests on the second and the third dampers, they exceeded the maximum allowable tensile stretch length<sup>(3)</sup>.

The 3 drag dampers were thus likely not in an airworthy condition before the accident. During the flight, the adhesion of the elastomer on the damper that broke continued to degrade to a level that was incompatible with the nominal absorption of the normal vibration levels in translation flight. The excessive movements of the associated rotor blade generated a sudden imbalance in the main rotor, which resulted in an unbalance incompatible with control of the helicopter and continued flight.

The accident was likely due to the degradation of the adhesion of the elastomer on the drag dampers that was not detected during the 300-hour maintenance check. This led to the sudden malfunction in flight of the first damper and to the pilot's loss of control of the helicopter. This maintenance operation on a critical part performed by a lone mechanic and without approval by another person or an organisation independent of the operator could have contributed to the accident.

- That EASA modify, for companies without an AOC in the context of their specific commercial activities, the approval procedure for re-entry into service of an aircraft. This procedure must ensure that the approval be performed by a different person from the one that performed the work or by organisation independent of the operator. [Recommendation FRAN-2012-013]**
