Report

**Serious incident on 29 June 2010
near Basel-Mulhouse (68) airport
between the Airbus A319 registered HB-JZQ
operated by easyJet Switzerland
and the Airbus A319 registered F-GRHA
operated by Air France**

BEA

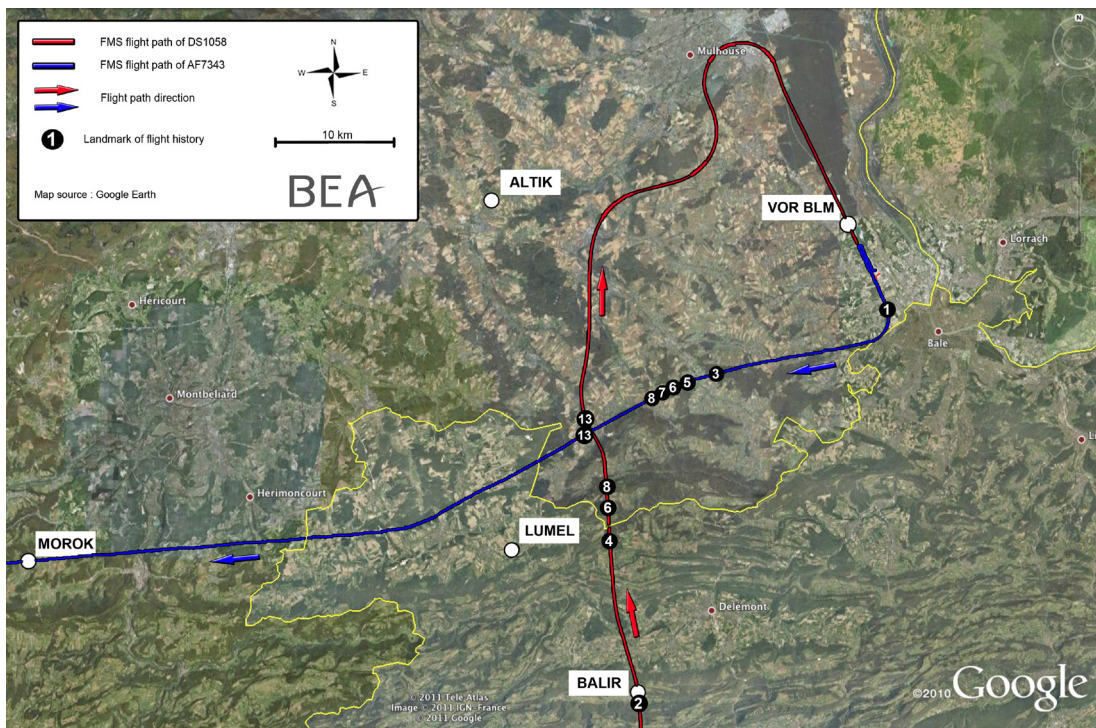
At 17 h 28 min 46 (2), the crew of DS1058 called out they were above waypoint BALIR and requested a visual approach. The controller requested they descend to FL110, refused the visual approach and asked if they could reach waypoint ALTIK. The crew indicated they needed to alter their heading 10° to the right to avoid a thunderstorm cell. The controller cleared them to do so and requested that they call back when they could fly direct to waypoint ALTIK.

At 17 h 30 min 01 (3), the crew of AF7343 requested permission to set their heading to 230° to the left to avoid a thunderstorm cell. The controller cleared them to do so and requested that they call back when they could fly direct to waypoint MOROK.

At 17 h 30 min 10 (4) DS1058 was at FL110. At 17 h 30 min 18 (5), AF7343 passed FL100 in a climb. Its vertical speed was greater than 3,000 ft/min⁽⁴⁾.

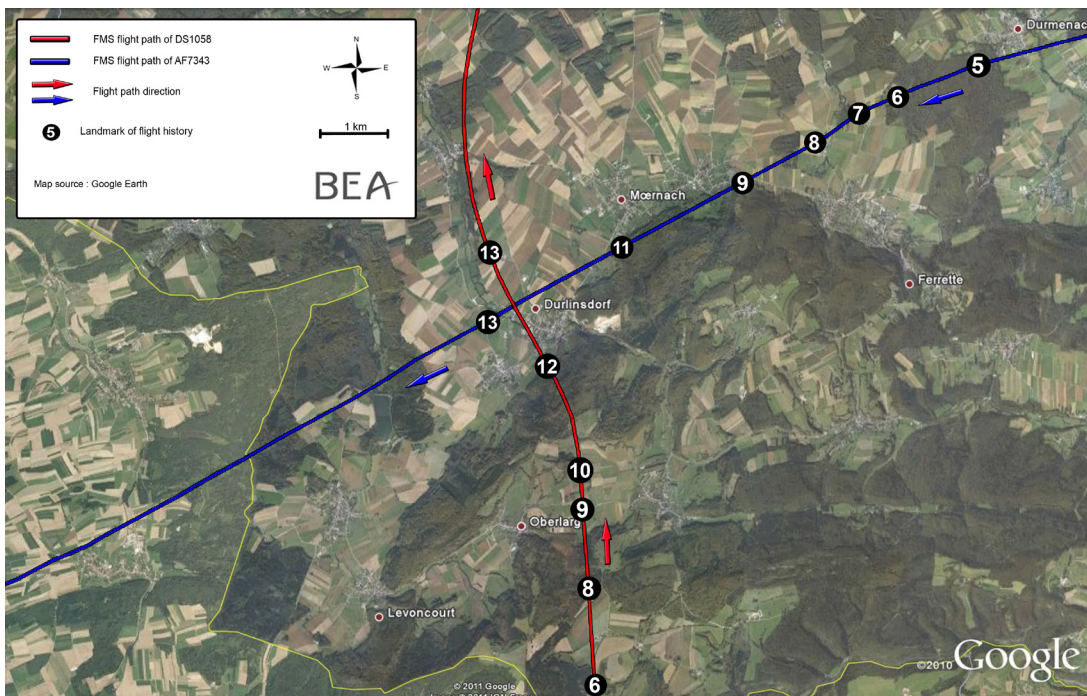
At the same time, aboard DS1058, the preventive RA "monitor vertical speed" was triggered, prompting the crew not to climb. The PF briefly applied a nose-up input while the AP was disengaged; the attitude changed from 2.8° to 5.3°. The FDs were kept triggered, the auto-thrust (ATHR) was disengaged and the thrust levers were moved forward. Approximately two seconds after the first action, the PF applied a nose-down input; the attitude changed from 5.3 to -5.6° and the vertical load factor reached -0.19 g.

At 17 h 30 min 45 (9), the altitude of DS1058 reaches a maximum of approximately 11,050 ft. The thrust levers were moved to the IDLE detent. The ATHR was disengaged. A corrective RA "descend, crossing descend" was temporarily recorded for 1 to 2 seconds, then the corrective RA "climb climb now" was triggered. The PF applied a nose-up input and started a turn to the left at a bank angle of about 30°.

The attitude increased from -5.6° to 13.8° and the heading decreased from 355° to 329° . Simultaneously, the corrective RA *"descend descend now"* was triggered aboard AF7343. The PF applied a nose-down input, the attitude changed from 6.7° to -5.3° .

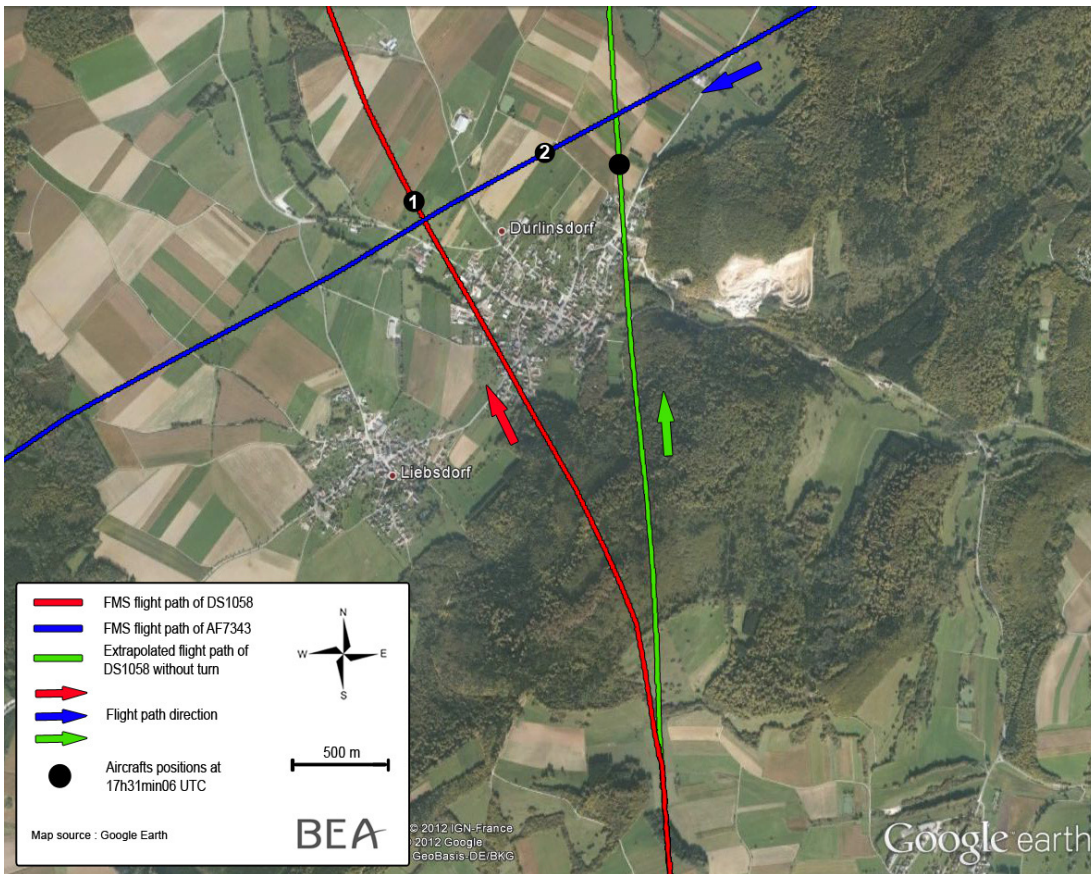
Analysis of the flight paths showed that the turn by the pilot of DS1058 made his aeroplane pass in front of AF7343 and not behind it, as it would have done if it had kept a straight path.

The positions of the aeroplanes shown on this diagram do not correspond to the point in time at which the minimum angular separation occurred. At that time (i.e. two seconds later), the distance between points 1 and 2 was smaller. In turning left, therefore, DS1058 did not increase the separation with AF7343.
