# Report

Serious Incident on **11 January 2010**  
At **Lagos Aerodrome (Nigeria)**  
To the **Boeing 777-300ER**  
Registered **F-GSQI**  
Operated by **Air France**

**BEA**

Bureau d'Enquêtes et d'Analyses  
pour la sécurité de l'aviation civile

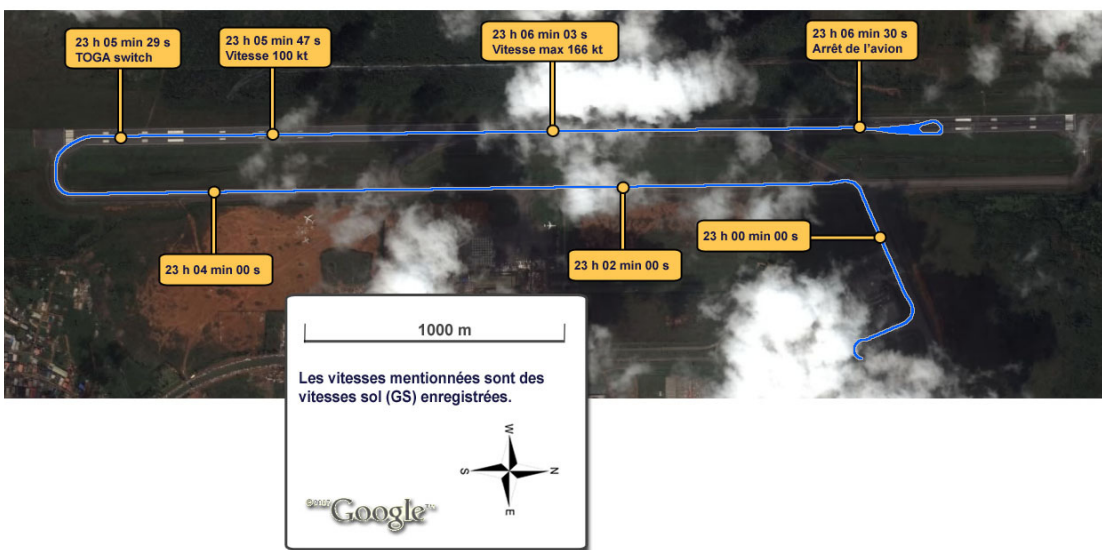
At 23 h 05 min 58, the copilot announced "*rotation*". The aircraft by then had travelled about 1,500 meters. Two seconds later the Captain announced "*abort takeoff*". The CAS recorded on the FDR was then 155 kt. The maximum airspeed of 164 kt was recorded 3 seconds later.

The automatic braking system of the aircraft was activated<sup>(3)</sup> and the aircraft stopped about 900 meters from the end of the runway at 23 h 06 min 30.

Partial flight path of F-GSQI calculated from the parameters recorded on the FDR

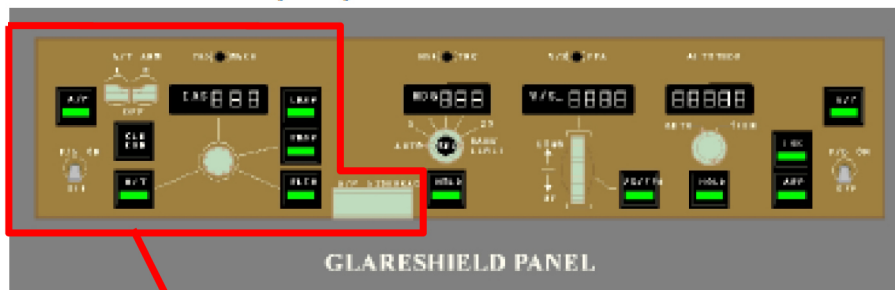
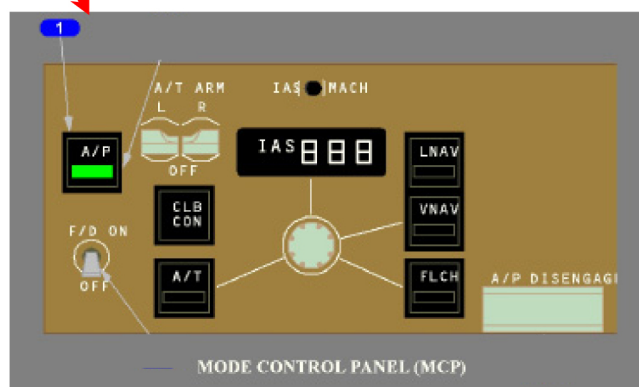
Representation of the Boeing 777-300ER MCP

The auto-throttle is armed by the 2 A/T ARM switches on the MCP beside the Captain (see the illustration above).

The autopilot is engaged by pressing one of the A/P pushbuttons (see reference 1 in the figure above). Engaging the AP results in the display of A/P on the PFD and the switching on of the green light on the corresponding pushbutton.

- ❑ The Captain noticed the auto-throttle did not engage when he pressed the TO/GA switches.
- ❑ The Captain removed his hand from the thrust levers to arm the auto-throttle on the MCP. Without noticing it, he engaged the autopilot while doing so.

On 22 January 2010 Boeing issued a service bulletin advising of the release of a new software version of the autopilot calculators preventing its involuntary engagement on the ground during the takeoff roll. Air France has applied the service bulletin on its entire Boeing 777 fleet.
