# Report

**Accident on 5 September 2010  
at Anse-Bertrand (971)  
to the Cessna 208B registered F-OIXZ  
operated by Tropic Airlines**

Bureau d'Enquêtes et d'Analyses  
pour la sécurité de l'aviation civile

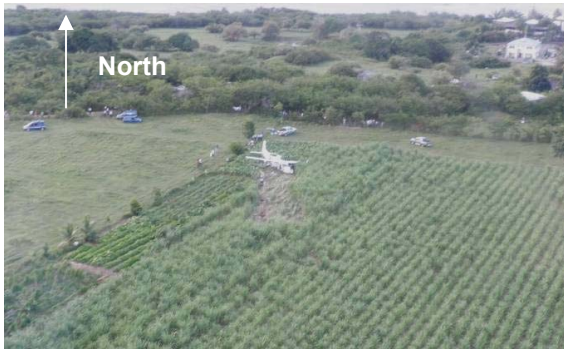
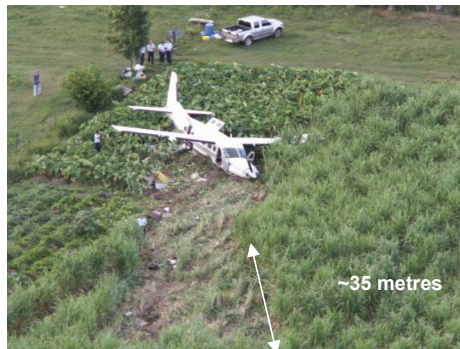
The aeroplane landed in a sugar cane field in Anse-Bertrand commune 12.5 NM from Pointe-à-Pitre aerodrome. The aeroplane came to a standstill 600 m from the coast and about 70 m from a hedge behind which were some houses.

The distance between the first marks on the ground and the aeroplane was about 35 m. Pieces of debris from the baggage hold, baggage and parts of the nose landing gear were recovered between the first mark and the aeroplane.

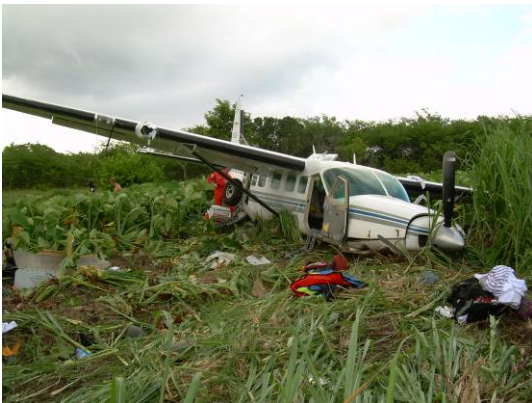
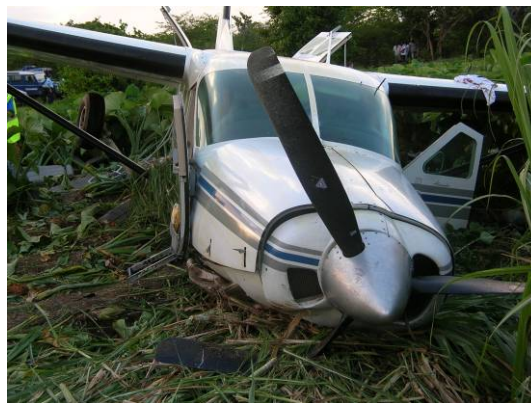
The aeroplane was oriented at a magnetic heading of about 140° (in the opposite direction to its final trajectory). The aeroplane was configured for landing. The fuselage and the rear stabiliser were only slightly damaged. The left wing tip was broken. The leading edge of the right wing and the pod housing the weather radar were damaged. The main landing gear was bent upwards.

Examination of the debris recovered along the trajectory, of the marks on the ground and the aeroplane damage showed that the aeroplane had struck the ground with a slight pitch down attitude slightly oriented to the right.

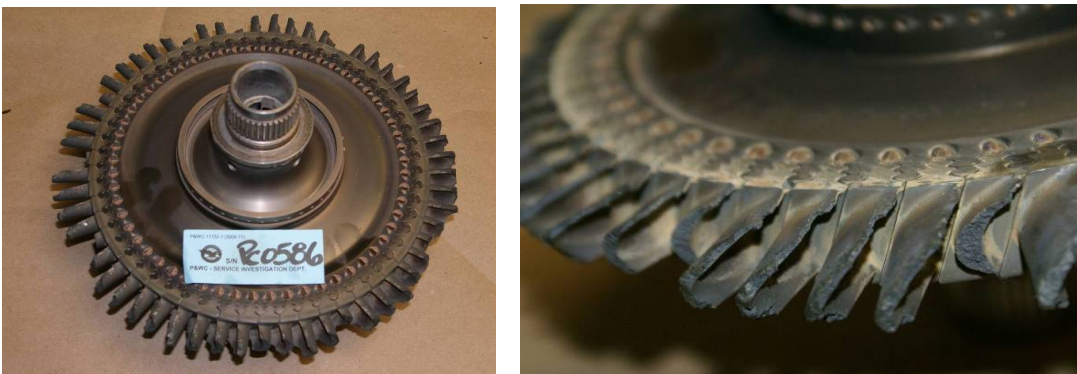
All the blades were fractured at varying profile heights from the middle to the base. Discoloration on each fracture was noted. Signs of impact were present on the blades' trailing edge with, in some cases, a loss of coating. The leading edges were distorted.

- ❑ The chemical composition of the CT blades base material complied with the manufacturer's specifications;
- ❑ The CT blade fracture surface showed no signs of fatigue cracking;

- ❑ Fractographic observations indicated that the fracture of one or several CT blades was probably the cause of the tensile overload fracture of the other CT blades;

- numerous "micro-voids" at grain boundaries, in the radial direction. This is a feature of creep (see paragraph 1.18.2);
- ❑ The seriousness of the damage on the CT blades made it impossible for any previous presence of a base material defect to be established. It was not possible to determine which blade (or blades) was (were) the cause of the damage to the other CT blades;

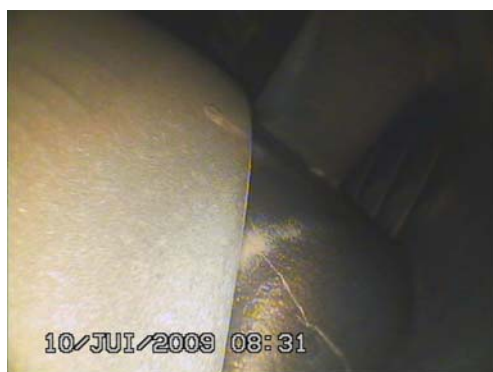
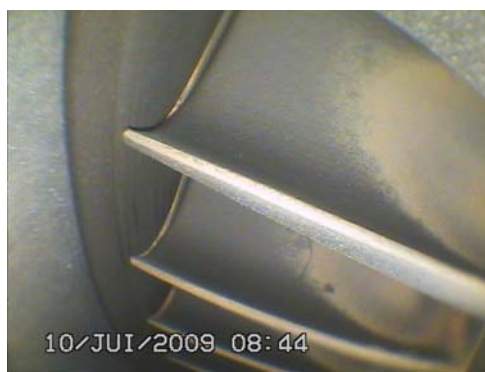
- ❑ **Inspection on 10 July 2009**  
TSN 6162

The two last boroscope examinations carried out found no anomaly likely to explain the engine shutdown.

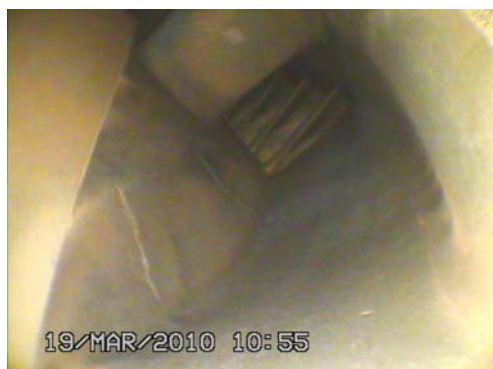
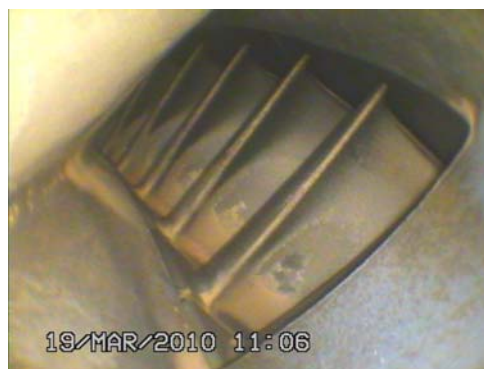
- ❑ **Inspection on 25 March 2010**  
TSN 6627

The work file relating to this boroscope examination mentioned:

- ❑ Slight cracks on the cooling ring and the leading edge of the CT stator;
- ❑ Loss of coating on the CT blades;
- ❑ To monitor changes, the next boroscope examination was before 400 hours.

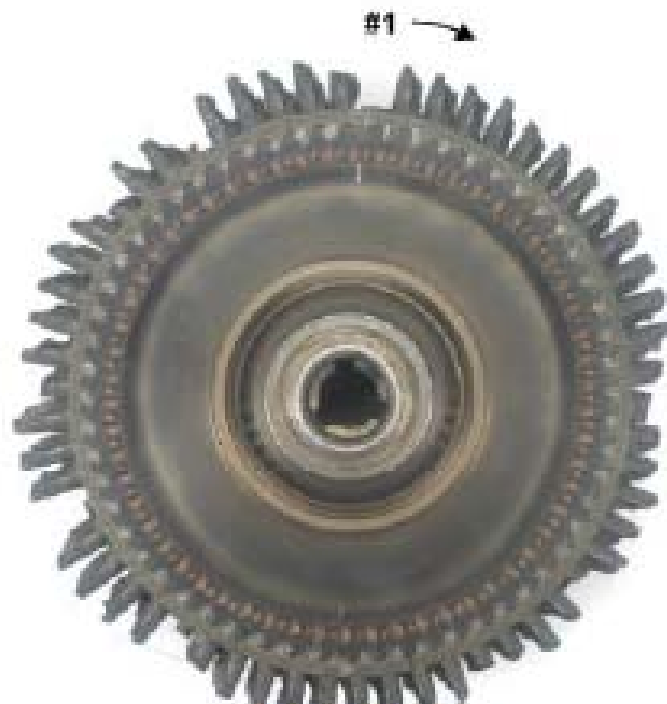
**Photo No. 46**  
General view of the CT disk and blades:

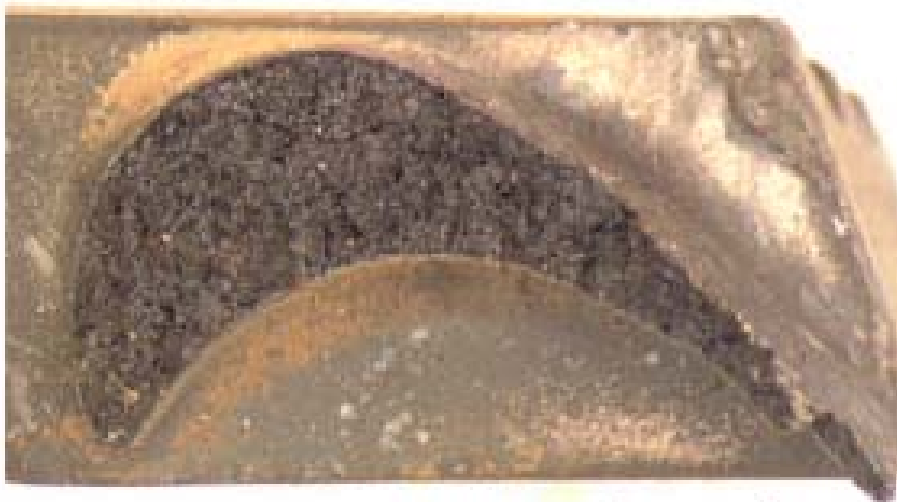
**Photo No. 47**  
Typical condition of the CT blade fracture surfaces:

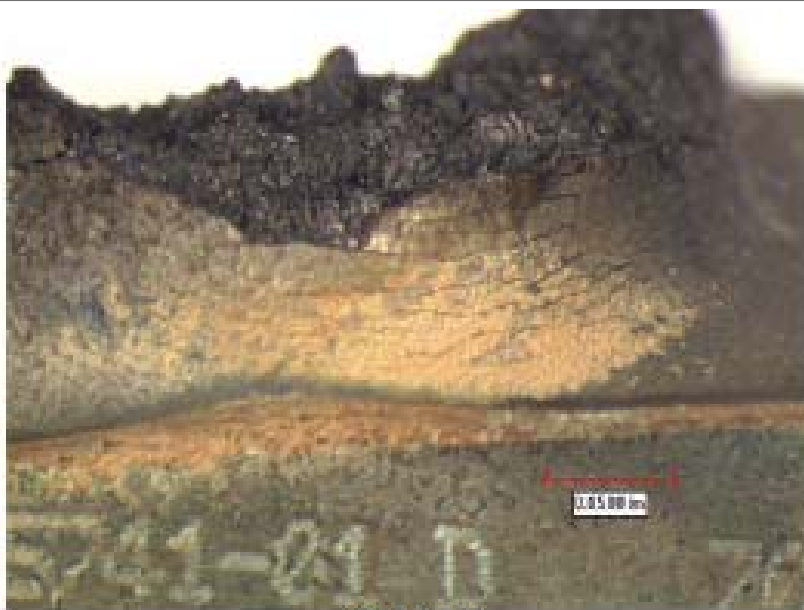
**Photo No. 48**  
Multiple cracks parallel to the fracture surfaces

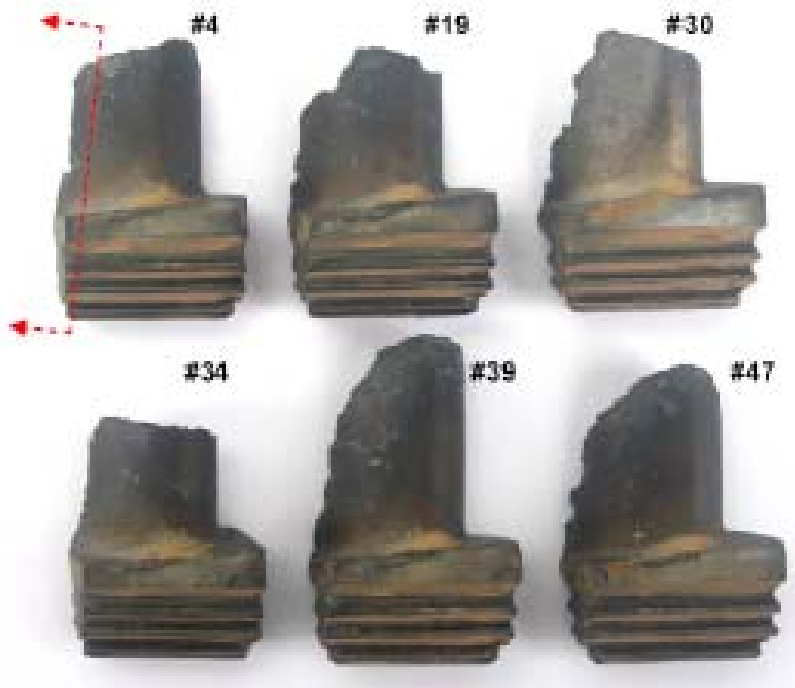
**Photo No. 49**  
Six blades chosen for metallographic examination

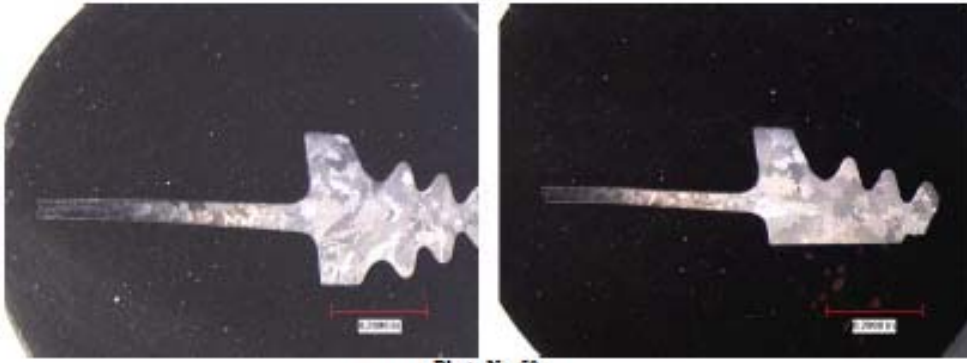
Photo No. 50  
Blades No. 39 & 47 cross sections

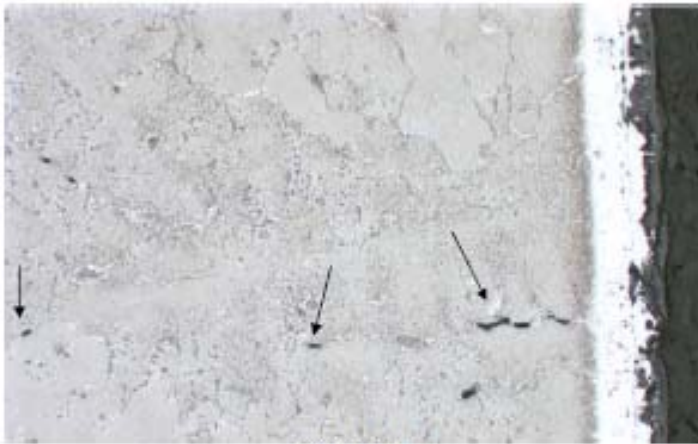
Photo No. 51  
Blade No. 47 showing microvoids

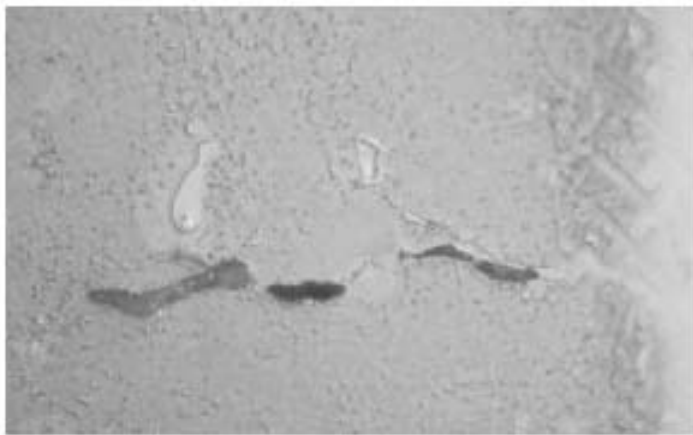
Blades No. 4, 19, 34 & 39 (Photo No. 52), revealed similar creep features (elongated and aligned microvoids) such as those found on blade No. 47. Blade No. 30 did not show any evidence of creep and it is believed that this blade was not exposed to the same engine condition (time). As such, it is believed that this blade is part of the two new blades that were installed during the last HSI.

**Photo No. 52**  
Blade No. 47 showing microvoids and a complete solution of the gamma prime

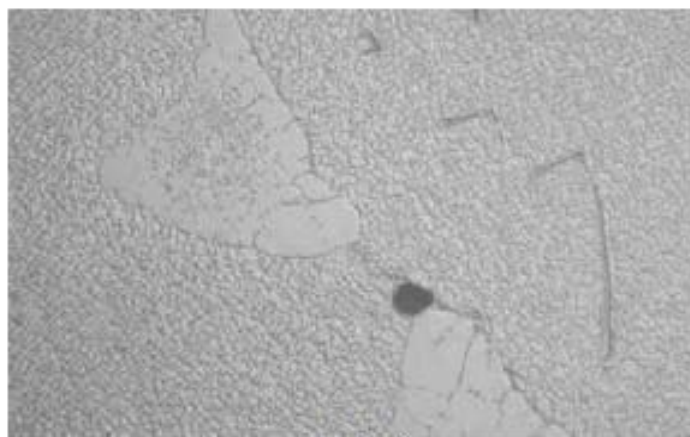
**Photo No. 53**  
Blade No. 47 showing a normal gamma prime in the root section

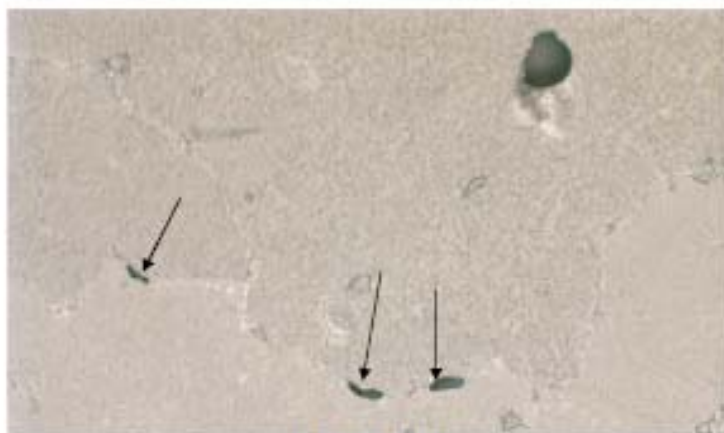
**Photo No. 54**  
Blade No. 39 showing microvoids
