Explosion of an oxygen pressure transducer

Aircraft	Bombardier CRJ700 registered F-GRZF
Date and time	1 July 2010 at around 7 h 25 ⁽¹⁾
Operator	BritAir
Place	Paris Charles de Gaulle Airport (95)
Type of flight	Scheduled public transport of passengers
Persons on board	Captain (PF), co-pilot (PNF)
Consequences and damage	Oxygen pressure transducer destroyed

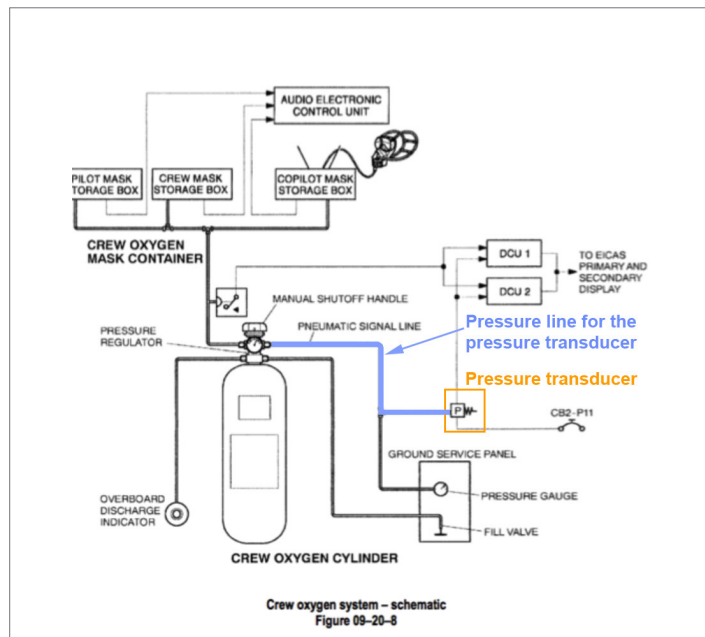
Crew Oxygen system

The cylinder contains about 1,415 l of oxygen at a pressure of 1,850 psi. Oxygen is relieved before being distributed to each mask. A capillary tube mounted on the cylinder head is connected to a transducer that measures the cylinder oxygen pressure (see Figure 1 below). This information is then transmitted to the pilots on the STATUS page on the EICAS.

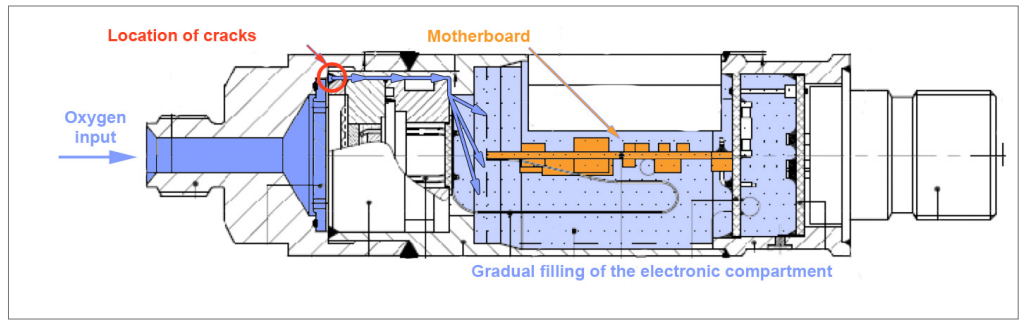
The examination revealed signs of an explosion and showed that the body of the pressure transducer failed at the electrical connector input/output.

During tests on the damaged transducer, a pressure of 870 psi of oxygen (which corresponds to about half of the nominal pressure in the cylinder) was applied to the metal membrane. A micro leakage of about 2 millilitres per hour was demonstrated between the oxygen input and the electronics compartment.

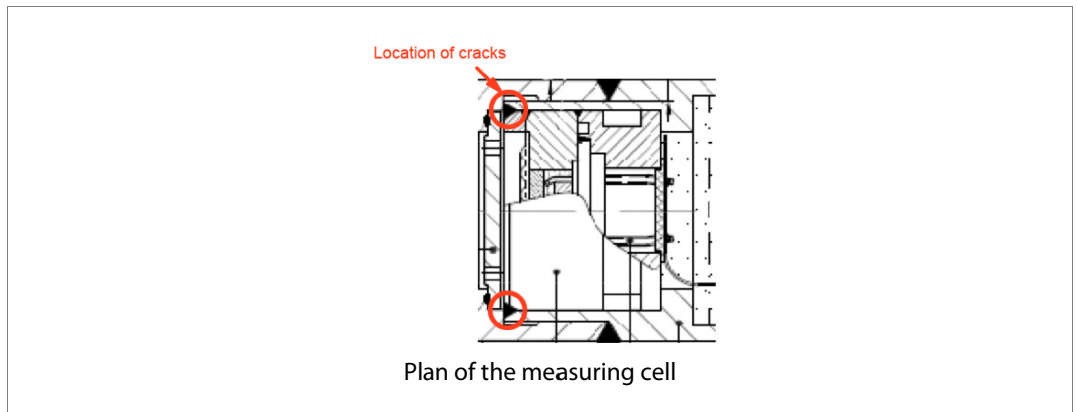
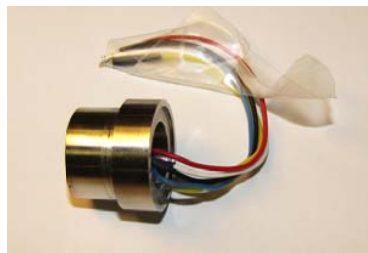
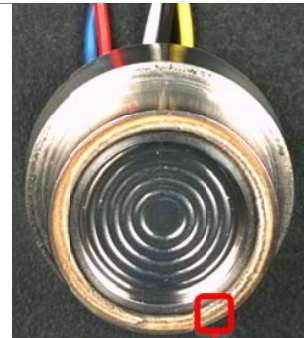
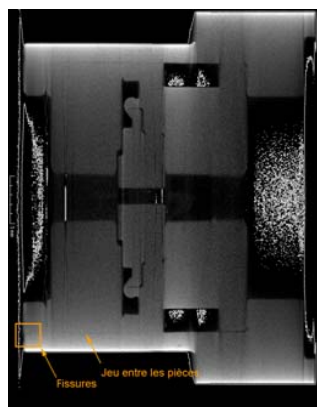
Longitudinal section view

The measuring cell was then extracted and examined. The upper weld connecting the membrane to the body of the measuring cell, as well as the metal in the measuring cell itself, had cracks.

The welding operations during the production of the transducer, on metal that likely had a minor defect, was one of the contributing factors to the appearance of these cracks. They may have appeared either at the time of the welding operations or during transducer use under the associated effect of the oxygen pressure.

Following this incident, the manufacturer decided to check the sealing of all measuring cells in production.

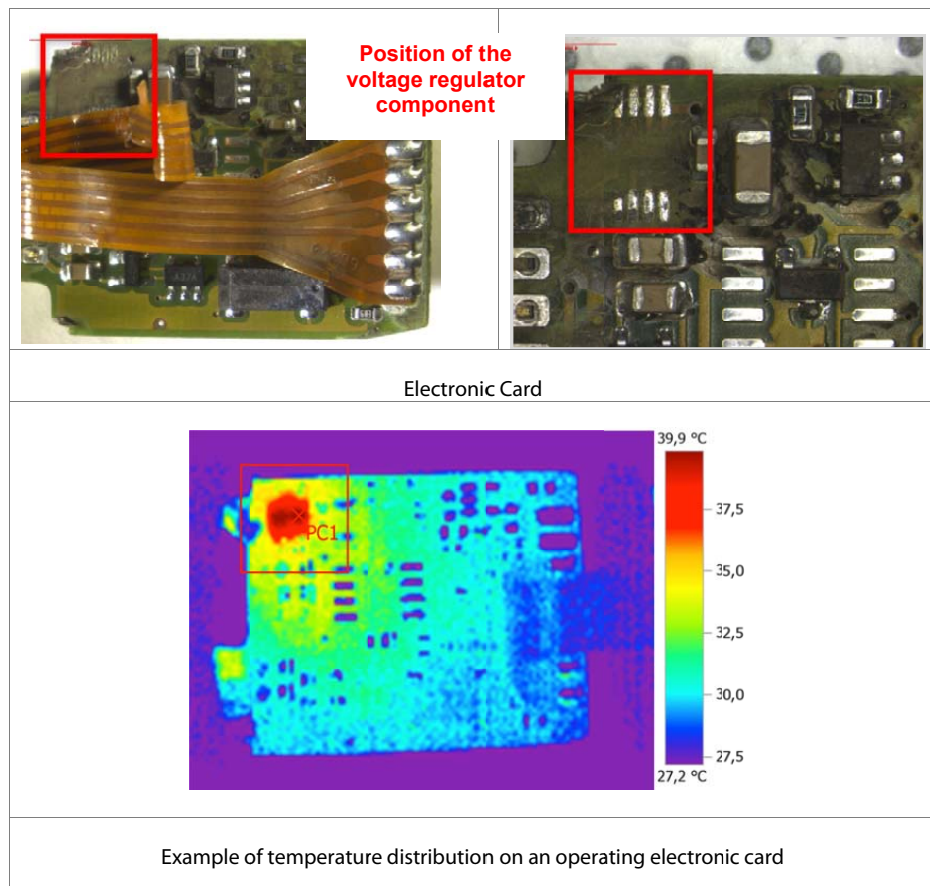
The motherboard had a lot of damage: the voltage regulator component was missing and there was some black residue present, especially around the missing component. This was a powered component, which induced a local increase in temperature on the electronic board at this point (see photos below).

Note: It is possible that the temperature of the card installed on the aeroplane reached higher values.

The explosion of the oxygen pressure transducer very likely resulted from ignition of a voltage regulator component on the motherboard in an oxygen rich environment under pressure. The micro-leakage of oxygen from the high pressure sealed container generated, over time, the oxygen concentration.
