**Vertical flight path excursion during ILS approach
with autopilot engaged**

Airplane	Bombardier Canadair CL-600 2B 19 (CRJ700) registered F-GRZK
Date and time	Tuesday 19 January 2010 at about 08 h 00 ⁽¹⁾
Operator	Brit Air
Site of accident	AD Paris Charles de Gaulle (95)
Type of flight	Public transport of passengers, scheduled flight
Flight crew	Captain (PF); Co-pilot (PNF)
Consequences and damage	None

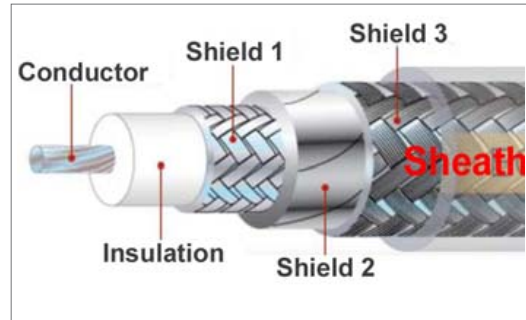
Action by the Brit Air maintenance system based on a plan drawn up by Bombardier made it possible to identify the origin of the radio altimetry system 1 malfunction as being in the coaxial cable between the receiver aerial and radio altimeter 1.

A coaxial cable is made up of a core wrapped in insulation, then metallic shields and an outer sheath.

An examination of the coaxial cable carried out by the operator showed:

- a short circuit between the core and the shields the origin of which could not be determined;
- an insulation failure of the cable connector of the radio altimeter 1 receiver aerial due to the presence of oily fluid between the shield and the connector.

After this examination, the coaxial cable was replaced and destroyed. Subsequent tests confirmed the normal functioning of the radio altimetry system.

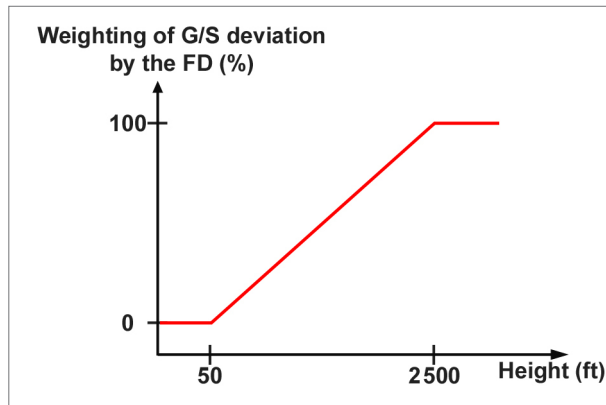
In order to adapt this correction to apply to return to the glide path, the FD instructions are weighted using height data supplied by the radio altimeter. This data enables the gain to be adapted, and thus the use of the G/S deviation in the FD guidance law on the glide path.

simplified diagram of the use of the G/S deviation by the flight directors during guidance on the ILS glide path

Approaching DA during the last approach, the altitude data supplied by radio altimeter 1 to FD1 led the latter to consider that the aeroplane was at a height of more than 2,500 ft and thus apparently far from the runway threshold. To correct the glide path, the FD thus ordered over-corrections⁽¹¹⁾, leading to an opposing G/S variation, which was again over-corrected. The G/S variation and the attitude then began to fluctuate with increasing intensity.

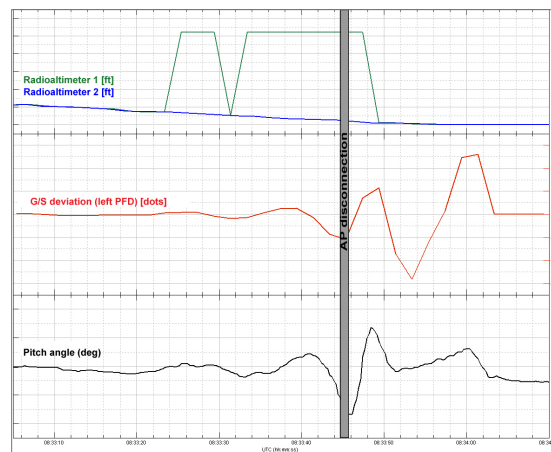
⁽¹¹⁾A G/S variation at a short distance from the threshold is corrected by an attitude adapted to this same variation at a greater distance.
