# Report

**Accident on 9 December 2010**  
at **Tourettes-sur-Loup (06)**  
to the **Robinson R22 helicopter**  
registered **G-CBVL**

Bureau d'Enquêtes et d'Analyses  
pour la sécurité de l'aviation civile

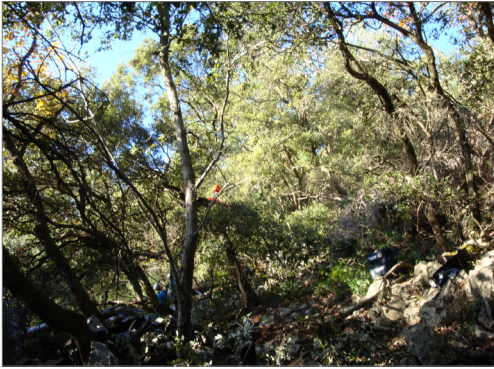
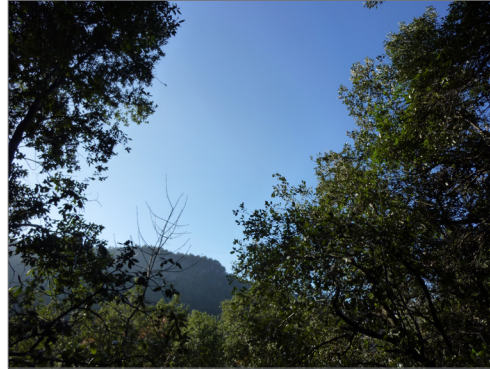
The accident occurred in a wooded area about 2 kilometres south-west of the commune of Tourettes-sur-Loup, between departmental road 2210 and the Colle-sur-Loup road. The site, located at an altitude of 220 metres, was very steep.

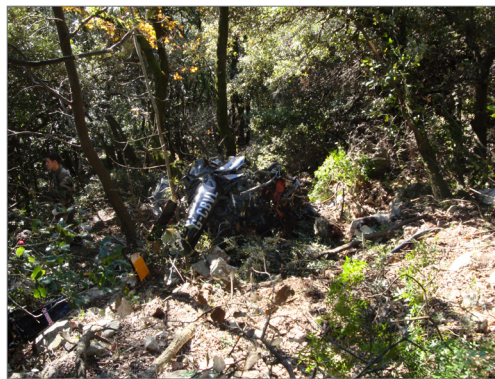
The helicopter was destroyed. The main section lay at the foot of a tree. A section of blade was found 30 metres before the site while a piece of the landing skids was located about 30 to 40 metres from the site.

Observation of the site and wreckage showed high vertical energy on impact. No component observed showed horizontal energy, or rotation of the main and tail rotors. The wreckage could not be fully examined on site. It was transported to the CEPr for additional examinations.

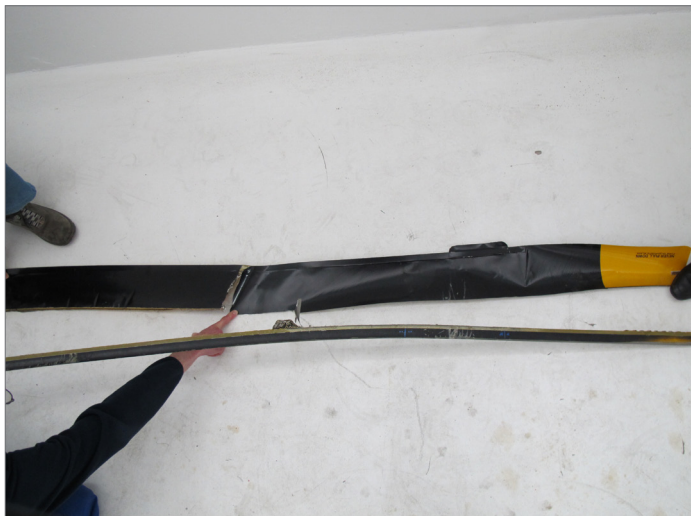
Blade reconstitution

One of the two blades from the main rotor was reconstituted with a section taken from the wreckage and the segment recovered in December 2011. Both parts of the blade were contiguous. Examination of the impacts present on its leading edge showed that the blade struck the front section of the left skid and the canopy.

Such a contact was only possible after main rotor rotation deviation following the failure of the droop restrainer of the main blades.
