Tail strike on runway during night landing

Airplane	McDonnell Douglas MD-81 registered OY-KHP
Date and time	6 February 2010 at 18h25 ⁽¹⁾
Operator	Scandinavian Airlines System (SAS)
Site of accident	AD Grenoble-Isère (38)
Type of flight	Public transport of passengers Unscheduled international flight
Persons on board	Captain (PNF); Co-pilot (PF); 4 PNC; 127 passengers
Consequences and damage	Rear part of fuselage seriously damaged

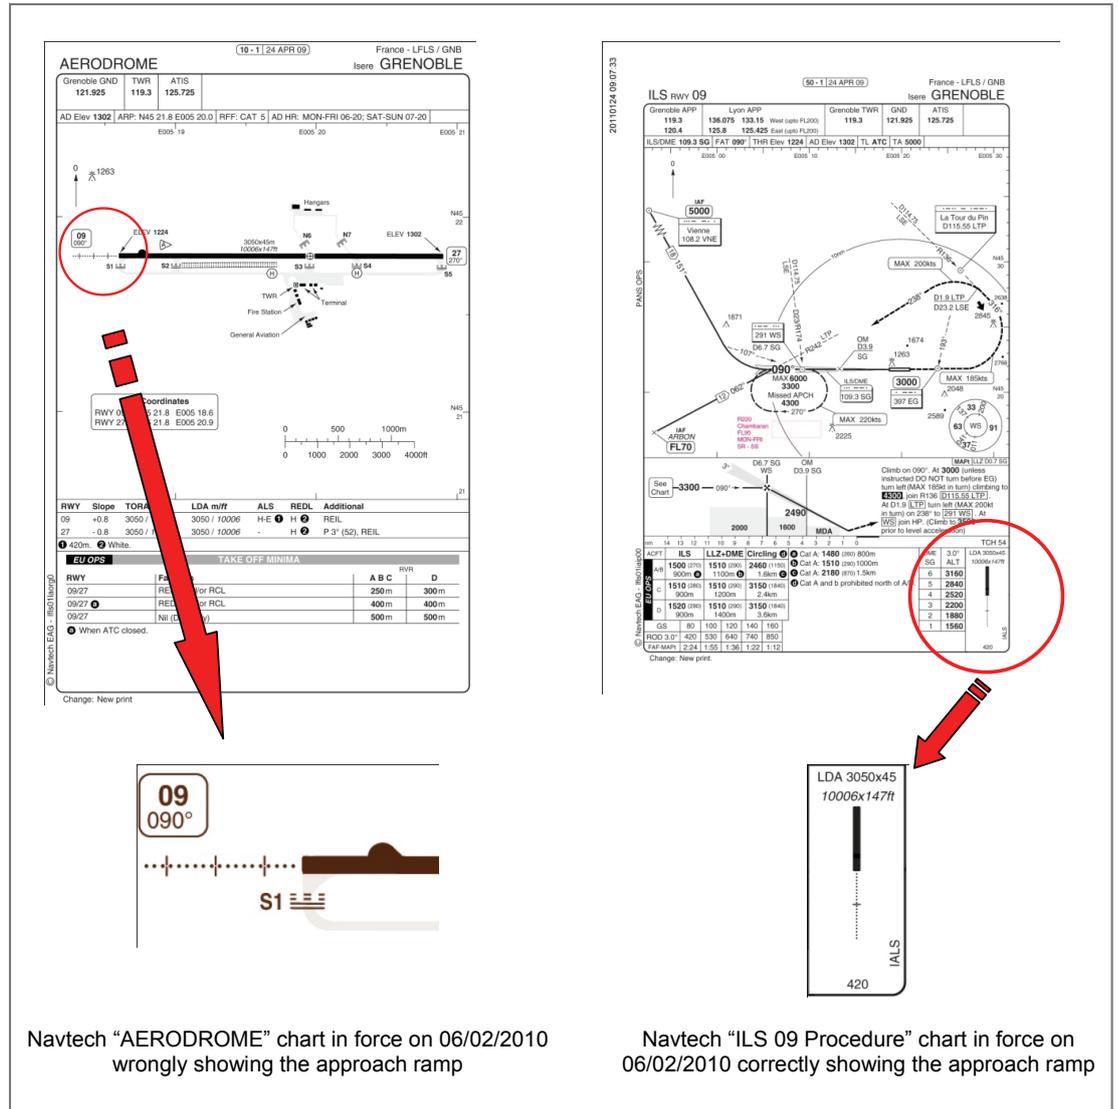
On the day of the accident, the "AERODROME" Navtech EAG chart indicated that the approach lighting system was at least 900 m long and had 3 crossbars, whereas in reality it was only 420 m and had only one crossbar.

The "ILS 09 Procedure" chart however showed the approach lighting system correctly.

Since the accident, this inconsistency has been corrected by Navtech.
