Fire on main left landing gear during taxiing after landing

Aircraft	ATR 72-200 registered EI-REJ
Date and time	19 April 2011 about 21 h 50 ⁽¹⁾
Operator	Air Contractors
Place	AD Paris Charles de Gaulle (95)
Type of flight	Scheduled international cargo transport
Persons on board	Captain (PF); Copilot (PNF)
Consequences and damage	Left main landing gear seriously damaged by fire

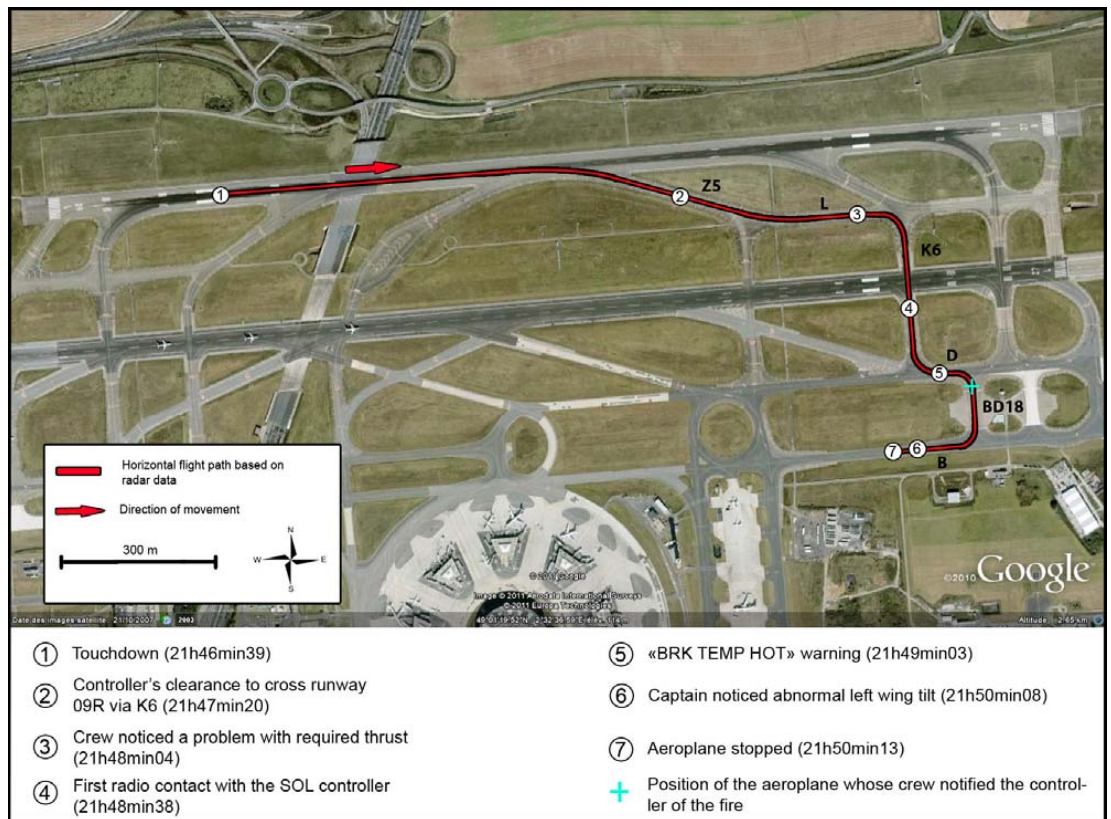
Figure 1: Aeroplane trajectory

The crew was carrying out a flight from Cork (Eire) to Paris Charles de Gaulle (95). They landed on runway 09 L at Paris Charles de Gaulle at 21 h 46. They cleared the runway via taxiway Z5. The controller cleared them to continue taxiing on taxiway K6, cross runway 09 R and asked them to contact the ground controller at the end (see figure 1).

At 21 h 51 min 40, the crew of the aeroplane that was following EI-REJ (in blue in Figure 1) informed the controller in French⁽⁴⁾ that there was a fire on the aeroplane in front of them.

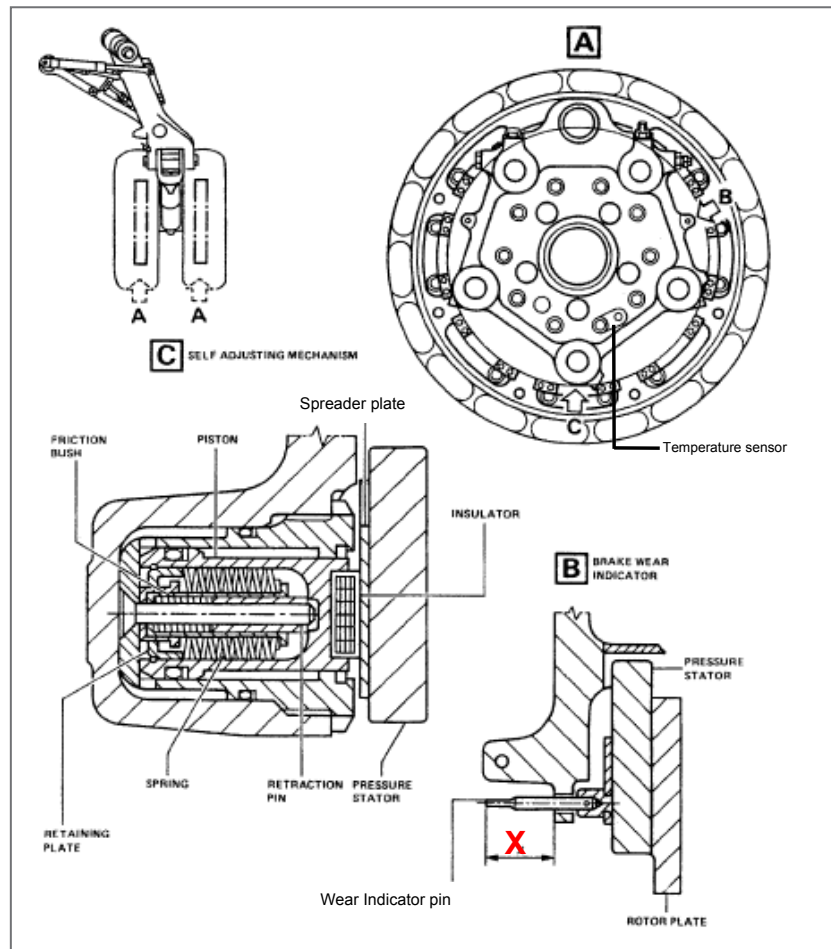
Figure 3: Detailed diagram of the brake block

Brake wear is assessed using an indicator pin located on the spreader plate. When the brakes are fitted on the wheels, the spreader plate is no longer visible and only the section of the indicator pin shown with an X in Figure 3 is visible. When this section is no longer visible, it means that the brakes have reached the wear limit.

Wear on brake block n°1 had exceeded the limit defined by the manufacturer. The spreader plate bearing the brake wear indicator was distorted before the accident and this distortion made it impossible to assess the real wear on the brake block, which appeared to be correct. The wear could not be detected⁽⁶⁾ during the daily maintenance checks. The equipment manufacturer indicated that this wear does not affect braking efficiency. However it did not specify if this wear could encourage a brake block piston malfunction.

The equipment manufacturer responsible for brakes designed a new spreader plate. Modifications were considered to avoid distorting the plate during normal operation of the aeroplane so that the wear indicator truly represented the condition of the brake block. This new model is currently being validated by the aeroplane manufacturer. Not having determined the cause of the brake block overheating as yet, the equipment manufacturer had not put in place corrective actions at the time of publication of this report.
