**FINAL REPORT ON ACCIDENT TO  
HELI- UNION COMPANY LTD.  
HELICOPTER SIKORSKY S76 C++  
NEAR YETAGUN IN ANDAMAN SEA  
ON 11.07.2011**

| 2. Aircraft type | : Helicopter SIKORSKY S76 C++ |
| 4. Registration | : F-HJCS |
| 6. Date & Time | : 11 July 2011 at 10 h 19 (local time) |

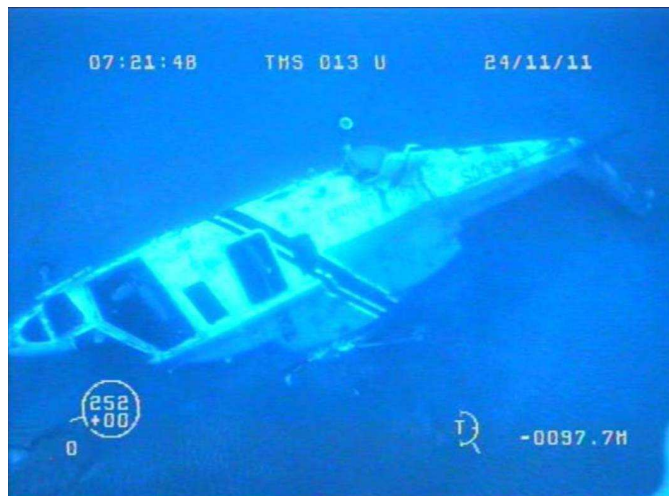
The helicopter was slightly damaged by the impact with the sea and it toppled just after ditching and the prolonged salt water immersion. The main rotor blades and tail rotor blades were broken. The right crew door, the window of the right sliding door, the right front window and the window of the left side door were missing, probably due to actions of the crew and passengers during evacuation.

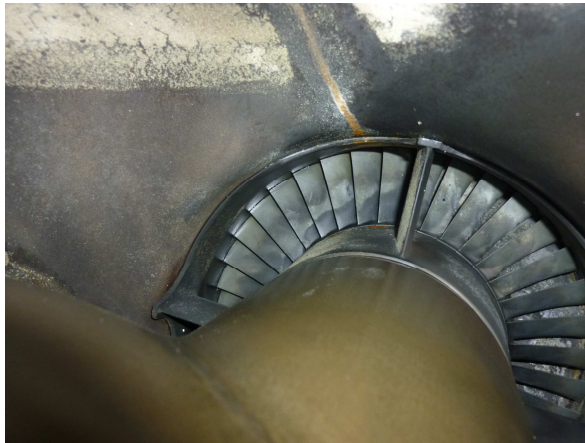
1 (s/n 42266) did not exhibit any pre-accident damage with no particular findings to report.

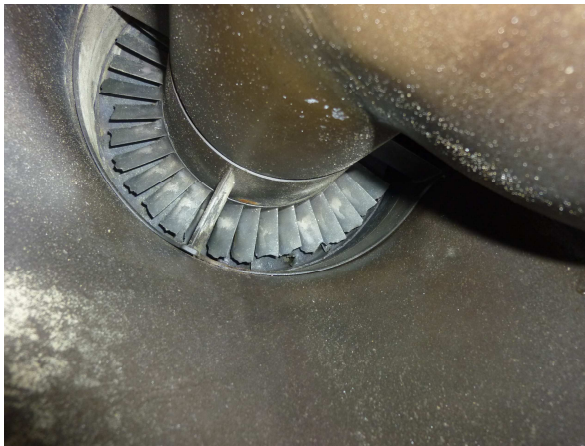
The on-site boroscopic examination of engine #2 (s/n 42265) revealed damages to the blade tips of both high pressure turbine (gas generator) and power turbine (free turbine). The pipes at the accessories gearbox breather gear output and at the bleed valve output were found disengaged. The moment of their disengagement could not be established. The disengagement of those pipes does not affect the engine's ability to deliver the required power. There were no other significant findings on engine #2.

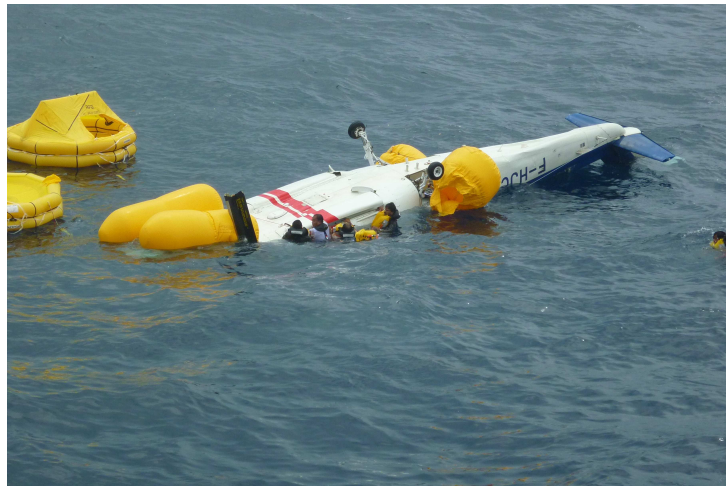
The helicopter was equipped with an emergency flotation system consisting of four inflatable units. A flotation bag was installed on each main landing gear compartment door and two were installed in compartments next to the nose landing gear. The emergency flotation system was successfully inflated by the PF just before ditching. The picture below shows that the devices were inflated.

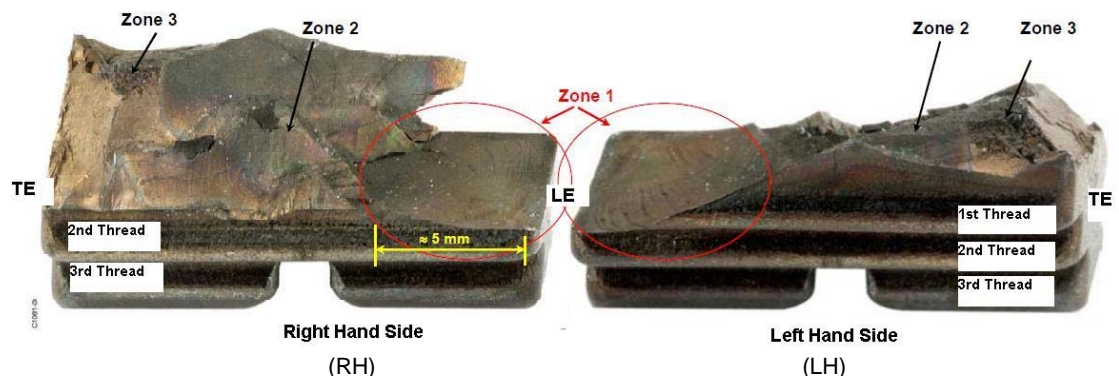
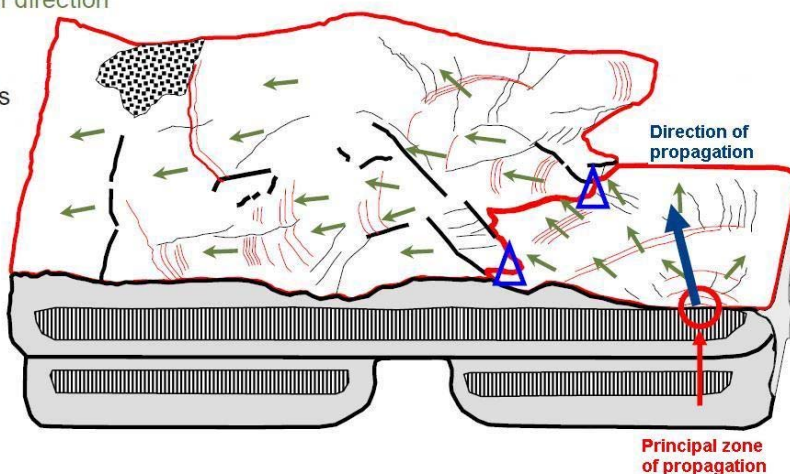
The engine #2 HP turbine wheel assembly was analysed. The examination identified the fatigue rupture of blade #6 below the platform. Damages to the other blades above the platform were consecutive to the rupture of this blade.

The fractured area was typical of a rupture by fatigue and was divided into three areas:

- First, a zone of initialisation near the leading edge of the blade and propagation in a plane towards the trailing edge.
- Second, a zone of propagation along crystallographic planes.  
(The first and second zones of propagation by fatigue represent 90% of the whole fracture surface)
- Third, a zone corresponding to the final rupture of the remaining section (approximately 10% of the total fracture surface).

It consists of adding a damper in the inter-blade area under the platform and reinforcing inspections on new and repaired HP turbine wheels.

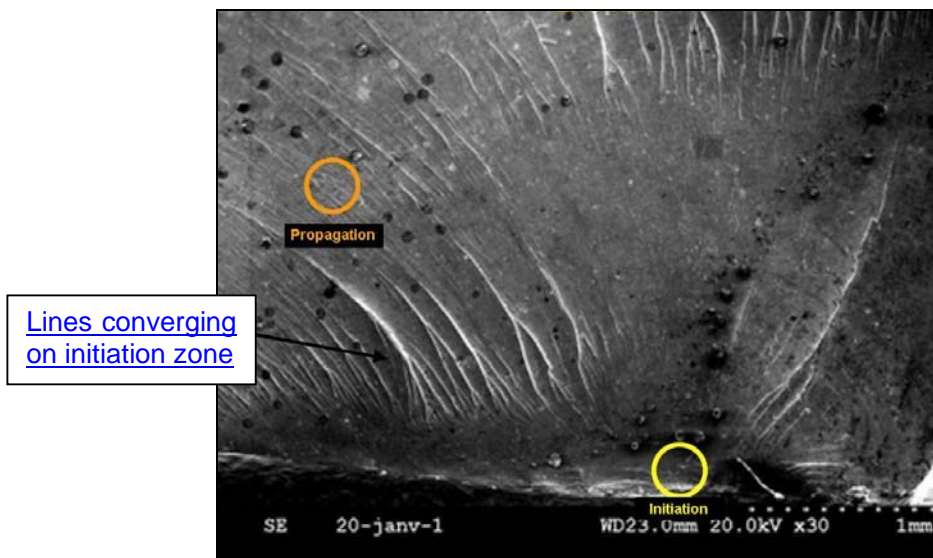
The microfractographic examination of the first zone of the fracture area showed a succession of lines corresponding to the propagation of the crack.

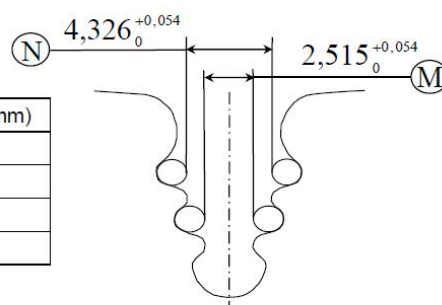
M = 2,515 +0 / +0,054 (mm)	N = 4,326 +0 / +0,054 (mm)
<b>Recess 5</b>	2,670 / 2,580	4,480 / 4,390
<b>Recess 6*</b>	2,510	4,315
<b>Recess 7</b>	2,560 / 2,550	4,360
<b>Recess 25</b>	2,560	4,360

(\*)– recess corresponding to the ruptured blade

The results for the distance between threads produced several values beyond the reference dimensions.

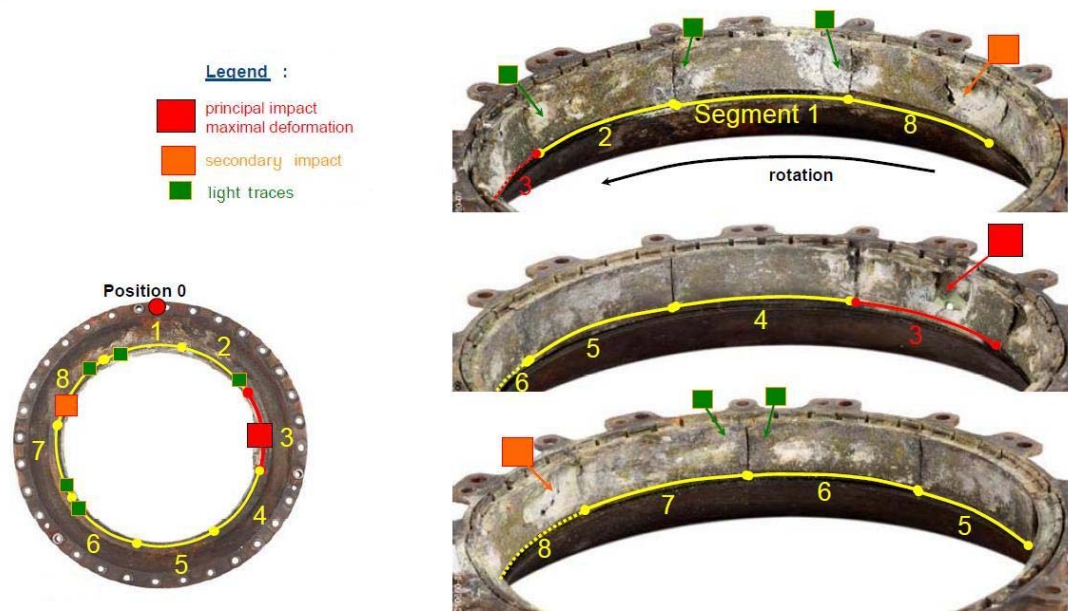
The shroud exhibited one deep impact, located at the 3 O'clock position, corresponding to blade #6's rupture. The impact distorted the outer diameter of the shroud locally without leading to a puncture.

Another impact, less deep, was visible at the 10 O'clock position. Several other minor impacts could also be seen inside the shroud.

None of the impacts punctured the shroud.

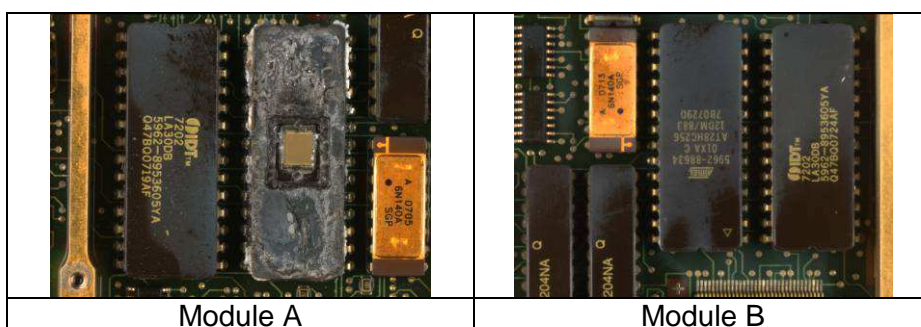
Both modules A and B were extracted from the computers. The main boards of each module are in good condition. The module A memory component in which the data is stored is not in good condition. The top cover of the ceramic package is not glued anymore; the bonding wires linking the lead frame pins to the silicium die are broken. The module B memory component seems to be in good condition. A small white deposit (probably glue) has been observed around the package.

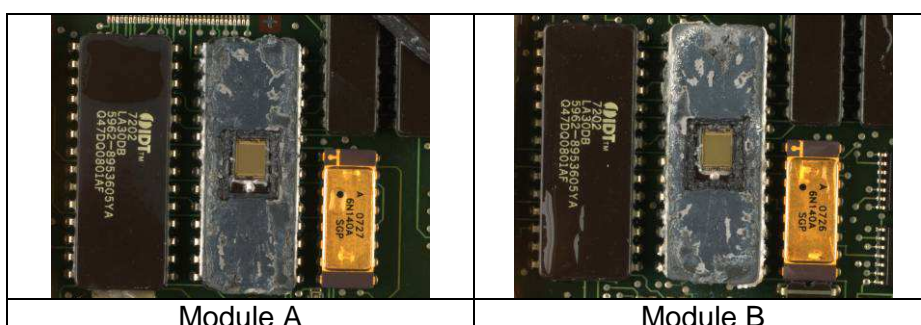
Both modules A and B were extracted from the computers. The main boards of each module are in good condition, except the memory components (EEPROM AT28HC256) in which the data is stored. The top covers of the ceramic package are not glued anymore; the bonding wires linking the lead frame pins to the silicium die are broken.
