Total electrical failure in IFR during initial climb, main landing gear collapse during return landing

Aircraft	Beech 200 registered F-GMPO
Date and time	Friday 7 January 2011 at 8 h 13 ⁽¹⁾
Operator	Company
Place	Montpellier Aerodrome (34)
Consequences	Aircraft seriously damaged

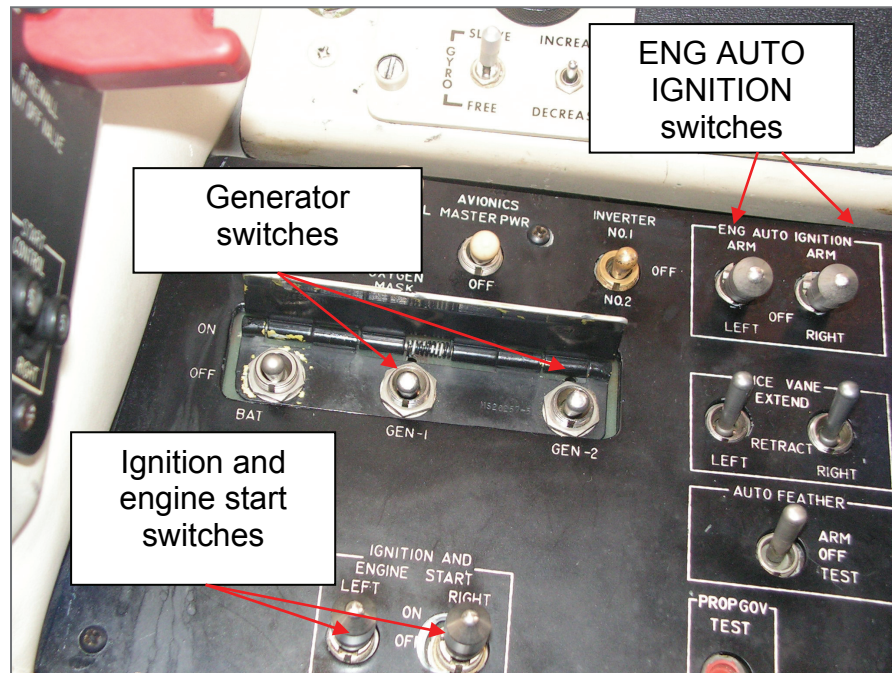
The pre-takeoff procedures include, among other things, positioning the ENG AUTO IGNITION switches in the ARM position when icing conditions are forecast (see photo below).

The two IGNITION AND ENGINE START switches, used to start the engines, are located near the ENG AUTO IGNITION switches and their appearance is similar (see photo above).

Note: The IGNITION AND ENGINE START switches are 3-position type and the ENG AUTO IGNITION switches are 2-position type.

In case of accidental positioning of the IGNITION AND ENGINE START switches in the ON position when the engines are in operation, the two generators are automatically disconnected. The two L DC GEN and R DC GEN amber lights come on in the panel at the bottom centre of the instrument panel and an amber light flashes on the MASTER CAUTION panel located at the top centre. Electrical charge is then supplied only by the battery. The amber MASTER CAUTION warning light can be switched off by a pilot action.

Shortly before takeoff, the PF likely confused the ENG AUTO IGNITION and IGNITION AND ENGINE START switches. Pushing the latter by mistake it automatically disconnected the two generators. The crew did not immediately notice the warning lights coming on that resulted from this and continued the take-off. The PF only noticed the anomaly when the left horizon was lost. The generator stop-start performed by the co-pilot had no effect because the IGNITION AND ENGINE START switches remained in the ON position. The total electrical failure then occurred when the co-pilot extended the landing gear. In a stressful environment, in low light conditions and worsening weather conditions, the pilots made an emergency landing while the manual landing gear extension sequence was not finished.

The similarity between the ENG AUTO IGNITION and IGNITION AND ENGINE START switches, and their proximity in the cockpit was a contributing factor.

Since this accident occurred, the operator has completed installation of foolproof ENG AUTO IGNITION switches.

- ask the manufacturer to modify the ergonomics of the ENG AUTO IGNITION and IGNITION AND ENGINE START switches on Beech 200 aeroplanes in order to avoid any confusion in their use by flight crew.**
