Drop in engine power in cruise, forced landing at an aerodrome

Aircraft	Aeroplane Diamond DA40D registered F-GUVQ
Date and time	Sunday 26 June 2011 at 16 h 45 ⁽¹⁾
Operator	Company
Site of accident	In cruise, above Montélimar aerodrome (26)
Consequences	None

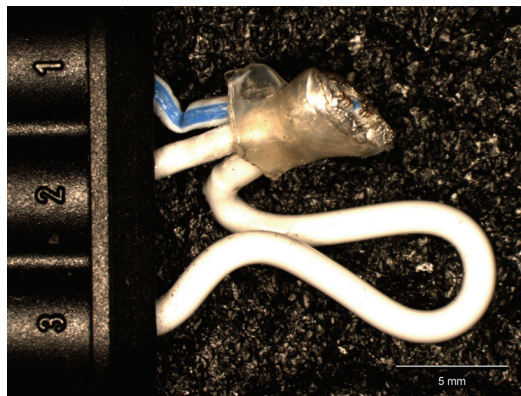
On the ground, a wire from the Vrail plug of the Prail Valve (rail pressure control valve) was recovered severed inside its sheath. Examinations carried out showed that at the place where the wire was severed the sheath was crushed and the cable was bent. The airplane was equipped with a Thielert TAE 125-02-99 engine. In the event of an electrical failure in the power supply of the rail pressure control valve, the Prail valve opens fully and the fuel pressure drops in the inlet duct, leading to a near total loss of engine power.

General view of the Vrail
plug after removal

The incident was due to the deterioration of a wire from the Vrail plug, probably during the replacement of the latter in March 2009. Successive interventions, during which the Prail valve was connected and disconnected on several occasions, probably led to the final break in the wire.

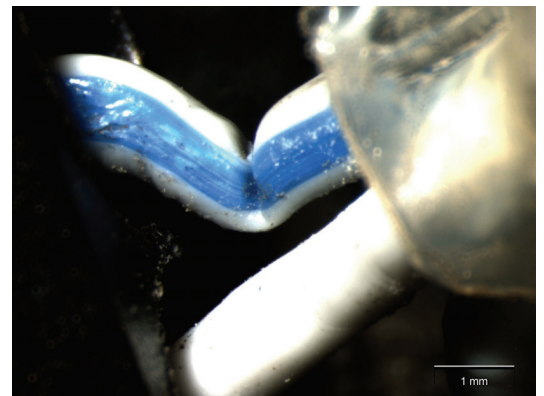
Close-up of cut wire inside the sheath

On 5 March 2009, the Prail valve was replaced by a new model and the Vrail plug had been modified, by application of the Thielert TM TAE 125-1008 P1 service bulletin, made mandatory by an EASA airworthiness directive. In order to install this new socket, the wires had to be cut and new connectors fitted. Given the time that passed between this operation and the incident, it was not possible to determine the precise circumstances of this maintenance operation. The initial deterioration of the wire inside its sheath nevertheless probably occurred at this moment.

The head of the maintenance workshop⁽³⁾ explained that since December 2010, ECU warnings had appeared repeatedly. The Prail valve had been replaced on several occasions, in December 2010 and in May 2011, without the warnings curtailing. These successive changes probably contributed to the deterioration of the Vrail plug wire.

This break led to the full opening of the Prail valve. The resulting fuel pressure in the inlet rail then dropped, leading to a significant loss of engine power and the impossibility of maintaining level flight.

- **EASA require that Thielert improves the electrical part of the fuel pressure regulation system on TAE 125 engines, in such a way as to make them less vulnerable to power outages;**
- **EASA require that Thielert develops specific checks following operations on the fuel pressure regulation chain, in order to detect possible failures.**
