## Engine fire during climb, turn back, emergency landing

<b>Aircraft</b>	Bombardier CRJ700 Canadair Regional Jet Series 700, registered F-GRZH
<b>Date and time</b>	15 August 2011 at 06 h 50 <sup>(1)</sup>
<b>Operator</b>	Brit Air
<b>Place</b>	Lyon Saint-Exupéry Airport (69)
<b>Type of flight</b>	Scheduled public transport of passengers
<b>Persons on board</b>	Captain (PF), Copilot (PNF), 2 cabin crew, 32 passengers
<b>Consequences and damage</b>	Left engine damaged

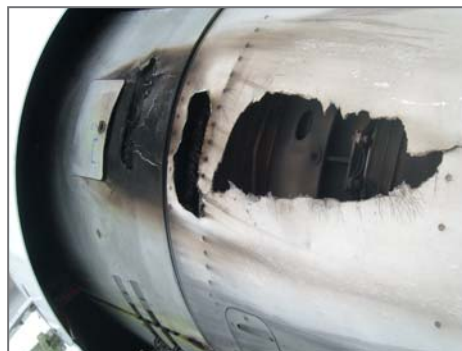
External damage to engine

The external examination of the left engine showed a burnt area. Opening the cowlings made it possible to localise the probable origin of the fire in the vicinity of the “operability bleed valve” (OBV).

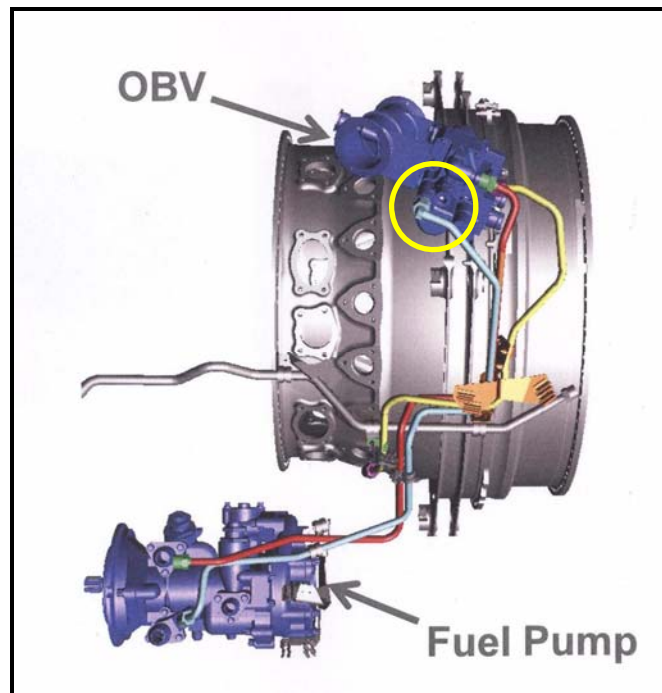
OBV assembly diagram

The OBV is a butterfly-type valve that allows air to be regulated in the compressor, controlled by a fuel supply under pressure. The OBV assembly includes three connectors identified as “Supply”, “Return” and “Drain”. When the valve is installed on the engine, the fuel supply pipes coming from the fuel pump are connected via three connectors on the valve.

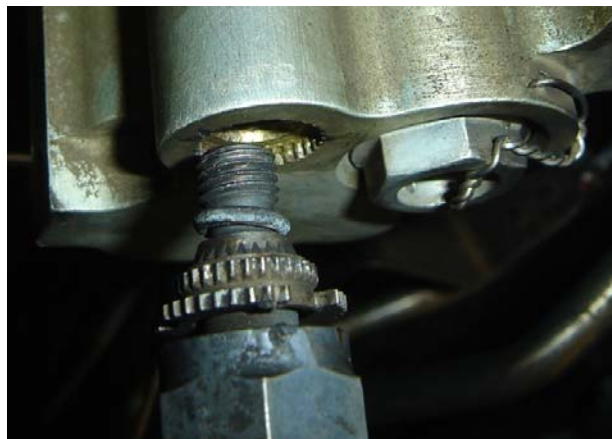
A more detailed examination of the engine revealed that the OBV fuel supply piping connector had come out of its seating, causing a fuel leak.

A fuel supply connector loosened, which introduced play and wore the threads in the aluminium OBV ring lock fuel fitting. The damage to the threads led to the disconnection of the connector and the fuel leak.

Disconnected OBV connector external damage

An OBV fuel supply pipe becoming dislodged from the ring lock fuel fitting caused a fuel leak under pressure on the hot parts of the left engine and caused the fire.

The forces applied on the piping were enough to cause the loosening of the connector, leading to wear on the threads in the ring lock fuel fitting .

Following this incident, the manufacturer selected another supplier who offered a more robust unit.

This event showed that the OBV installed on the engine was not subject to any specific maintenance during the life of the engine. This event and the other incidents of a similar type reported on identical engines led the FAA to issue an Airworthiness Directive (AD 2013-06-06<sup>(2)</sup> of 8 May 2013) specifying the replacement of OBV's installed on GE CF34-8C and CF34-8E engines, depending on the following criteria:
