# Report

Serious incident on **22 July 2011**  
**in cruise at FL350, north Atlantic Ocean**  
to the **Airbus A340-313**  
registered **F-GLZU**  
operated by **Air France**

**BEA**

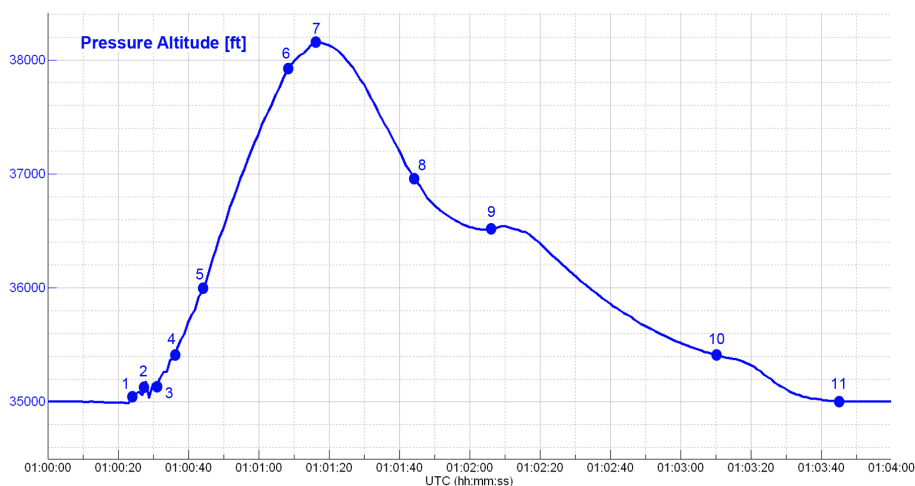
Figure 1 - Vertical flight path

At 1 h 00 min 24 (point n°1 on Figure 1), about 2 NM after passing coordinates 18N 60W, the aeroplane entered a zone of moderate turbulence. The overspeed warning ("OVERSPEED") was triggered<sup>(3)</sup> and the "Master Warning" warning light came on. The crew stated that they were very surprised by this warning. Mach reached 0.87.

At 1 h 00 min 27 (point n°2), the PNF manually disengaged the AP by pressing the takeover pushbutton on the side-stick. A pitch-up input on the PNF's side-stick going as far as  $\frac{3}{4}$  to stop was recorded for 6 seconds. This input was accompanied by an input to bank to the right then left. The PNF stated that he did not remember these inputs.

At 1 h 00 min 31 (point n°3), the PF extended the speedbrakes. Mach was 0.84 and started to decrease 2 seconds later.

At 1 h 00 min 37 (point n°4), the speedbrakes started to retract automatically. Pitch attitude then varied between 8° and 10°.

At 1 h 00 min 44 (point n°5), the aeroplane was at FL360. The speedbrakes were retracted. Pitch attitude increased to about 12° in 2 seconds. The aeroplane continued to climb and Mach decreased.

At 1 h 01 min 08 (point n°6), while the aeroplane was at 37,950 ft in climb, the PF disengaged the A/THR and moved thrust levers forward to the TO/GA detent.

At 1 h 01 min 17 (point n°7), altitude reached maximum: 38,150 ft. Mach was 0.66.

At 1 h 02 min 06 (point n°9), the aeroplane descended past 36,520 ft. The PF then became aware of the disengagement of the AP and made a pitch-down input on his sidestick. Pitch attitude began to decrease 2 seconds later.

From 35,400 ft (point n°10), the PF re-engaged AP1, altitude stabilised at FL350 (point n°11), and A/THR was re-engaged.

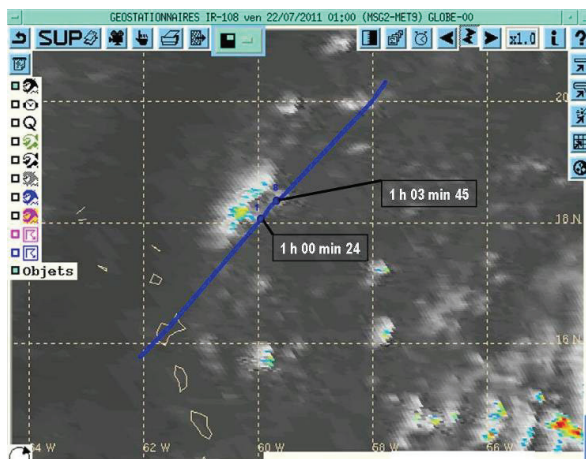
Figure 2 – Trajectory on IR image at 1 h 00

However, infra-red satellite images obtained by the BEA from Météo-France showed the presence of isolated cumulonimbus of moderate intensity between 0 h 30 and 1 h 30 in the area around point 18N 60W, with the top situated at FL380<sup>(7)</sup>. The recorded trajectory showed that the aeroplane flew close by these clouds during the event.

It should be noted that this type of isolated cloud in an inter-tropical zone is beyond forecasting abilities other than immediate or very short term forecasts.

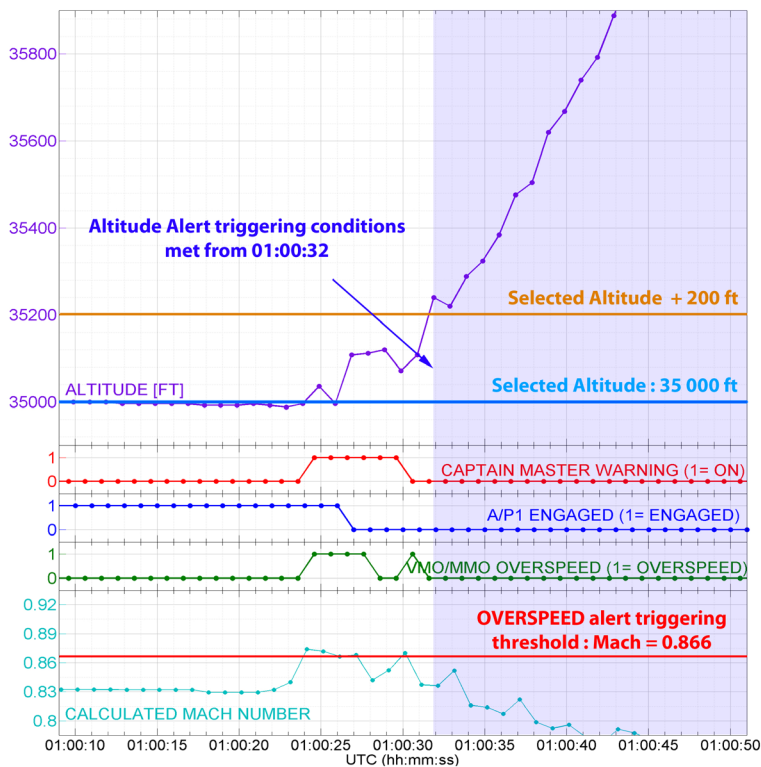
Figure 5 - Warnings recorded

The recorded data showed that there was initially an OVERSPEED warning, which generated a CRC aural warning. This warning was active as long as the Mach was greater than 0.866.

Three seconds later, the AP was disengaged, but as the CRC was still active, the “Cavalry Charge” aural warning was not generated, as it was masked by the CRC. While it was not generated, it could not be cancelled by a possible 2nd press on the sidestick takeover pushbutton.

The moment the 1st OVERSPEED stopped corresponded to the end of the 1.5 second maximum sounding of the “Cavalry Charge”, which was therefore not activated. The “Master Warning” continued to be active between the 1st and the 2nd OVERSPEED as the disengagement of the AP generates a “Master Warning” of 3 seconds if it is not cut off.

The moment of theoretical triggering of the “C-chord” warning, at 35,200 ft, was one second after the end of the 2nd OVERSPEED. Pressing the “Master Warning” warning light, at 36,900 ft, the PNF cancelled the “Altitude alert” about 20 seconds after it appeared. In the absence of a CVR recording, it was not possible to confirm what the real duration of the “C-chord” warning was.

- **EASA evaluate the possibility of requiring that the autopilot disengagement aural warning for all aeroplanes of a maximum mass on take-off of more than 5.7 t be triggered in compliance with paragraphs AMC 25.1322 and AMC 25.1329(j) of the CS-25. [Recommendation FRAN-2012-022]**

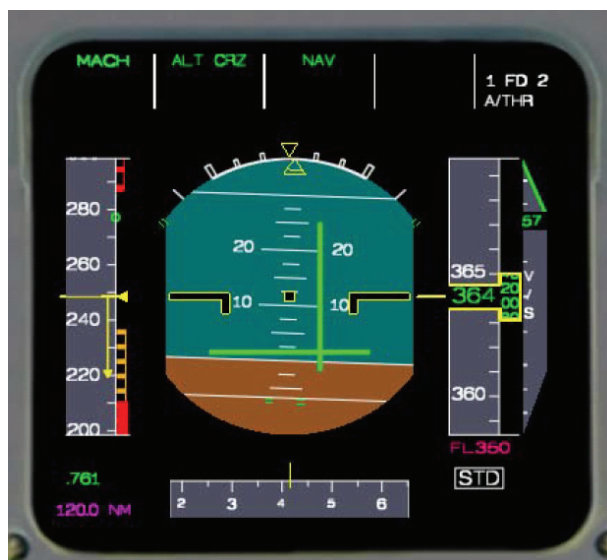
Figure 6 - Reconstitution of display on the PFD during climb at 01 h 00 min 49

modifying the range of his ND. The PNF's attention was drawn to the announcement to the cabin crew. This prioritisation occurred at the expense of monitoring essential parameters such as pitch angle, altitude and the FMA strip during the climb phase. Neither pilot was aware that the AP had been disengaged. The following visual displays were not detected (see Figure 6):

- ❑ Nose-up attitude, which had reached 12° pitch up,
- ❑ High vertical speed, which had reached 5,700 ft/min,
- ❑ The flashing frame around the altitude display on the PFD when the altitude passed 35,200 ft,
- ❑ The position of the FD cross bars,
- ❑ Altitude until it reached more than 38,000 ft,
- ❑ The "AP1" display which had disappeared from the FMA strip,
- ❑ The amber ECAM "AP OFF" message which remained displayed for 9 seconds after the AP disengagement.

It should be noted that perception of these displayed items was made more difficult due to the absence of specific corresponding aural warnings and the level of turbulence which made instrument reading more difficult.

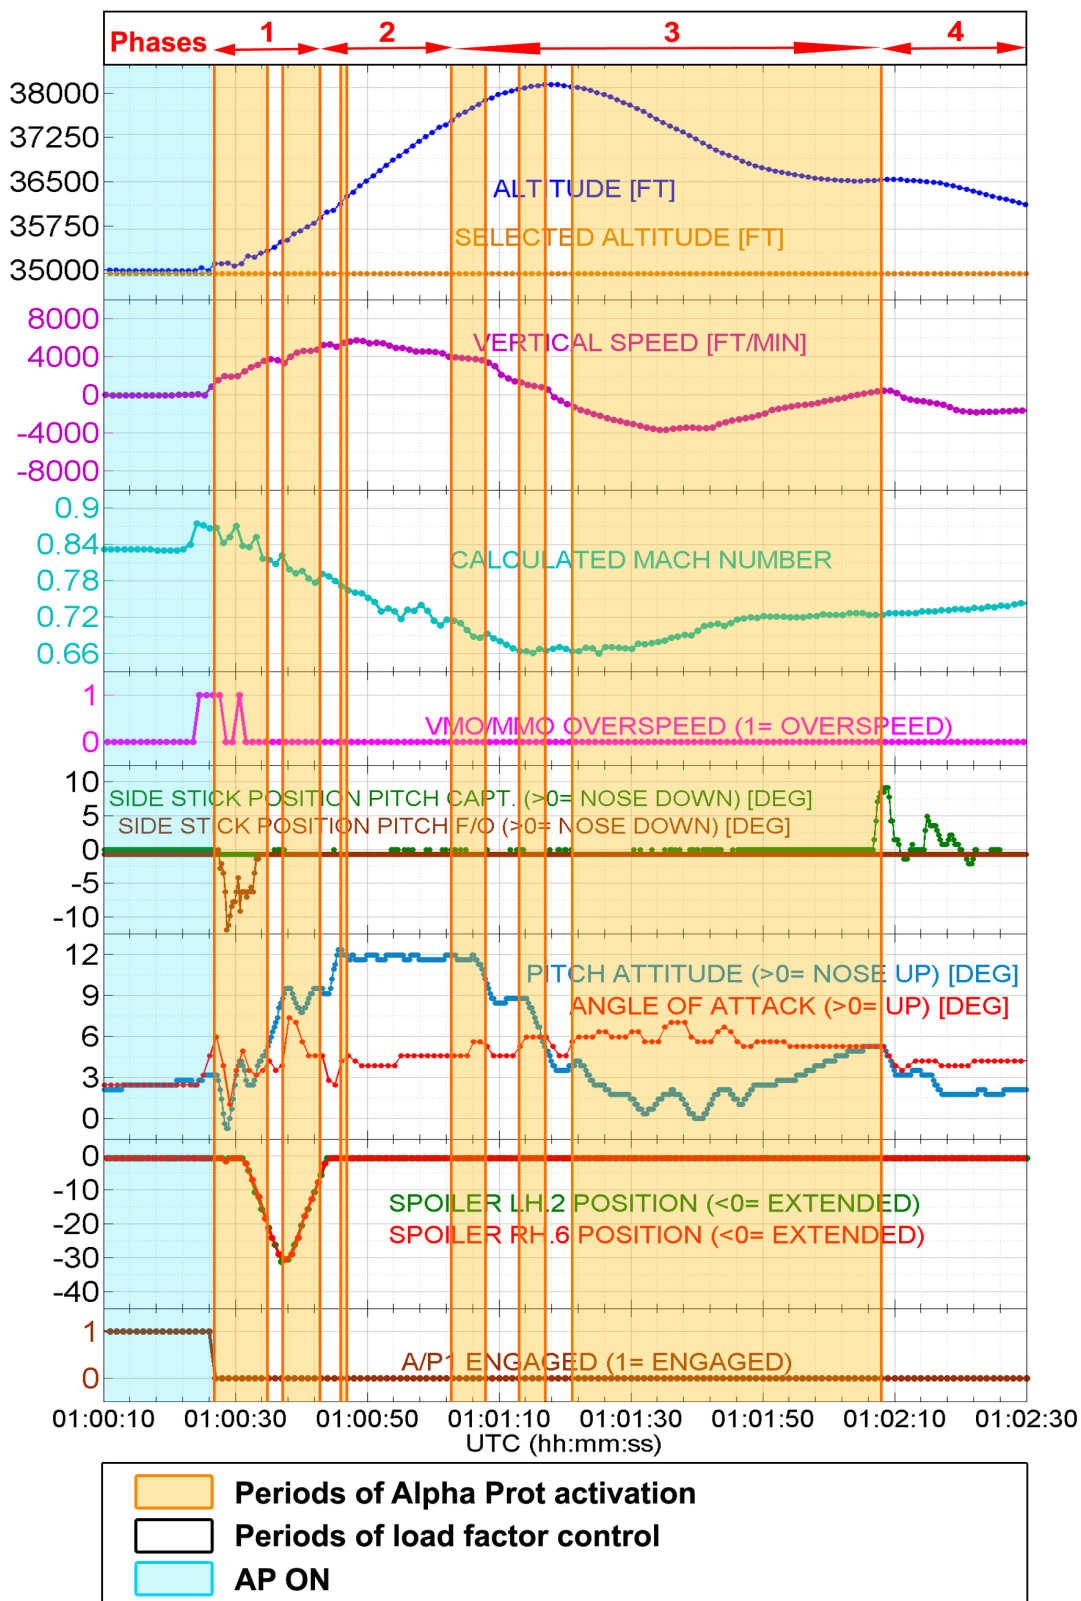
The level bust can be divided into 4 phases:

- ❑ Phase 1: Initially, a gust of headwind<sup>(1)</sup> generated overspeed and the activation of the “OVERSPEED” warning. A few seconds later, a rising gust caused an increase in the angle of attack and vertical speed. Then, the PNF disengaged the autopilot and made a pitch-up input for 6 seconds while the PF extended the speedbrakes. From the start of the pitch-up input, the angle of attack being greater than Alpha Prot, the high angle of attack protection was activated. Then, for 2 seconds, the angle of attack moved briefly below Alpha Prot, with the sidestick in neutral, which meant it exited the protections. The combined effects of turbulence, sidestick input and the extension of the speedbrakes led to increases in pitch, vertical speed and altitude. An angle of attack spike greater than Alpha Prot activated the high angle of attack protection again. The angle of attack continued to increase and passed Alpha MAX, which caused the automatic retraction of the speedbrakes.

- ❑ Phase 2: The intensity of the turbulence decreased and the angle of attack again became less than Alpha Prot (except for 2 seconds). In the absence of sidestick input, the high angle of attack protection deactivated. The load factor control law then maintained the rising trajectory of the aeroplane. During the climb, since the vertical speed exceeded the capacity to climb at constant speed, the aeroplane speed decreased. When lift became less than weight, the pitch decreased. Maintaining the load factor at 1 g induced a slight increase in the angle of attack.

- ❑ Phase 4: The angle of attack was equal to Alpha Prot therefore less than Alpha MAX. Consequently, the PF’s pitch-down input for more than one second on the sidestick caused the high angle of attack protection to be exited and the longitudinal control law returned to load factor. The pitch attitude decreased then stabilised until the crew re-engaged the autopilot.
