## Vibrations, failure of the right main landing gear torsion link during landing roll

<b>Aircraft</b>	Boeing B737-300 registered G-CELD
<b>Date and time</b>	23 July 2011 at 8 h10 UTC <sup>(1)</sup>
<b>Operator</b>	Jet2.com
<b>Place</b>	Paris Charles de Gaulle Airport
<b>Type of flight</b>	Scheduled international transport of passengers
<b>Persons on board</b>	Captain; Co-pilot; 3 cabin crew; 128 passengers
<b>Consequences</b>	Right main landing gear damaged

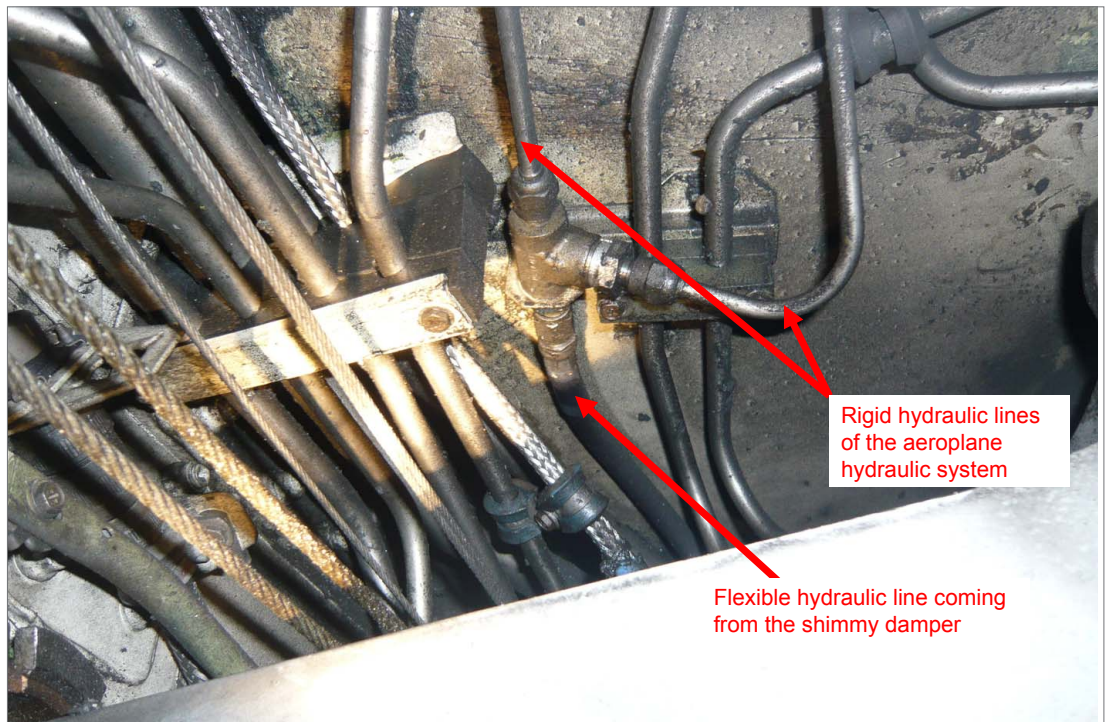
Figure 3 - Installation of lines in normal position

A flexible hydraulic line links the shimmy damper to the aeroplane hydraulic system, located in the upper part of the landing gear (see below).

On Friday 22 July 2011, the aeroplane underwent maintenance operations that included the complete replacement of the landing gear. These operations took place at the Jet2.com maintenance centre at Leeds/Bradford Airport. During installation of the new right main landing gear, the shimmy damper hydraulic line was not reconnected to the aeroplane's hydraulic system. The following day, the aeroplane took off bound for Paris Charles de Gaulle. This was the first flight after changing the landing gear.

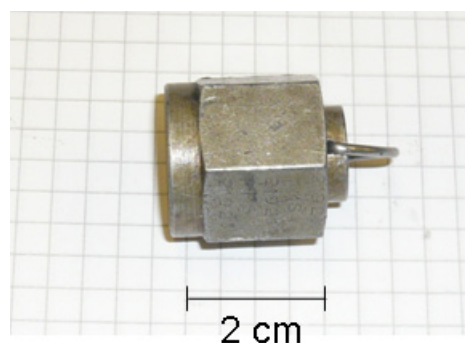
Figure 4 – Metal plug

The examinations undertaken after the accident showed that the threaded end that enabled connection of the flexible line to the hydraulic system at the level of the T-junction was blocked by a metal plug similar to that shown in figure 4 below.

This plug allows hydraulic pressure to be maintained in the aeroplane's hydraulic system even if the shimmy damper is not connected. The check tests that are performed at the end of the maintenance operation involve extending and retracting the landing gear ten times, with the aeroplane still jacked up. These tests do not engage the shimmy damper and did not make it possible to detect the anomaly.

The shimmy damper was thus not supplied by the aeroplane's hydraulic system. It could not then function normally. During the landing, the vibrations caused by the high speed of the wheels and the heavy braking could not be damped down. The strong vibrations quickly weakened the lower torsion link until it failed suddenly.

- A new technical procedure was published relating to managing and checking plugs to blank off hydraulic systems, as well as pneumatic and gas systems. This specified the attachment of identification tags visibly on the plugs used and making an entry in a log every time a plug is placed on a pipe or line. As soon as a plug is removed, a new entry in the log is to be made. At the end of the operation, the procedure requires a check that the number of plugs placed should be the same as the number of plugs removed.

- Jet2.com added some items on the landing gear change work card that specifically require checking the hydraulic connection on the shimmy damper and an independent check being made by a 2nd supervisor.
