Loss of visual references on final in snowstorm, collision with terrain

Aircraft	Socata TBM 700 registered D-FALF
Date and time	Friday 10 February 2012 at around 17 h 30 ⁽¹⁾
Operator	Private
Place	Cuers Pierrefeu Aerodrome (83)
Consequences	Pilot and passengers lightly injured Aeroplane destroyed

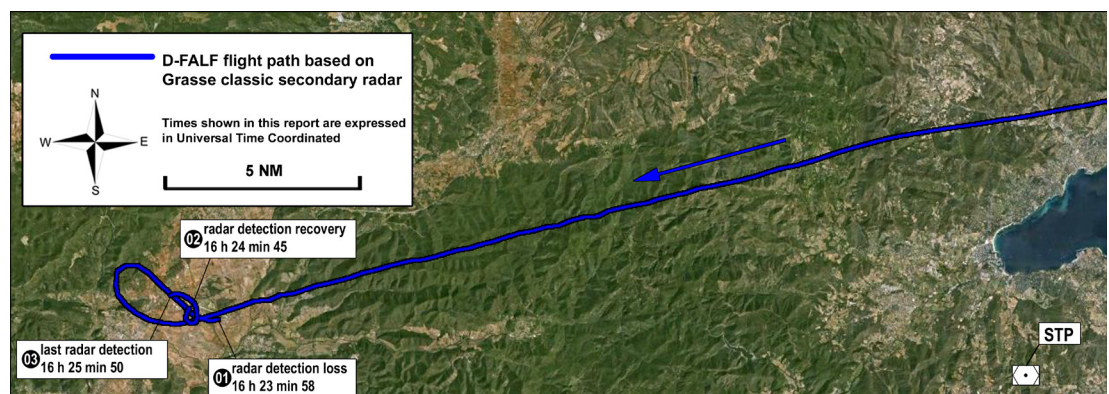
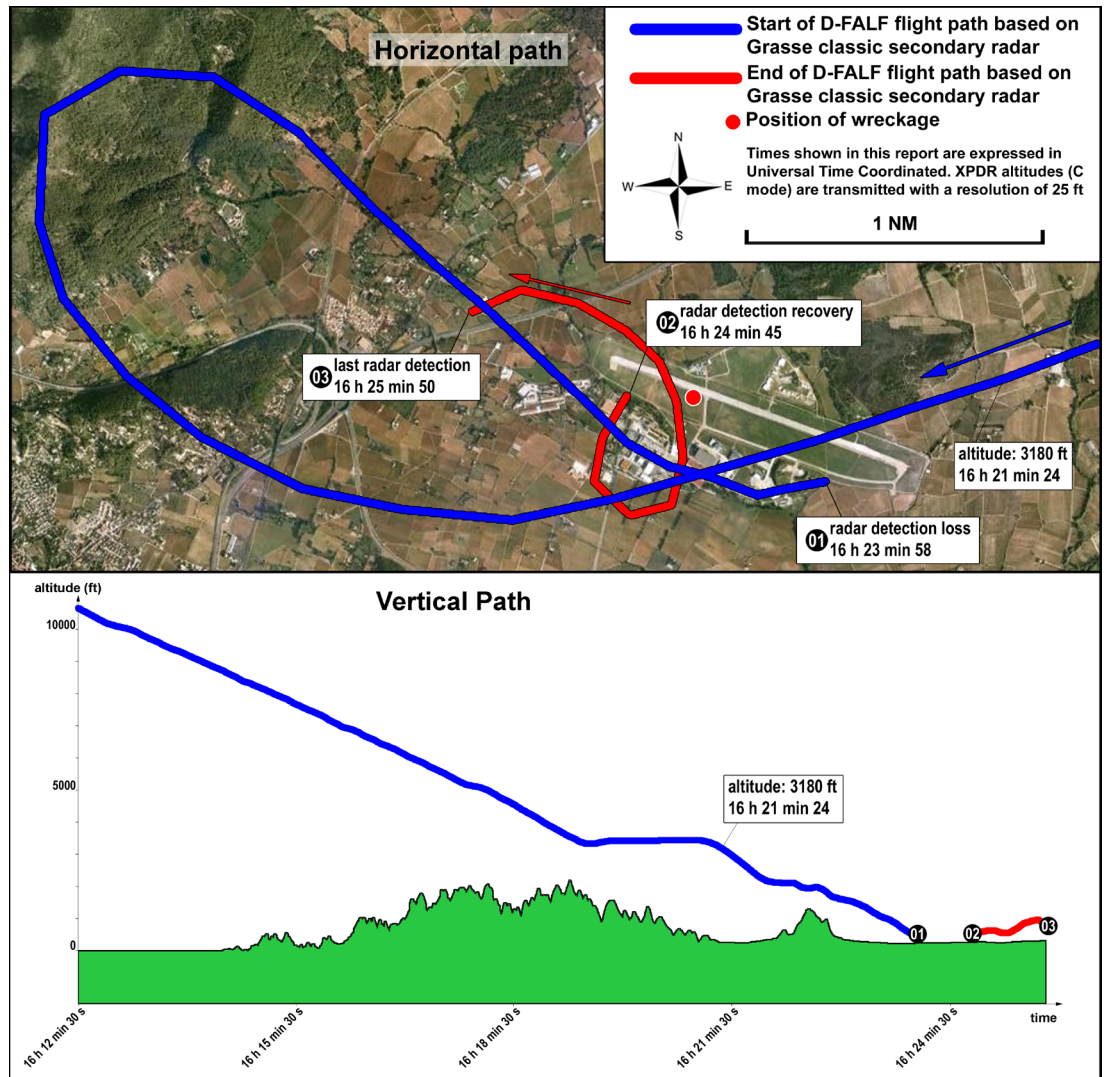
It was possible to partially reconstitute the aeroplane's trajectories based on radar recordings. They show that the pilot overflew the runway three times before attempting to land.

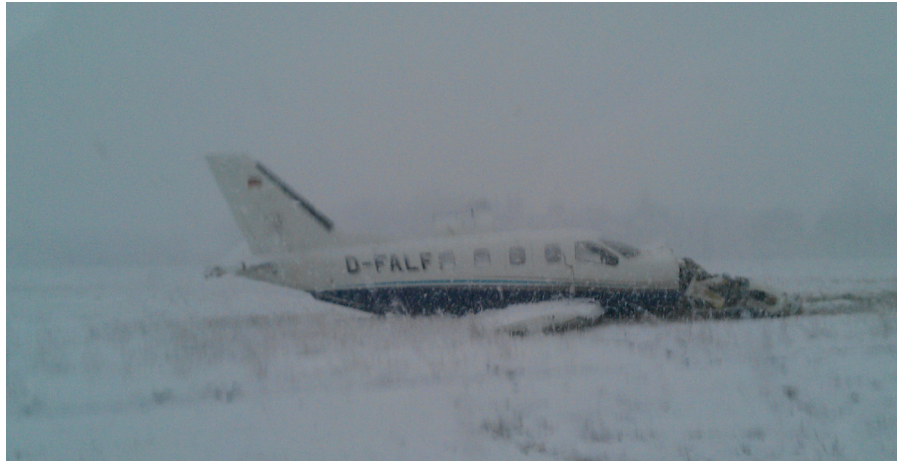
Photo of the wreckage about 10 minutes after the accident

Examination of the wreckage confirmed that the aeroplane had struck the ground with a high left bank angle. The landing gear was extended and the flaps set at 10°. The engine was supplying power at the moment of impact, though it was not possible to determine the power level. A strong smell of kerosene was noticeable around the wreckage. In the cockpit, the inertial switch was found in the « OFF » position.
