## Emergency landing gear extension, nose landing gear collapse during landing roll

<b>Aircraft</b>	Beech-200 King Air registered EC-KNP
<b>Date and time</b>	10 May 2012 at 16 h 12 <sup>(1)</sup>
<b>Operator</b>	Air Taxi et Charter International
<b>Place</b>	Paris le Bourget (93) Airport
<b>Type of flight</b>	Public transportation, non-commercial, ferry flight
<b>Persons on board</b>	Captain (PF); Co-pilot (PNF)
<b>Consequences and damage</b>	Propellers and fuselage damaged

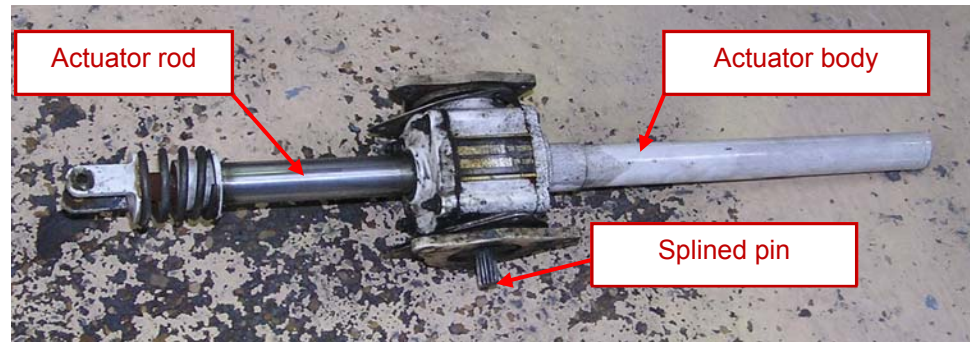
The actuator comprises:

- The actuator body with a threaded rod inside it;
- The actuator rod which has a threaded sleeve on its inside and end.

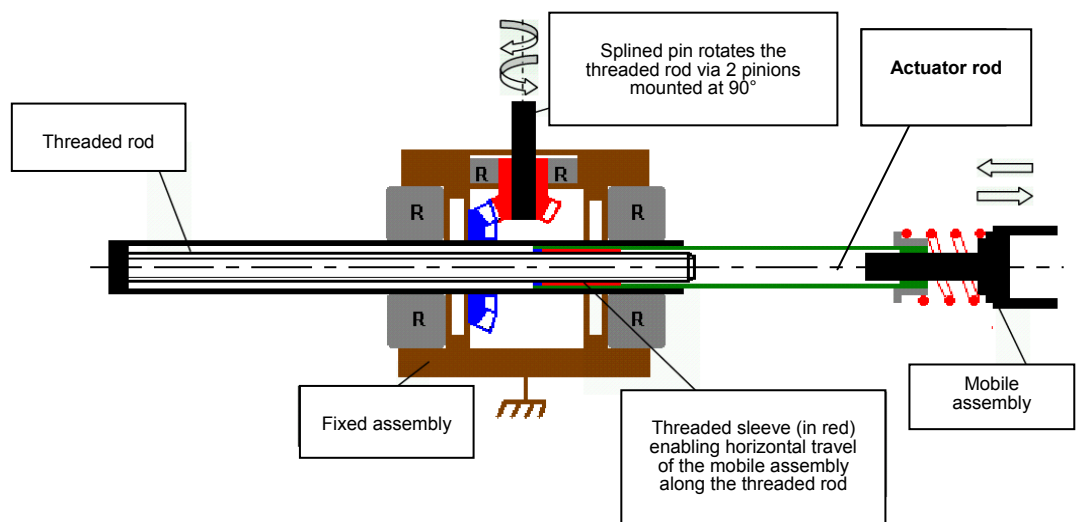
In normal operation, the electric motor that extends and retracts the landing gear drives an accessory gearbox which rotates the mechanisms of the main landing gear and the nose landing gear. The mechanism of the nose landing gear is coupled to its actuator via a splined pin.

The actuator rod enables horizontal travel of the threaded rod in the actuator body via its threaded sleeve.
