Undetected Decrease in Approach Speed, Triggering of High Angle of Attack Protection on Approach

Aircraft	Airbus A321 registered F-GTAN
Date and time	20 July 2012 at about 15 h 00 ⁽¹⁾
Operator	Air France
Place	Paris Charles de Gaulle (95) Airport
Type of flight	Scheduled public transport of passengers
Persons on board	Captain (PF); Copilot (PM)
Consequences and damage	None

This is a courtesy translation by the BEA of the Final Report on the Safety Investigation. As accurate as the translation may be, the original text in French is the work of reference.

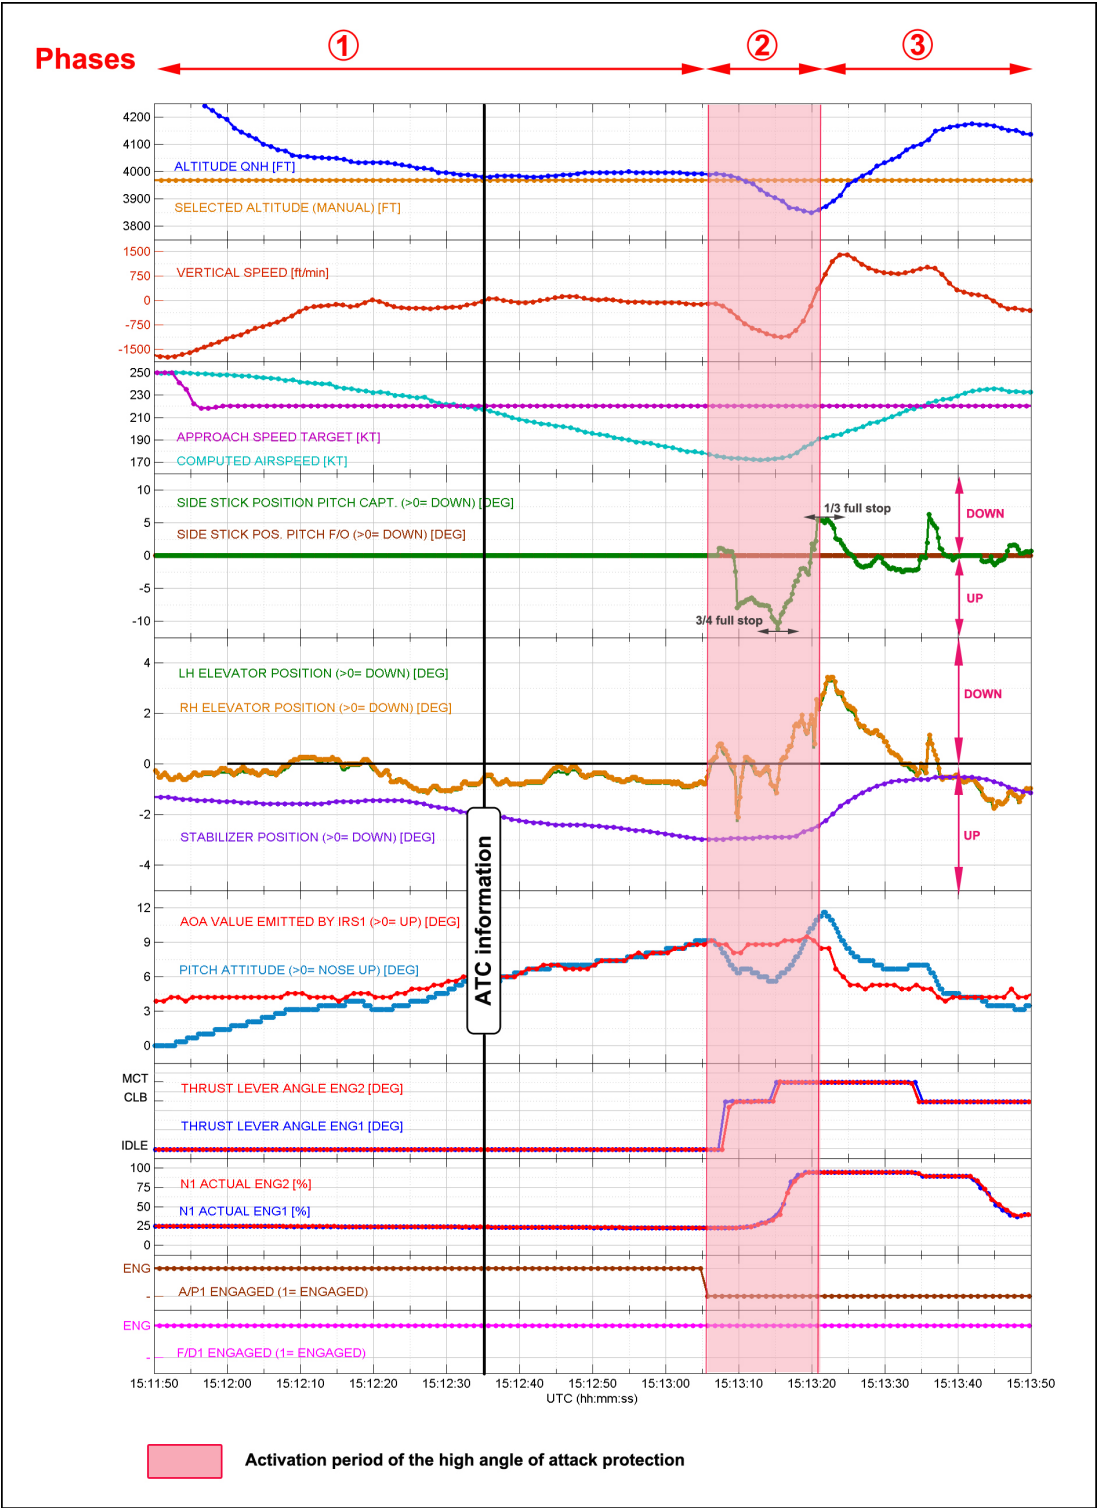
The rest of the flight can be broken down into three phases (see graph on page 3).

Phase 1: Mixed flying situation with AP ON and A/THR OFF

At about 15 h 12, the PF selected a speed of 220 kt at the request of the controller. A few seconds later, the aeroplane reached an altitude of 4,000 ft and the ALT⁽⁷⁾ mode engaged.

The thrust at idle was not sufficient to maintain the speed in level flight. Maintaining the altitude was only then possible by increasing the angle of attack. That was why the AP gave pitch-up input orders to the trimmable horizontal stabiliser (THS) and the elevator. Under these conditions the speed decreased.

During this phase of flight the thrust levers were on IDLE. The pitch and the angle of attack increased progressively, the speed decreased and the altitude remained stable at 4,000 ft.

Phase 2: Triggering of the high angle of attack protection

At 15 h 13 min 05, the autopilot disengaged in accordance with the angle of attack criteria. The high angle of attack protection (Alpha PROT) (see paragraph 2.6) was triggered. The speed was then 177 kt, 26 kt lower than the lowest selectable airspeed (VLS). Two seconds later, the PF pushed the thrust levers forward to CLB. Simultaneously and for about ten seconds he made a pitch-up input since the aeroplane was in descent. At that time, the thrust was not yet established, the angle of attack being limited, the speed was insufficient to develop lift equal to the weight of the aeroplane, which explains its descent. The speed reached a minimum of 172 kt (VLS -31 kt) with a descent rate of about 1,000 ft/min. The PF stated that he saw the speed *"in the red"* on the speed scale and that throughout this phase of flight his priority was to maintain the altitude constant at 4,000 ft.

At 15 h 13 min 15, while the thrust was starting to stabilise, the PF positioned the thrust levers in the FLEX/MCT detent. He later explained that he did not place the levers in the TOGA detent so as to avoid too high a pitch-up moment. Simultaneously his pitch-up input on the stick reached maximum (about $\frac{3}{4}$ of the travel to stop).

The altitude reached a minimum of 3,840 ft QNH. While the thrust stabilised at about 94%, the speed increased. The aeroplane's climb gradient became positive and it pitched up. When it reached 11°, the PF made a pitch-down input for about three seconds, in order to counter the pitch-up moment generated by the engine thrust. This input de-activated the high angle of attack protection, without the PF being aware of it.

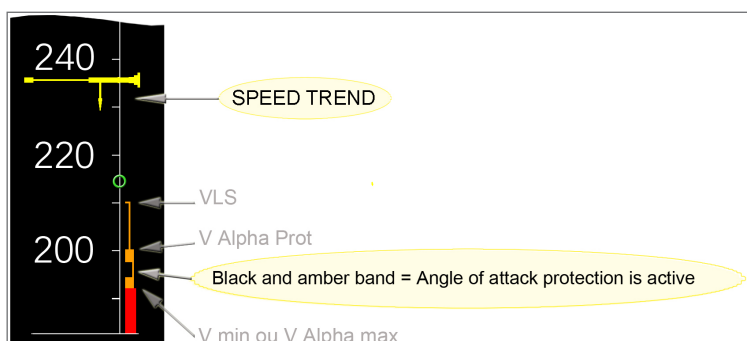
The aeroplane's deceleration is displayed on the speed scale by a descending yellow bar called the "SPEED TREND".

The triggering of the high angle of attack protection is shown on the speed scale by a striped amber and black zone. Its triggering is not signalled by a specific aural indication.

The automatic disengagement of the AP, which follows exceeding the Alpha Prot angle of attack plus one degree, triggers a Master Warning and a Cavalry Charge warning.
