Hard landing, nacelle tip-over and bounce, ejection of a passenger

Aircraft	Cameron Balloons Z-750 balloon registered F-HDJH
Date and time	19 August 2012 at approximately 18 h 30 ⁽¹⁾
Operator	Air Magic, SARL Flying Circus
Place	Feings (41)
Type of flight	Non-scheduled public transport of passengers
Persons on board	Pilot, flight attendant, 32 passengers
Consequences and damage	Death of one passenger

This is a courtesy translation by the BEA of the Final Report on the Safety Investigation. As accurate as the translation may be, the original text in French is the work of reference.

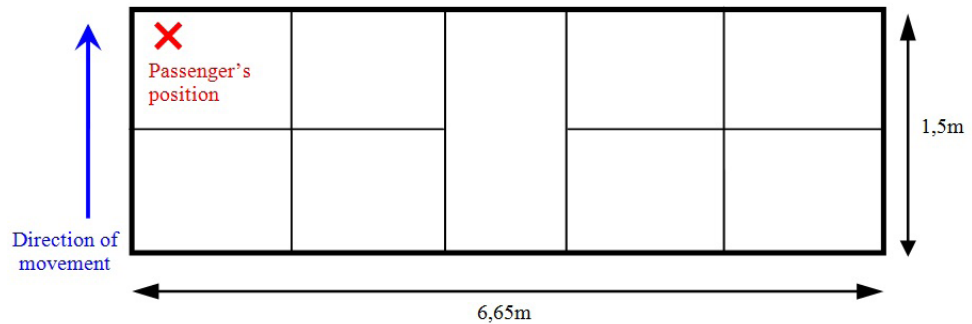
Diagram of basket

The nacelle is equipped with eight compartments of about 1 m², each accommodating four passengers⁽³⁾. Each compartment is equipped with:

- protective pads on the walls;
- handles for passengers to hold onto during the landing⁽⁴⁾;
- a carpet of high density foam covering the floor.

The corpulence and physical strength of the passenger who was killed, and the cramped compartments in the nacelle probably did not make it possible for him to simultaneously squat and hold onto the handles before the impact with the ground.

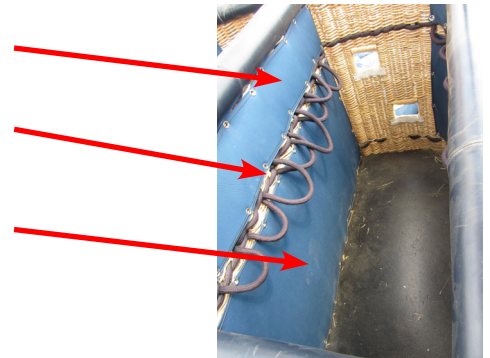
Nacelle similar to that of F-HDJH

The nacelle has a vertical speed indicator to control the vertical speed and a skid for landing. The envelope is equipped with a rapid deflation system (RDS).
