Elevator trim system cable failure on initial climb, flight aborted

Aircraft	Beechcraft 1900D registered F-GOPE
Date and time	9 October 2012 at about 07 h 40 ⁽¹⁾
Operator	Hex'air
Place	Lyon Saint Exupéry (69) airport
Type of flight	Public transport, scheduled domestic passenger service
Persons on board	Captain (PM); copilot (PF); six passengers
Consequences and damage	None

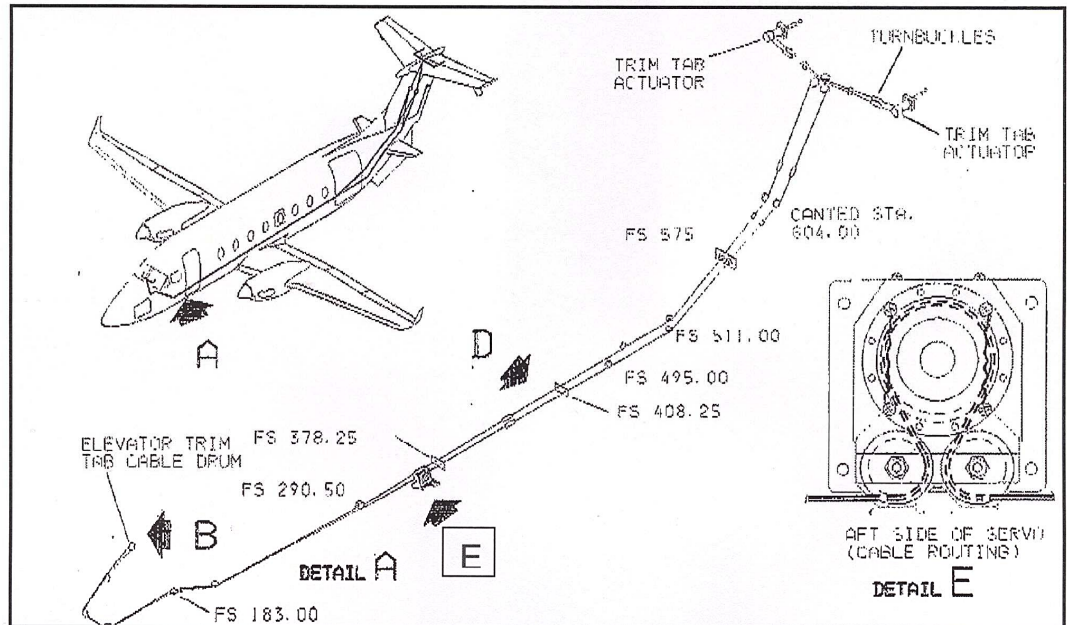
Diagram of Trim System

F-GOPE elevator trim cable was found fractured at the winding level around the pulleys of the autopilot servo-control (see diagram above). Half of the wires fractured through overload and the other half through fatigue crack propagation.

This fatigue fracture seemed to be related to the specific stresses of the cable when being wound round the pulley (see detail E of the diagram in paragraph 2.2)

The incident was due to wear by fatigue cracking of steel wires making up the strands of the elevator trim cable, which could not be detected during scheduled maintenance.

- **FAA, in coordination with the manufacturer, make mandatory a modification of the elevator trim system or, failing that, the replacement of the elevator trim cable at regular intervals, in order to avoid undetectable fatigue fracture of the cable. [Recommendation 2015-013]**
