Report

Accident on **16 October 2012**
at **Lorient Lann Bihoué (56) Aerodrome**
to the **the Bombardier CRJ-700**
registered **F-GRZE**
operated by **Brit Air**

BEA

Bureau d'Enquêtes et d'Analyses
pour la sécurité de l'aviation civile

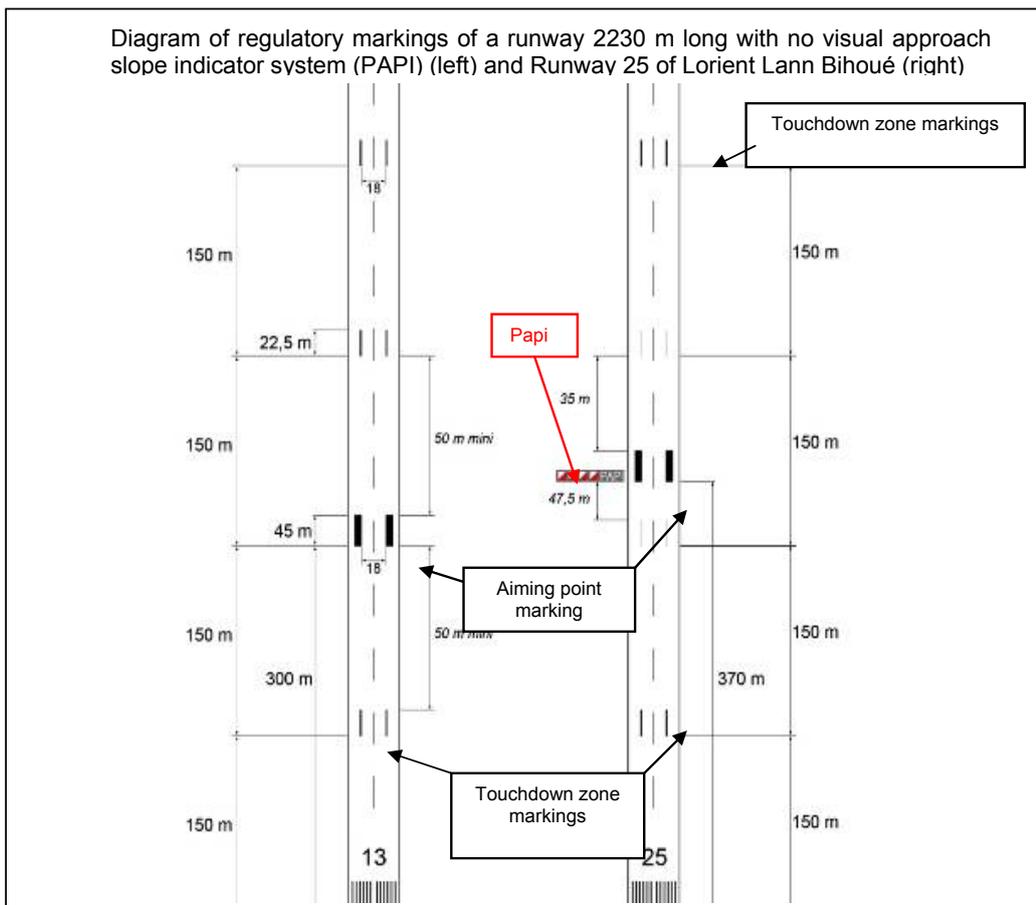
The markings defining the touchdown zone are located every 150 m from the threshold. However, those that coincide with the aiming point markings or are located less than 50 m away from them are not to be placed.

At Lorient Lann Bihoué, the PAPI is located 370 m from the threshold of runway 25. The aiming point markings are therefore also located in the same place. Touchdown zone markings are placed 150 and 600 m from the runway threshold. The other touchdown zone markings (theoretically 300 and 450 m from the runway threshold) are not apparent due to their proximity to the aiming point markings.

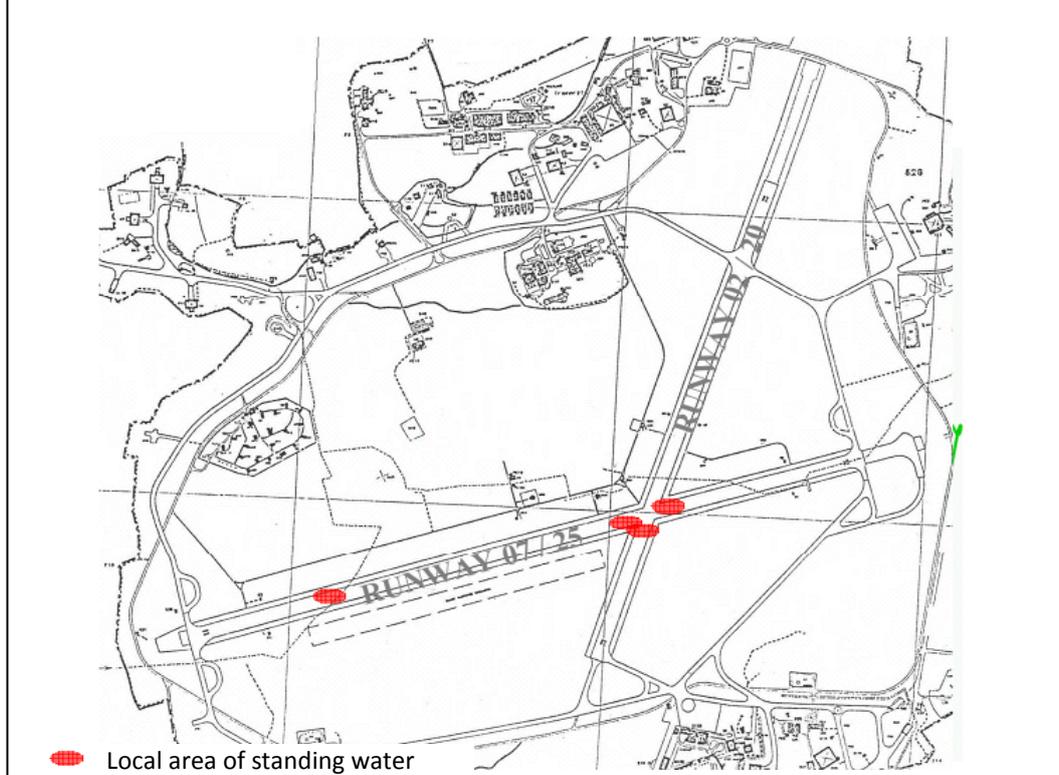
APPENDIX I
RUNWAY PROFILE CORRECTION ZONES TO ELIMINATE RAINWATER
RETENTION AND PHOTOGRAPHS OF THE RUNWAY IN RAINY WEATHER

After the accident, two fire trucks poured water on the south side of the runway over the last 1,200 m. Water retention zones were found on certain sections⁽¹⁶⁾.

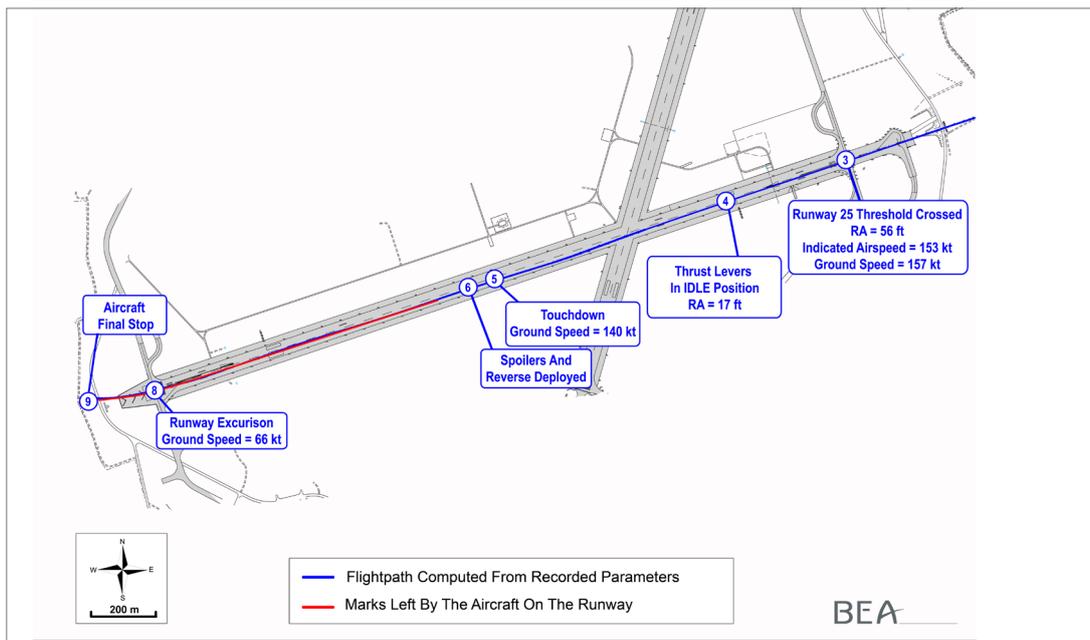
The flight path of the aeroplane was calculated from its ground speed, magnetic heading⁽¹⁸⁾ and drift recorded on the FDR. It was consistent with the marks left by the aeroplane on the runway.

The positioning of the thrust levers to IDLE and touchdown of the main landing gear occurred respectively at 330 and 1.130 m from the threshold of runway 25.

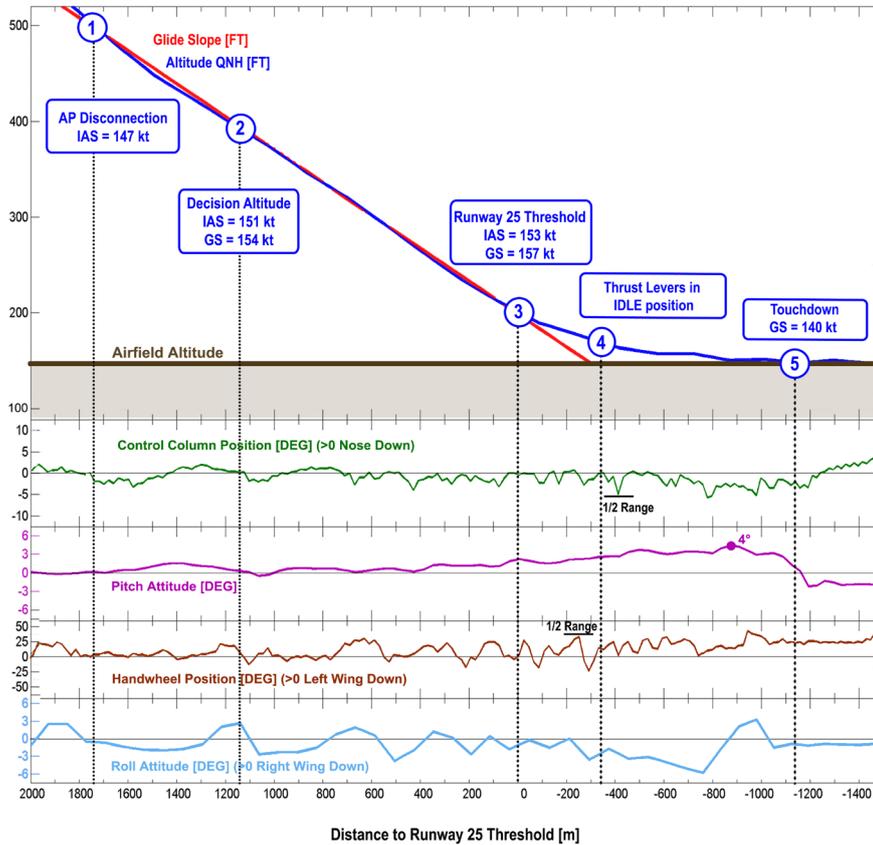
A comparative graph of the aeroplane's descent profile and the glide path of the ILS 25 approach was made from the moment the AP was disconnected until touchdown.

This graph also shows the attitudes and control column inputs.

- ❑ From the disengagement of the AP to 50 ft above ground level, the aircraft was on the glide path to runway 25;
- ❑ On final approach, the roll inputs were substantial (up to half of the maximum amplitude);
- ❑ The aeroplane passed the runway threshold at a height of 56 ft with 4 knots of tailwind;
- ❑ Between reducing the thrust 17 ft from the ground and touchdown, the aeroplane travelled approximately 800 m.

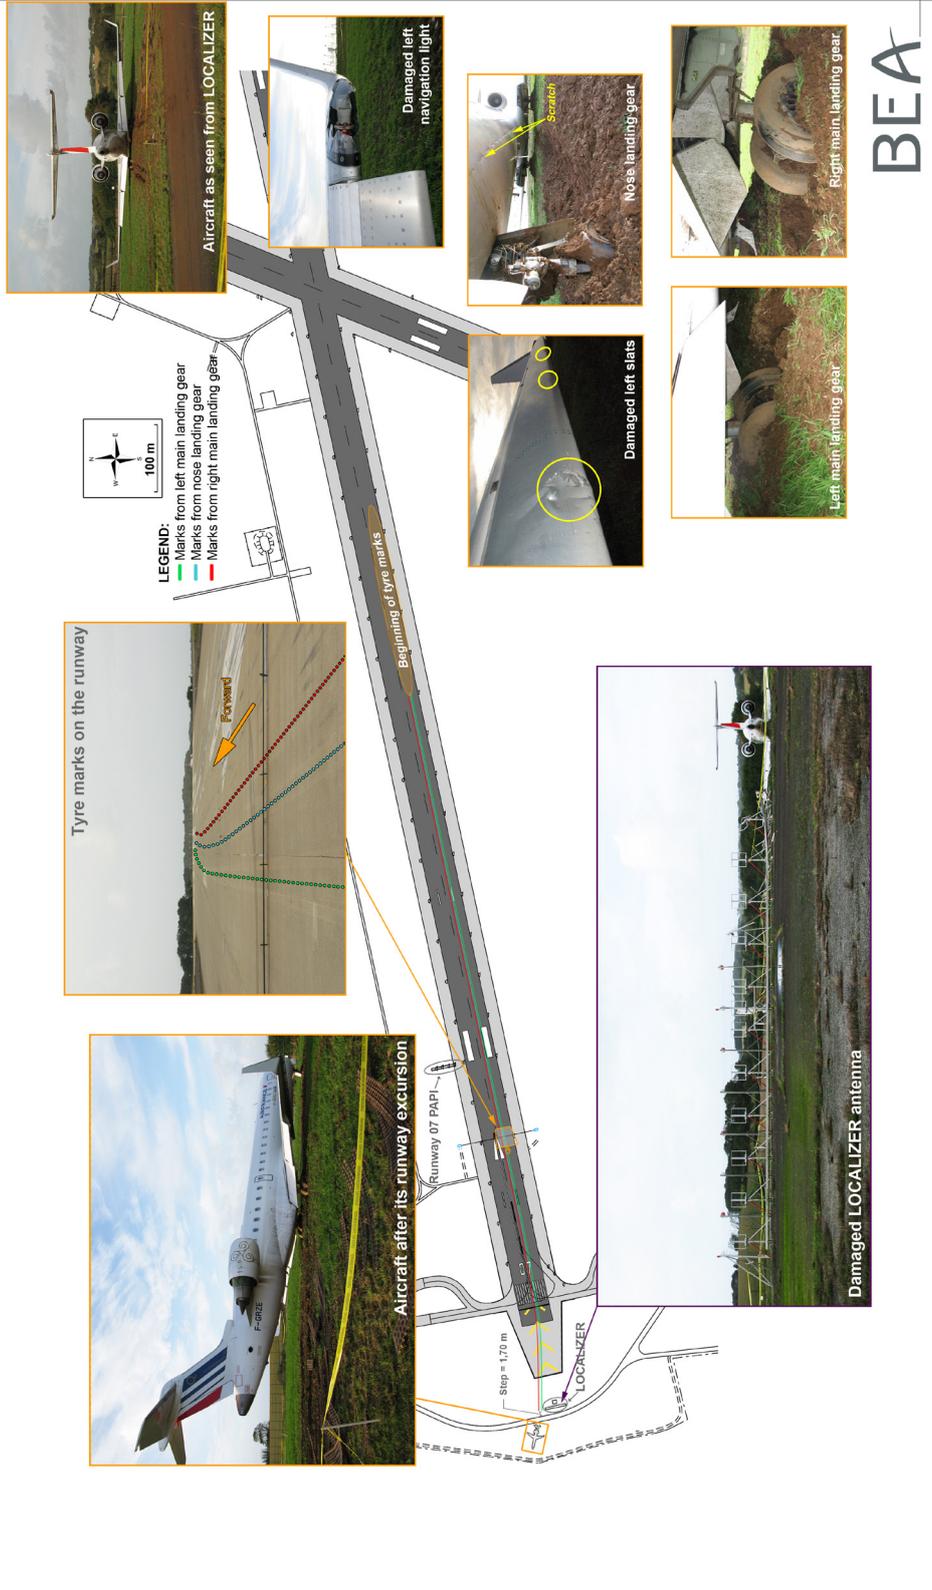
EXTENT OF DAMAGE ON SITE

The main landing gear and the nose gear suffered significant damage requiring their replacement.

Major structural damage was found.

The LOC antennae were damaged when the aeroplane collided with them.

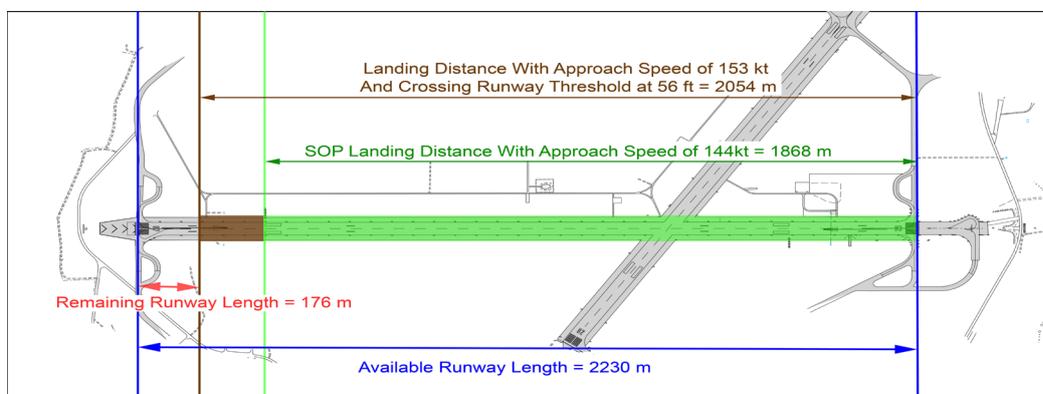
Under the event flight conditions, aeroplane performance would theoretically permit it to land on a contaminated runway, even if the remaining length of runway after the aeroplane came to a complete stop had only been 176 m.

The diagram below summarizes the previous results for the contaminated runway:

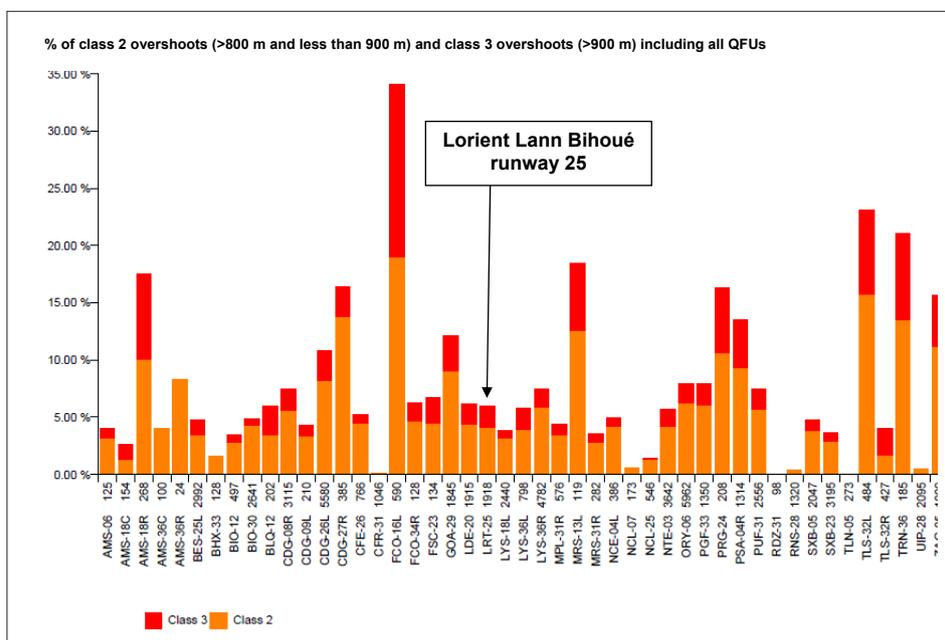
At the request of the BEA, the airline forwarded the graph for overshoots by CRJ-700 on runways where the LDA is less than 2,400 m. It shows that 551 out of 1,680 landings occurred more than 650 m from the threshold, i.e. 32.8% of the landings (see Appendix 9). In this classification, it can be seen that the largest number of overshoots occurred at Lorient Lann Bihoué.

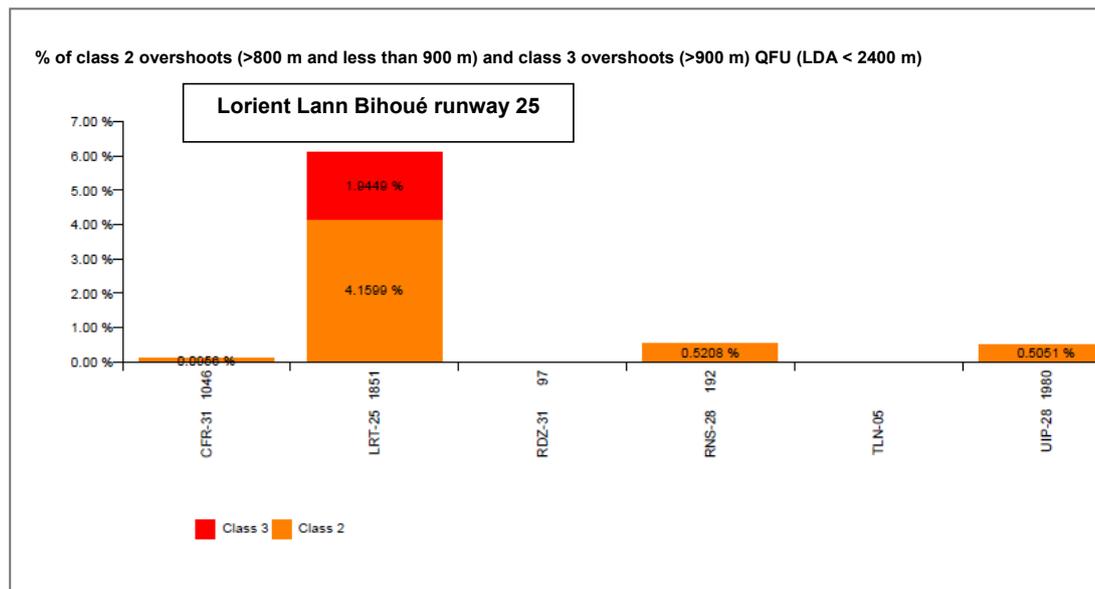
11 of the 12 landings more than 950 m from the threshold of runway 25 at Lorient Lann Bihoué did not follow a UA.

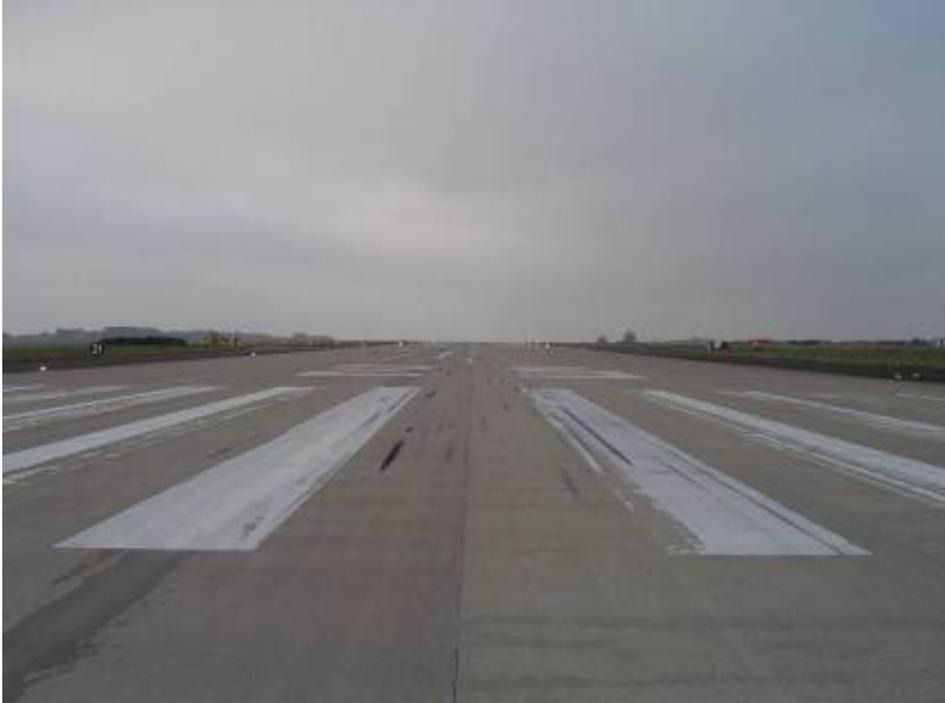
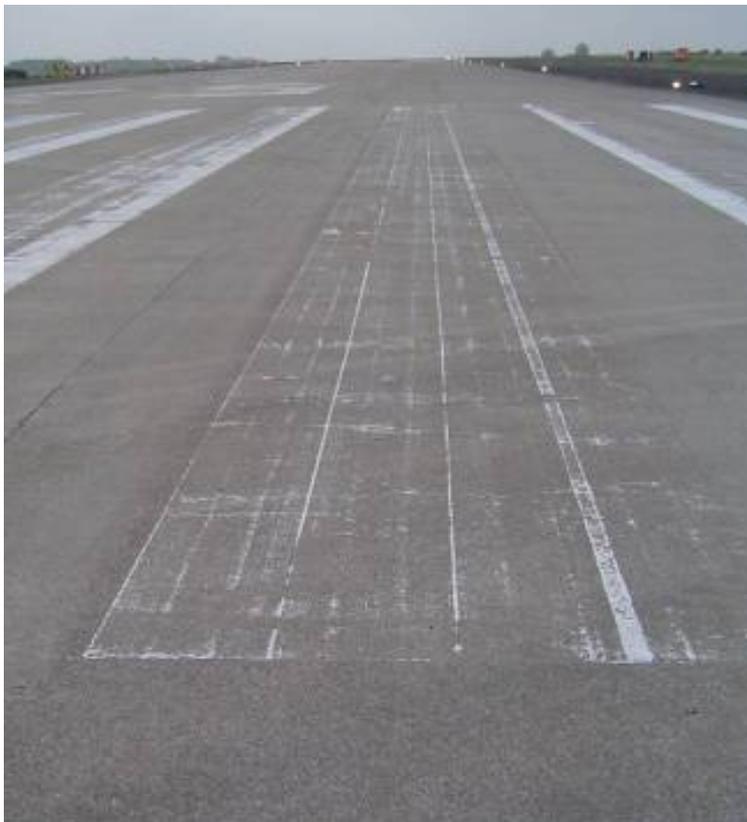
-Markings on the threshold of runway 25

- Deviation n°7: Presence of numerous rubber marks that mask the daytime markings and appear to alter the friction characteristics when the runway is wet.
- Deviation n°13: The daytime markings are generally in very poor condition and do not guarantee any contrast, even less so because the surface is made of concrete.
- Deviation n°14: There are no side markings on the main runway used for precision approaches.
- Deviation n°16: The markings for the touchdown zone on the main runway only measure 1.70 m wide (instead of 3 m minimum).

On 14 November 2012, an inspection of runway 25 showed that the ground markings lacked a significant amount of paint (see appendix 5).

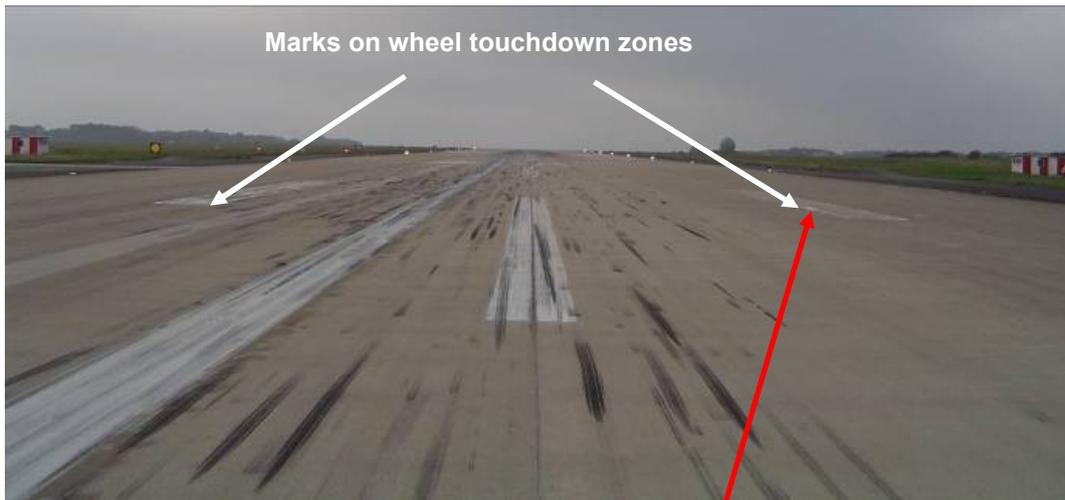
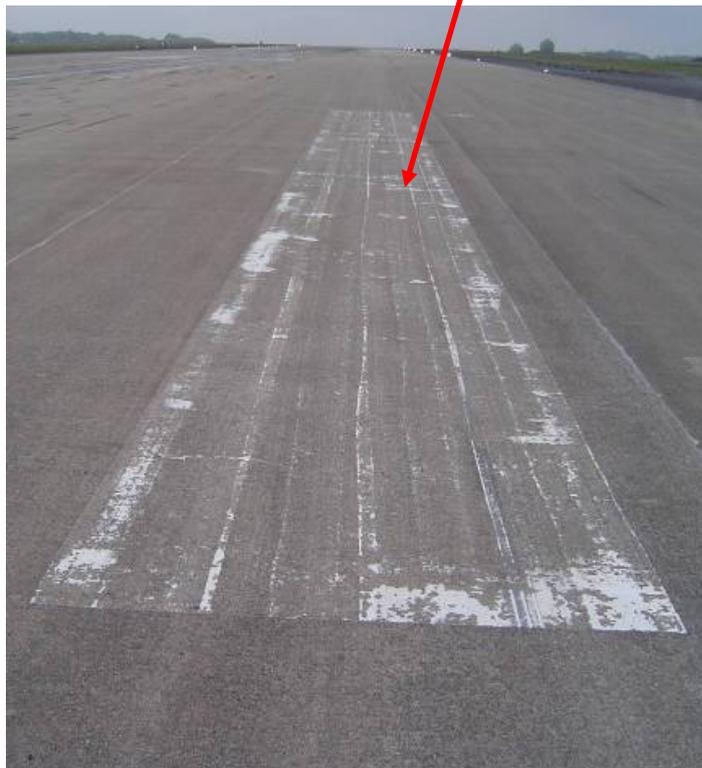
Wheel marks on touchdown zones 150 m from threshold 25

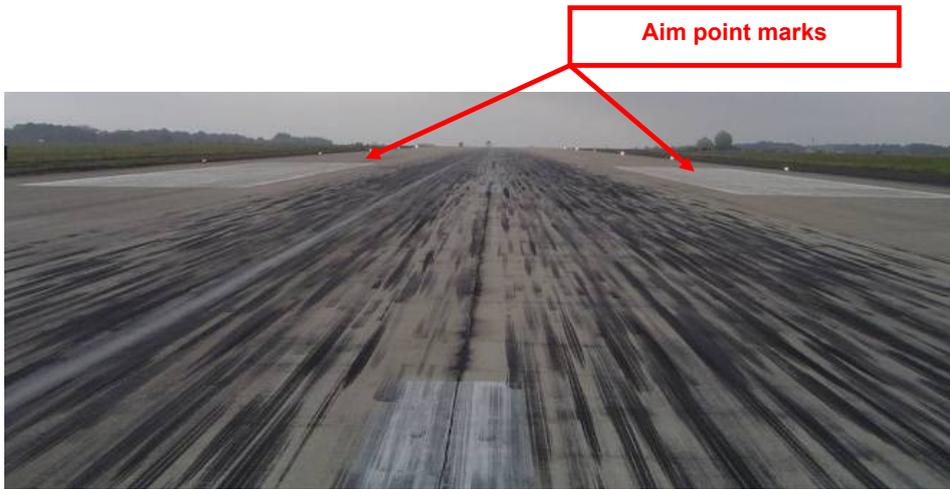
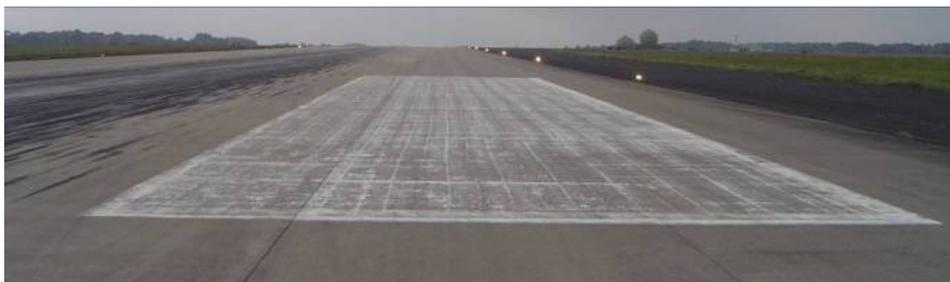
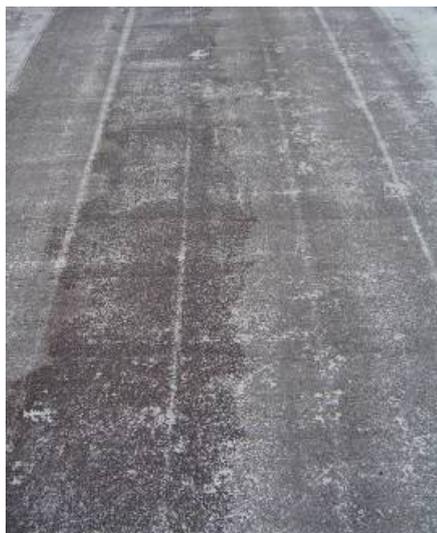
- Aim point marks and markings for the runway centreline

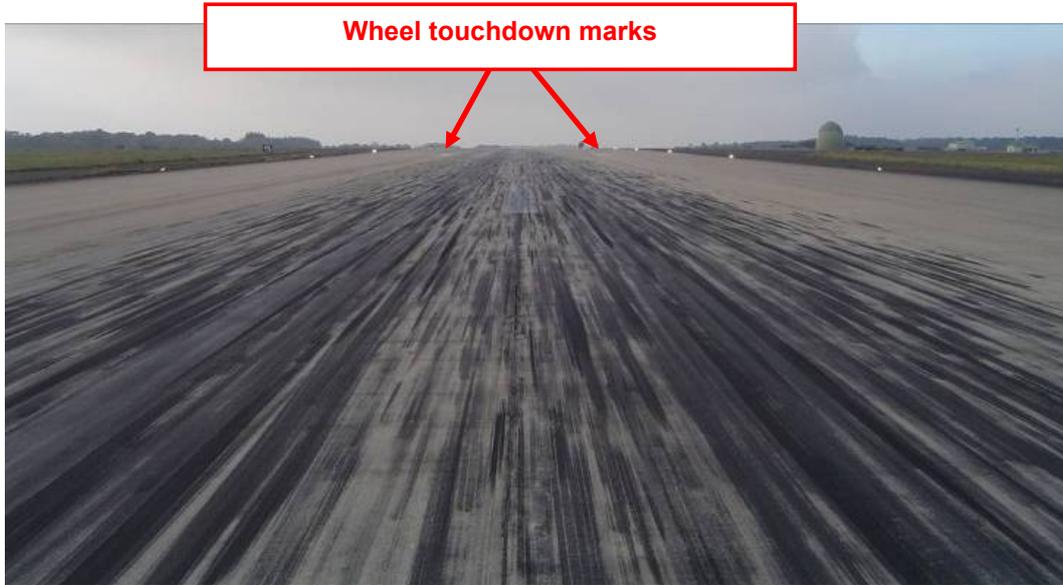
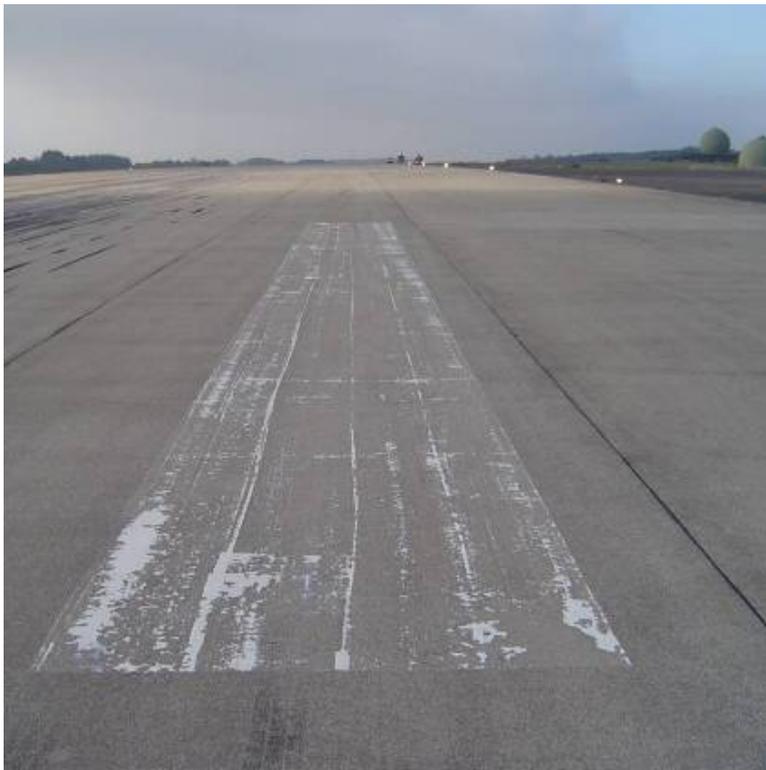
- Wheel marks on touchdown zones 600 m from threshold and runway centreline

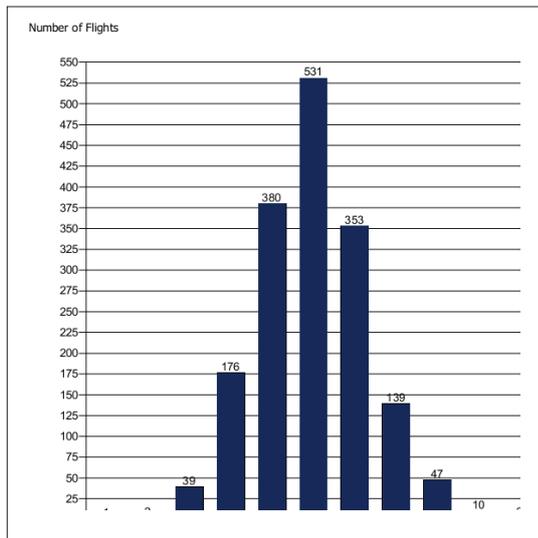
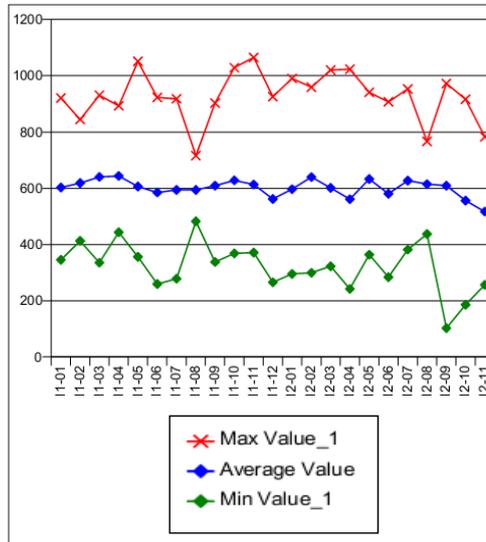
- Number of CRJ-700 long landings compared to the total number of CRJ-700 landings on runway 25 at Lorient Lann Bihoué from January 2011 to December 2012.
