Landing on an Occupied Runway

Aircraft	Dyn'Aéro "MCR Sportster" registered HB-YKH
Date and time	30 December 2012 at 15 h 10 ⁽¹⁾
Operator	Private
Place	Carcassonne Salvaza Aerodrome (11)
Type of flight	General aviation
Persons on board	Captain
Consequences and damage	None

This is a courtesy translation by the BEA of the Final Report of the Safety Investigation. As accurate as the translation may be, the original text in French is the work of reference.

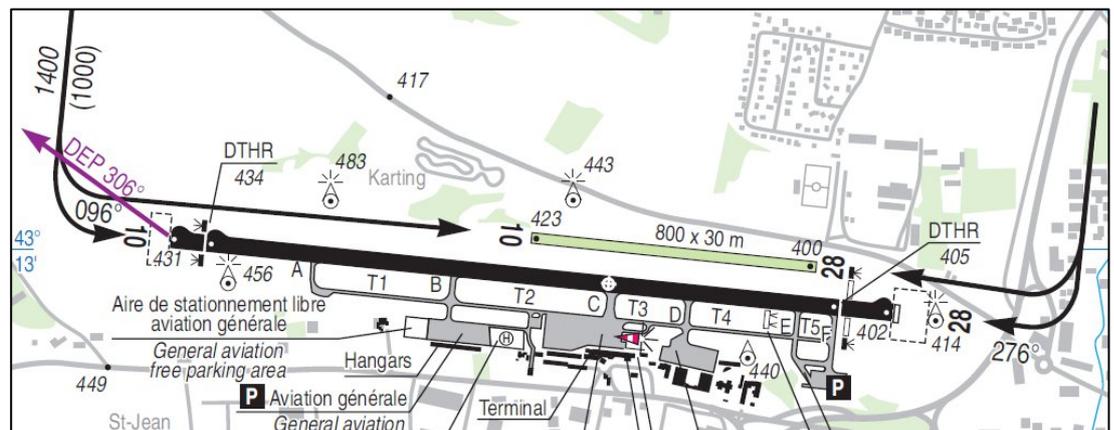
Extract from the Carcassonne Salvaza aerodrome VAC chart

The threshold of runway 28 is at an altitude of 402 ft; the runway then slopes up to about 425 ft in the middle, then to 431 ft at the end. The public transport aeroplane was between taxiways B and C when the MCR landed, that's to say about 7 m above the threshold of runway 28.
