**Unstabilised approach, triggering of GPWS and MSAW warnings,  
dual input, missed approach, at night under instruction**

<b>Aircraft</b>	Airbus A320 registered SX-BHV
<b>Date and time</b>	April 11 2012 at around 00 h 24 <sup>(1)</sup>
<b>Operator</b>	Hermes Airlines
<b>Place</b>	On approach to runway 36L at Lyons Saint-Exupéry airport (69)
<b>Type of flight</b>	Non-scheduled public transport of passengers
<b>Persons on board</b>	Student pilot-in-command (PF), instructor (PNF); 5 cabin crew members; 178 passengers
<b>Consequences and damage</b>	None

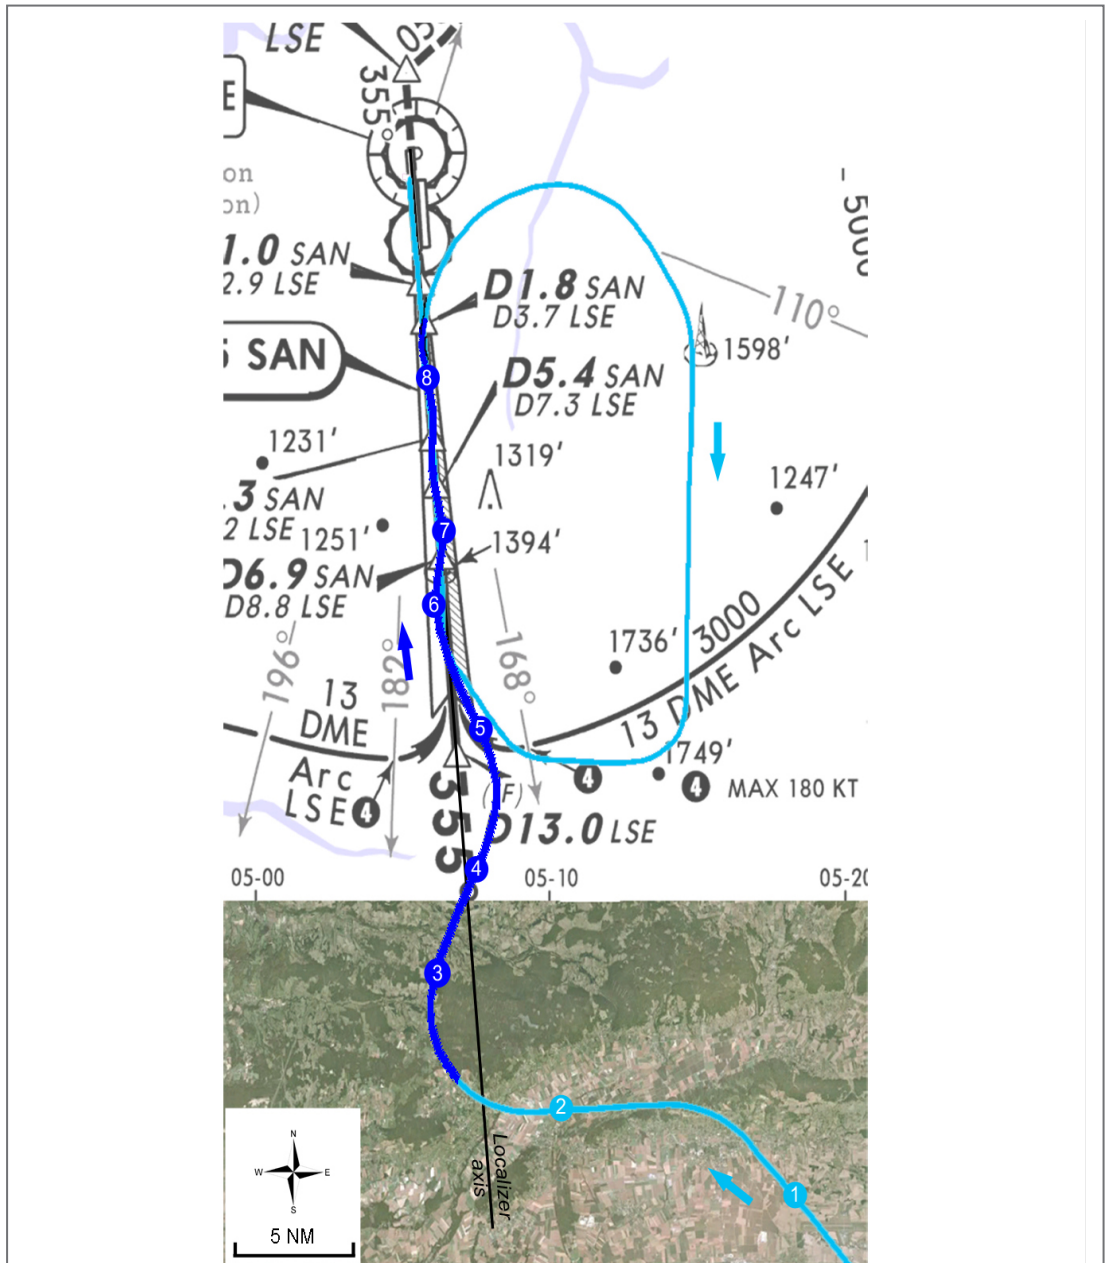
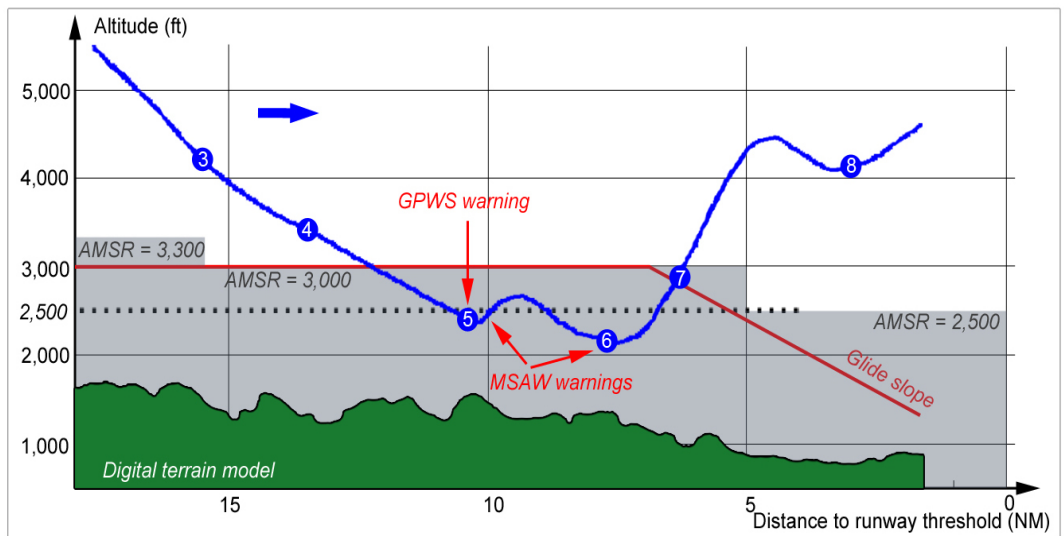
— SX-BHV flight path based on SSFDR data from 00 h 19 min until the end of the flight  
 Times are given in UTC

The controller specified a heading of 320° so that the aeroplane would intercept the localiser axis for runway 36L<sup>2</sup>. As the frequency of the ILS for runway 36L was not active, the aeroplane crossed the axis without intercepting it. About 30 seconds later, noting that the aeroplane had overshoot the axis, the controller ordered the crew to follow a right heading of 020°, to descend to 3,000 ft and then cleared them for an ILS approach to runway 36L. The PNF read back and asked the PF to set the frequency: "[Set the frequency, set SAN, ILS is SAN]<sup>(3)</sup>" The ILS frequency switched from 110.30 MHz (Ajaccio ILS frequency) to 110.75 MHz (ILS frequency of runway 36L at Lyons Saint-Exupéry)<sup>3</sup>. The aeroplane then crossed the localiser axis for a second time.

While the Capture mode engaged for a selected altitude of 3,000 ft at a speed of 240 kt, the crew decided to select an altitude of 400 ft on the control panel (FCU)<sup>4</sup><sup>(4)</sup>, which caused a mode reversion of the autopilot from ALT\* to VS 1200 ft/min, the current vertical speed of the aeroplane at that time. They set the approach mode and engaged the AP 2 autopilot. The crew turned left to intercept the localiser axis, and then the aeroplane descended below the radar minimum safe altitude of 3,000 ft.

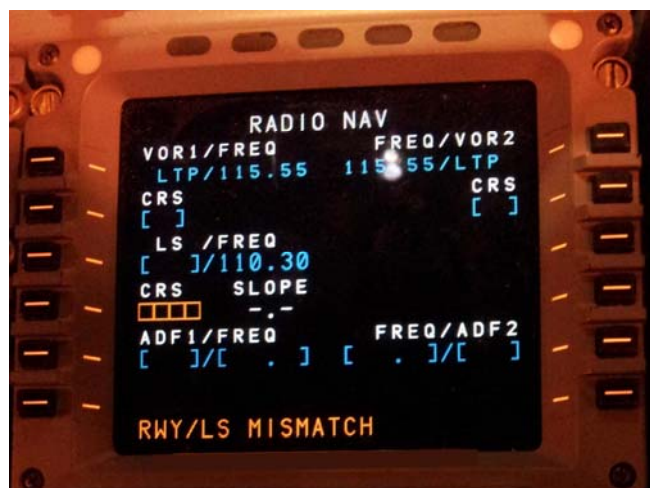
Where there is a difference between the frequency of the ILS approach FMGS entered manually and the RADIO NAV page, the post RWY / LS MISMATCH is displayed at the bottom of the MCDU screen (see example below).

In this example, the font size of the frequency automatically entered by the FMGS (e.g. VOR1 and 2) is by default smaller than that manually entered (e.g. ILS).
