INTERSTATE AVIATION COMMITTEE
AIR ACCIDENT INVESTIGATION COMMISSION

FINAL REPORT
ON RESULTS OF INVESTIGATION OF ACCIDENT

Type of accident	Fatal accident
Type of aircraft	ATR72-201 aeroplane
Registration	VP-BYZ, Bermudas
Owner	BLF Limited
Operator	UTAir Aviation, JSC
Place of accident	1500 m from RWY 21 threshold; cross-track deviation about 400 m, Roschino aerodrome, Tyumen. Coordinates: N 57°09.440' E 065°16.000'
Date and time of accident	02.04.2012, 01:35 UTC (07:35 local time), day time

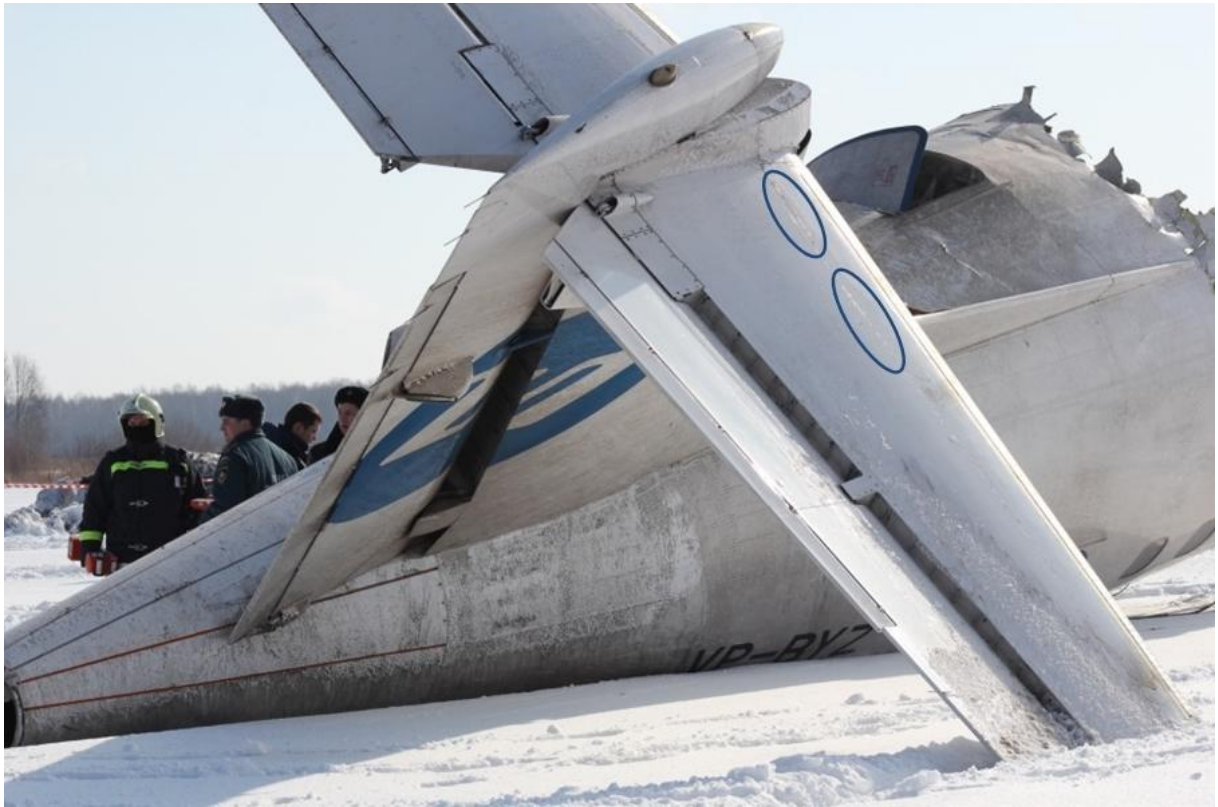
No traces of ice contamination were observed at the fuselage rear section and at the vertical stabilizer at the time of their inspection. However the examination of photographs taken during the first hours after the accident revealed some snow and ice contamination residues on the horizontal stabilizer right side. The residual snow and ice contaminants are located along the front spar of the stabilizer that was the "cold accumulator" within the period of the aircraft parking that is on this area the contamination must be more abundant. (see Figure 1).

Figure 1. Horizontal stabilizer right side with traces of snow and ice deposits

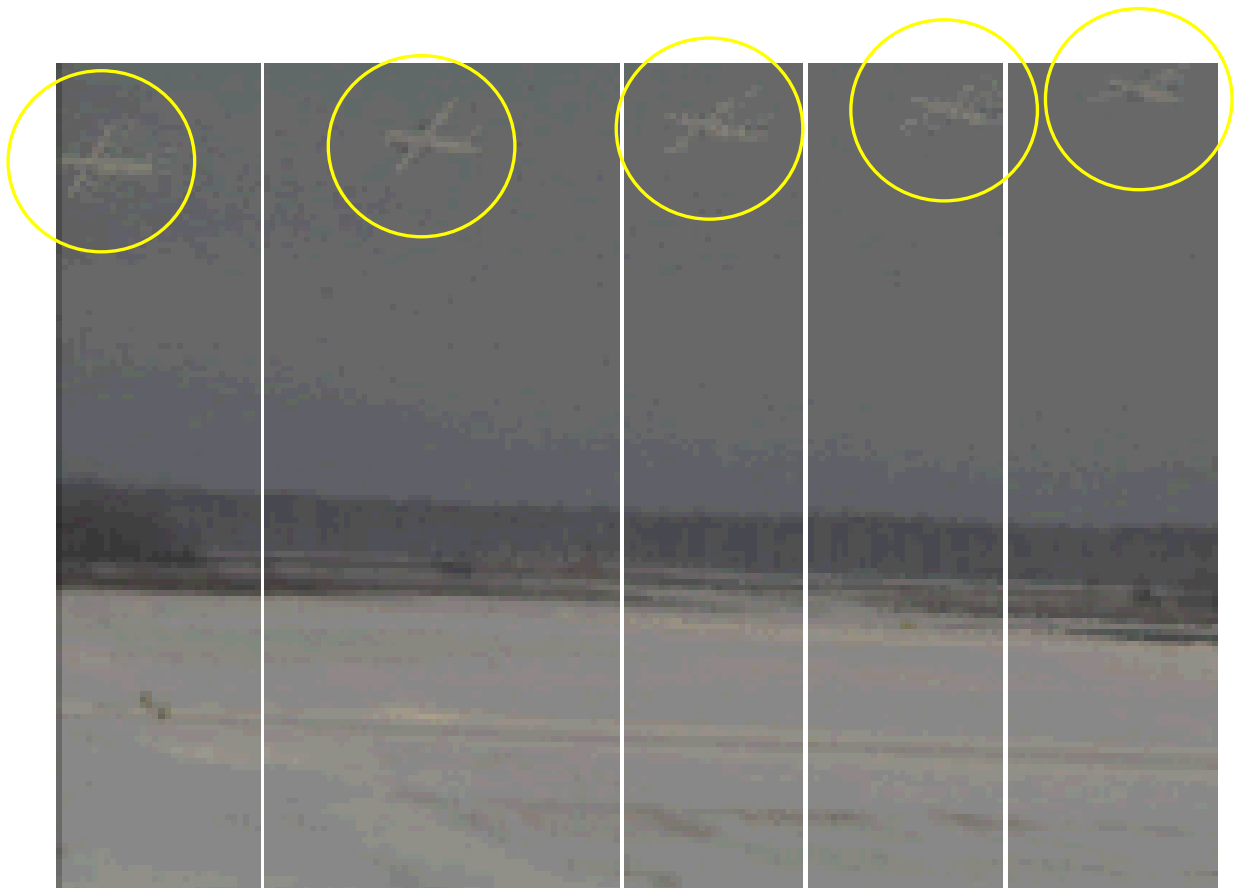
Figure 28. The trajectory of the A/C after the takeoff with developing left bank and descent

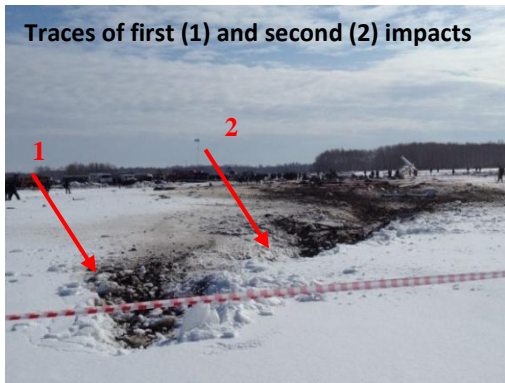
Figure 33.

The initial ground impact was with the LH outer wing and resulted in the outer wing destruction. The initial impact “spot” dimension is 1.6 x 4 m.

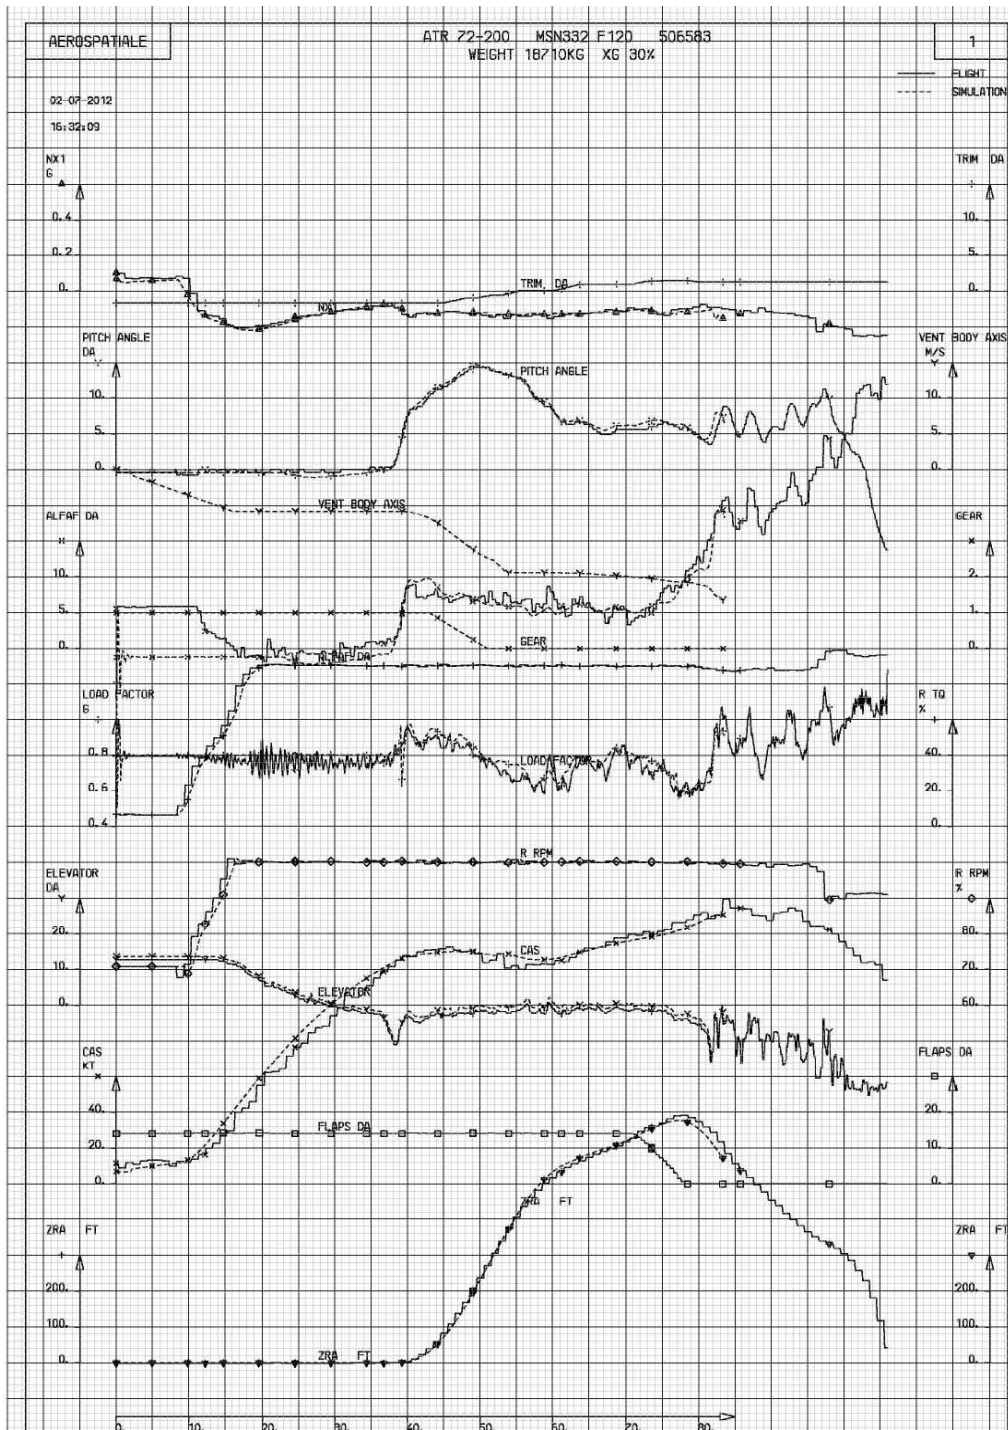
At the next stage of the simulation the lift and drag were modified to make the simulation match the DFDR data taking into account the actual flight control inputs and thrust (Figure 45).

Figure 45. Simulation compared to FDR Flight UTA-119 – with extra drag and lift

The simulation revealed that during the takeoff run at angle of attack near 0° , a loss of lift and an increase of drag were $\Delta CL_0 = -0.23$ and $\Delta CD_0 = 0.05$ (Figure 46). The graph analysis shows that at that phase of flight CL was reduced by approximately 25%, while drag was doubled. Further after the landing gear retraction the loss of lift remained more or less constant, while the drag increased with angle of attack, providing a $\Delta CD_0 = 0.064$ (Figure 46). After the flaps retraction the loss of lift still remained almost constant, while the drag increasing was $\Delta CD_0 = 0.05$ (Figure 47).

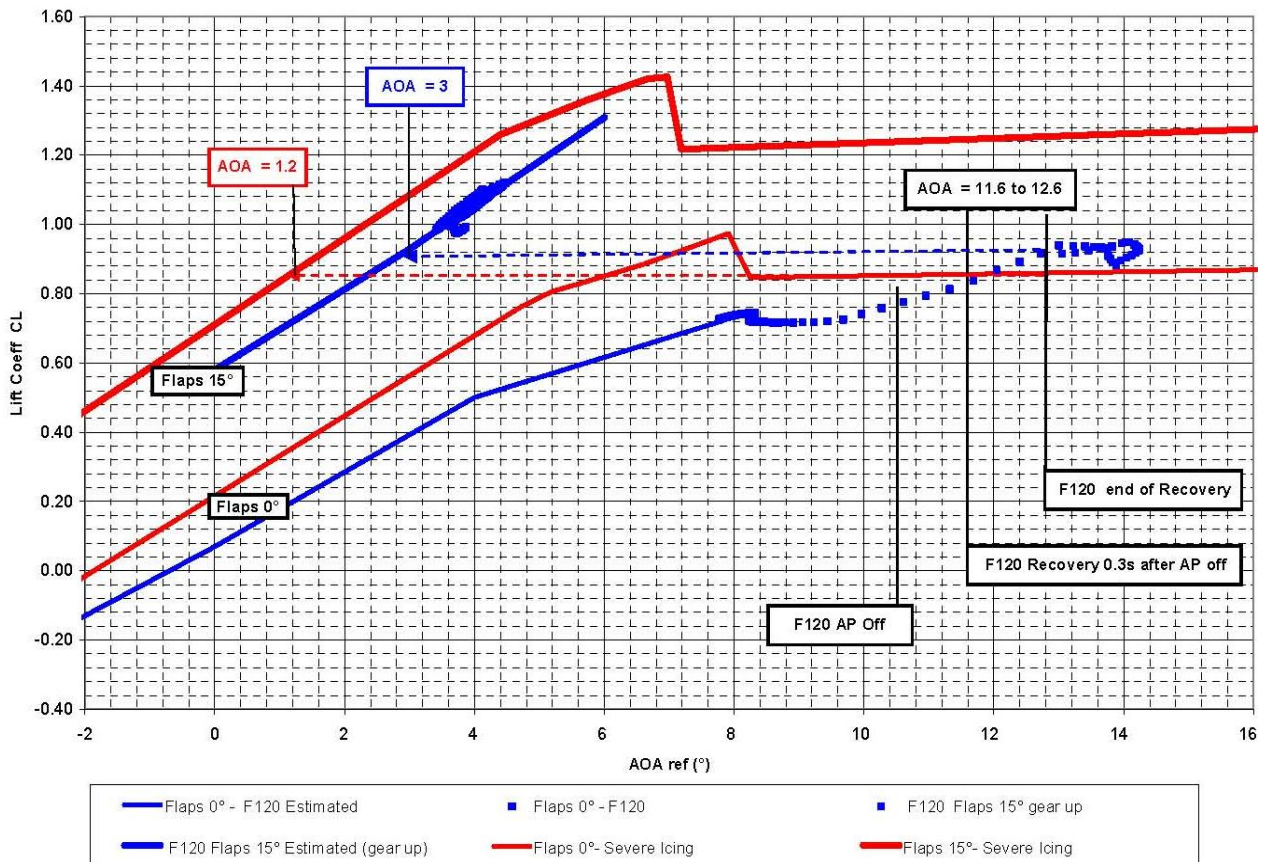
The effect of the flaps extension (in the way it reduces the required angle of attack to reach the same CL) is comparable. Thus, the FFS test findings can be used to assess the possibility to recover the aircraft performance after the stall in the accident flight.

Figure 50. FFS (severe icing) and FDR performance compared

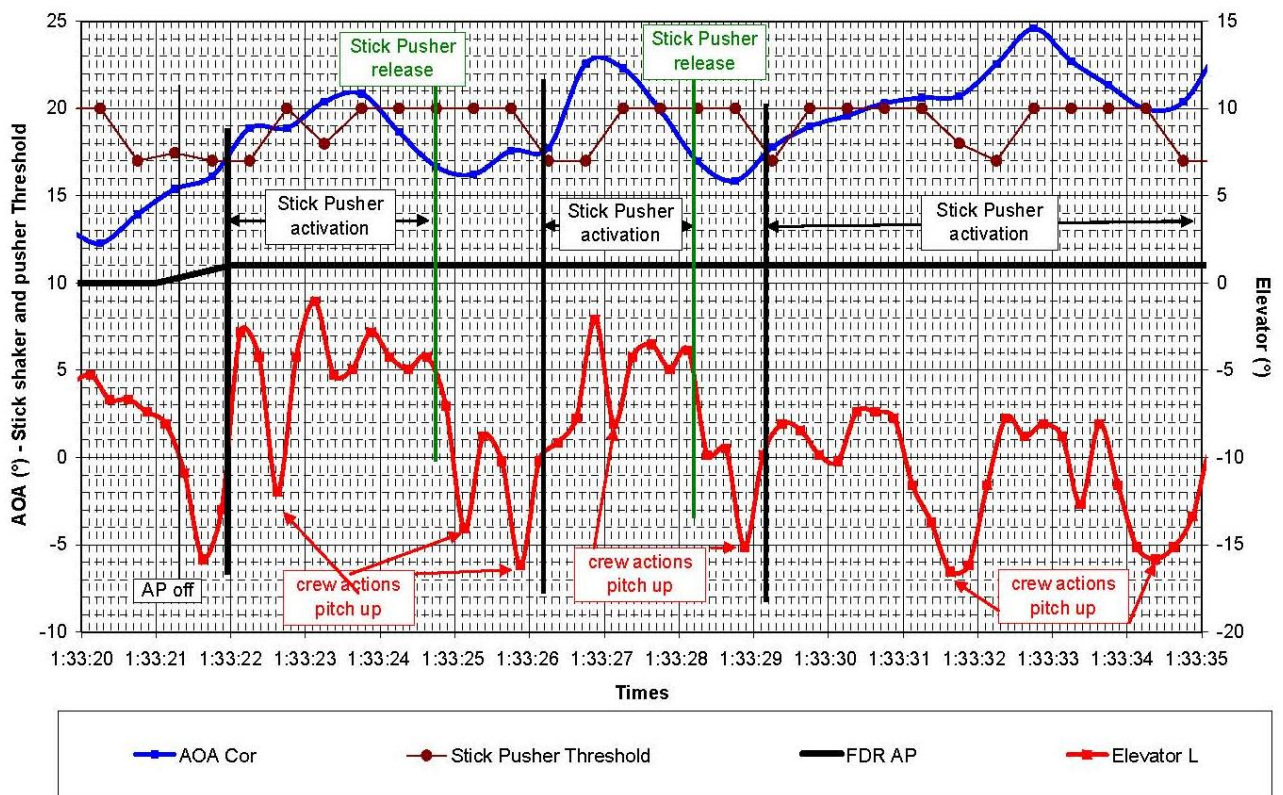
According to the analysis, while the emergency developed, the conditions for stick pusher activation were met several times (Fig. 53)²⁶. At the same time, it is necessary to note that the activation of the pusher is inhibited at the radio altitude less than 500 ft (after the time instant 01:34:16.5 of the accident flight), at that the inhibition in question is armed during the climb of the radio altitude more than 500 ft after takeoff (in the accident flight the maximum registered radio altitude was 701 ft at 01:34:06.5). The analysis of the record, given on Figure 53 shows that the first pusher activation occurred at 01:34:11 (в 01:33:22 by the time on Figure 53), at that the crew resisted the pusher operation (the elevator deflection to nose down). The force that is necessary to apply on the control column to “overpower” the pusher is equal to 30-50 daN (depending on the elevator position). After the force from the control column is released and if activation conditions are still met the pusher will continue to deflect control column to pitch-down.

Figure 53. The estimated times of the stick pusher activation

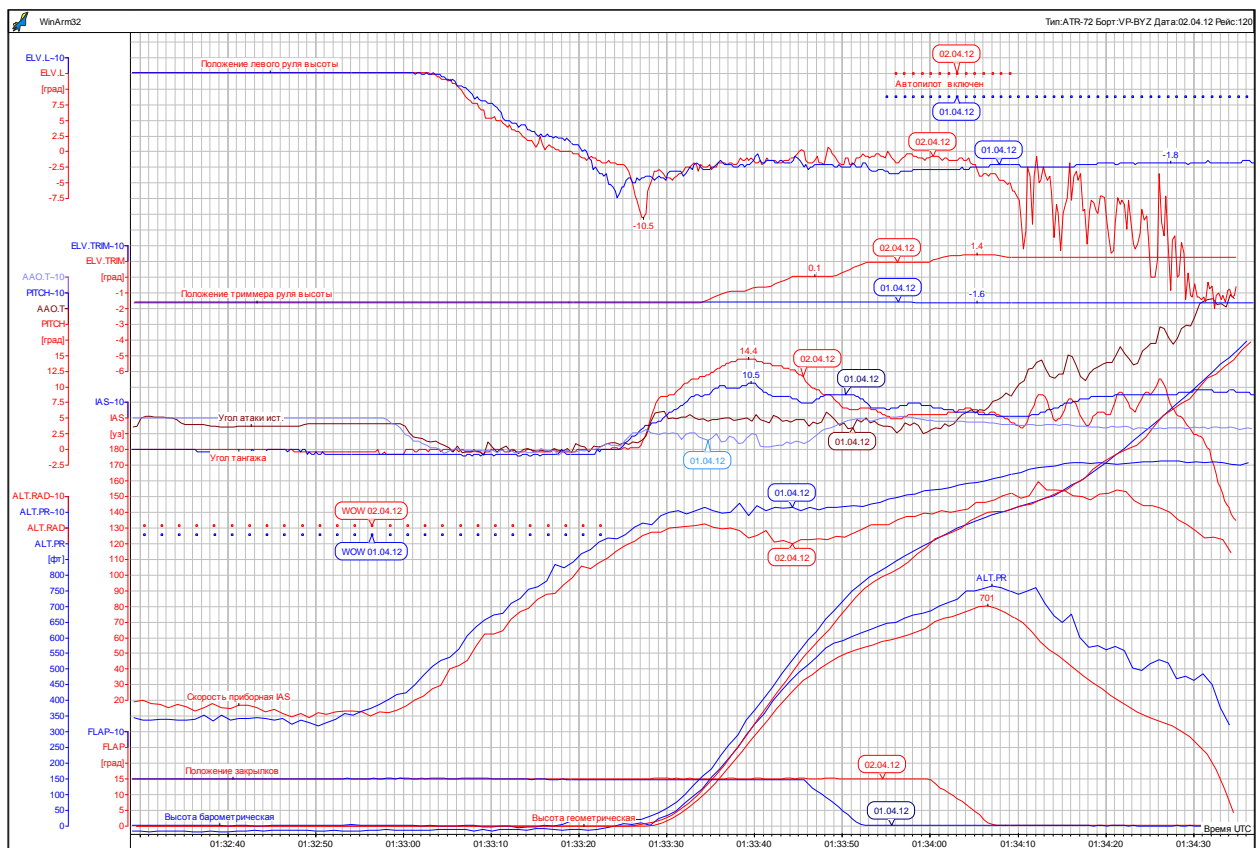
The comparison of the climb envelopes after takeoff (Figure 54) for the accident and the previous flight (TOW ~ 19350 kg, OAT $+6^\circ$) shows, that in the previous flight with greater TOW, with the same engine operating mode, a significantly smaller angle of attack value was necessary to climb with a greater vertical speed, meanwhile the speed in the previous flight also increased faster.

Figure 54. The comparison of the climb envelopes in a previous and accident flight

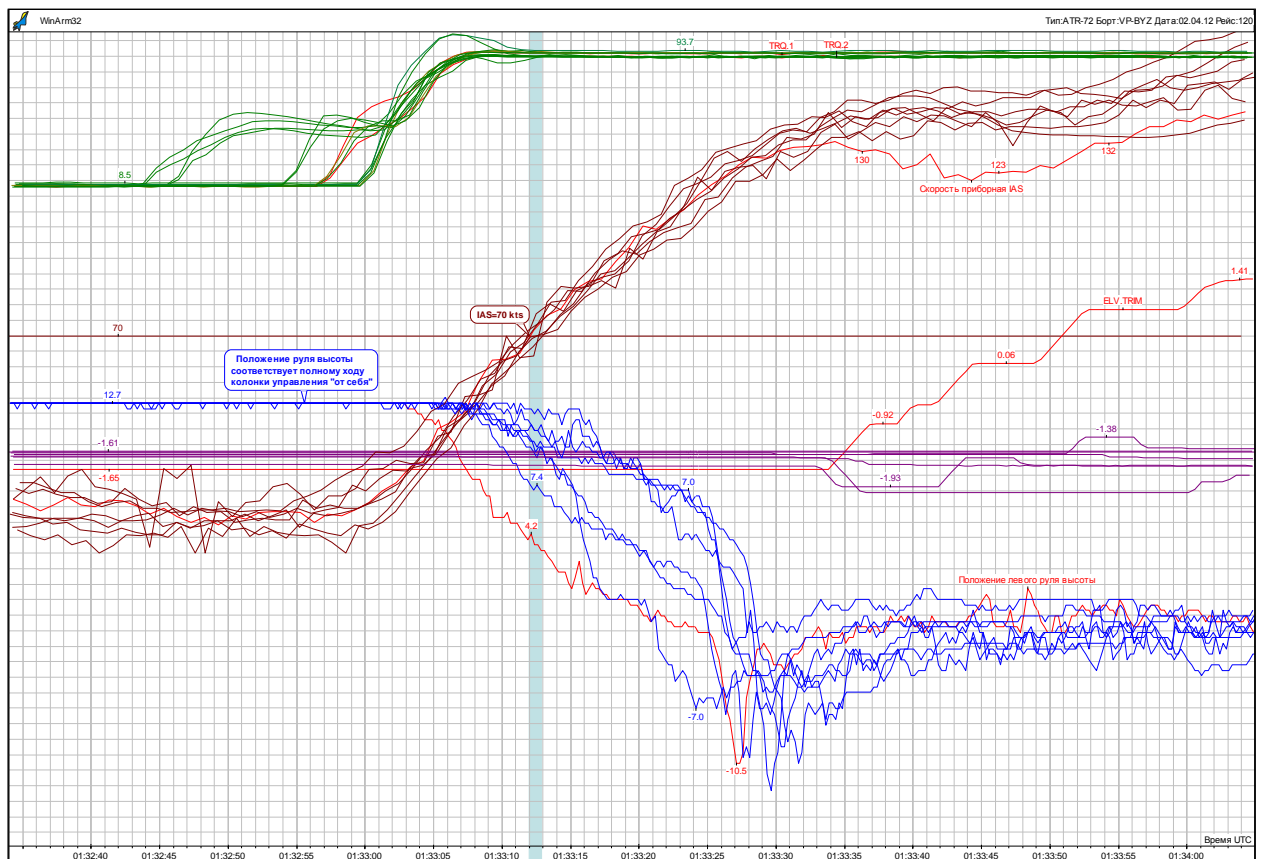
Figure 55 shows the changes in the elevator position in some flights with the elevator trim $\approx -1.65^\circ$ nose up. As it can be concluded from the graph, at the initial phase of the takeoff run (up to the speed of 70-80 knots, when pilots hardly apply any forces on control column in pitch, that is the elevator is deflected under the effect of hinge moment) the way the elevator position was changing in the accident flight with the speed (hinge moment) increase is significantly different from the other flights, which confirms the difference in the air flow over the stabilizer and the elevator.

Figure 55. The comparison of the elevator deflection at the takeoff run with the elevator trim position $\approx -1.65^\circ$

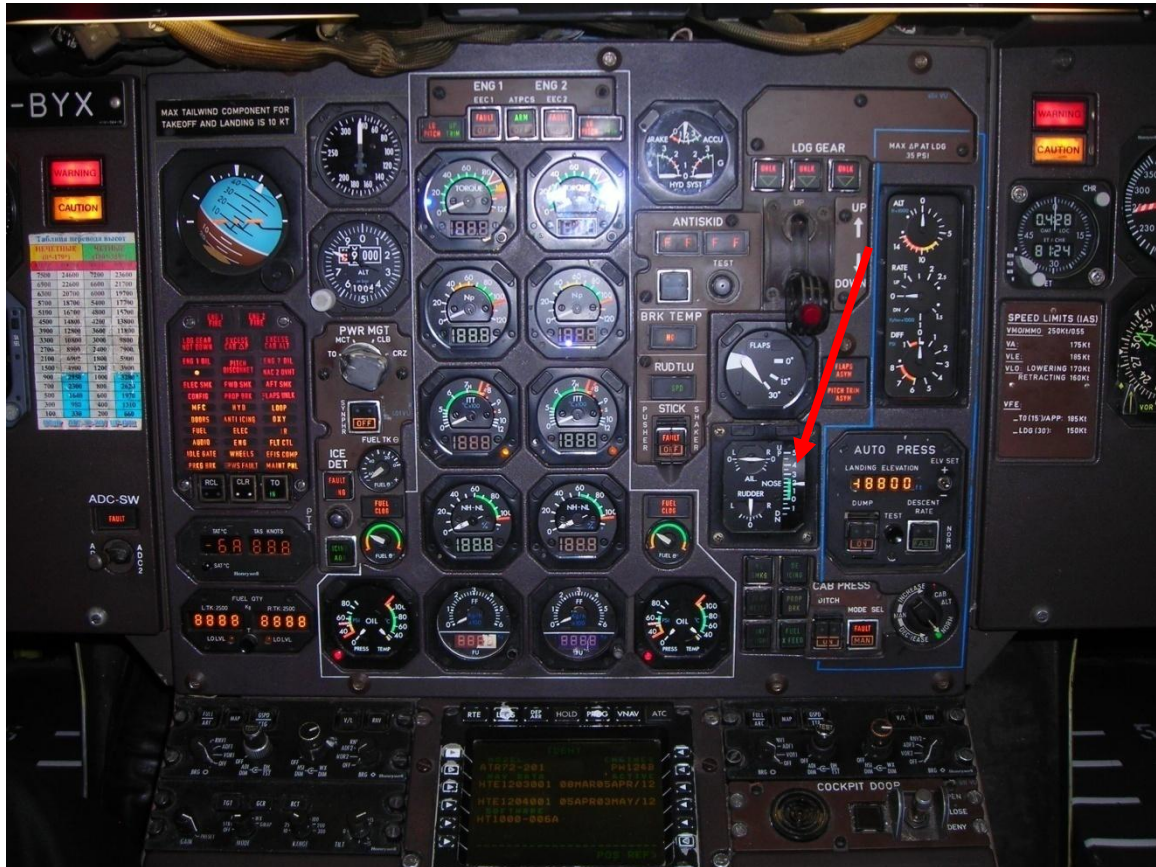
Altogether, from the moment of the engines start-up and till the rise of the emergency the SOPs were fulfilled. It should be pointed as a shortcoming that before the flight the elevator trim was set by the crew incorrectly. The actual trim position (-1.65° , nose up) did not comply with the estimated one for CG 30.72% MAC ($\approx -0.7^\circ$, nose up), however the trim position was in a green zone permitted for takeoff (Figure 59).

Figure 59. The instrument panel with the indication of the elevator trim position
