Bounce on landing in strong wind, go-around and collision with terrain

Aircraft	Cirrus SR22 registered F-HTAV
Date and time	11 May 2013 at about 16 h 20 ⁽¹⁾
Operator	Private
Place	Aix les Milles (13) aerodrome
Type of flight	General aviation
Persons on board	Pilot; 2 passengers
Consequences and damage	Pilot killed, one passenger injured, aeroplane destroyed

This is a courtesy translation by the BEA of the Final Report on the Safety Investigation. As accurate as the translation may be, the original text in French is the work of reference.

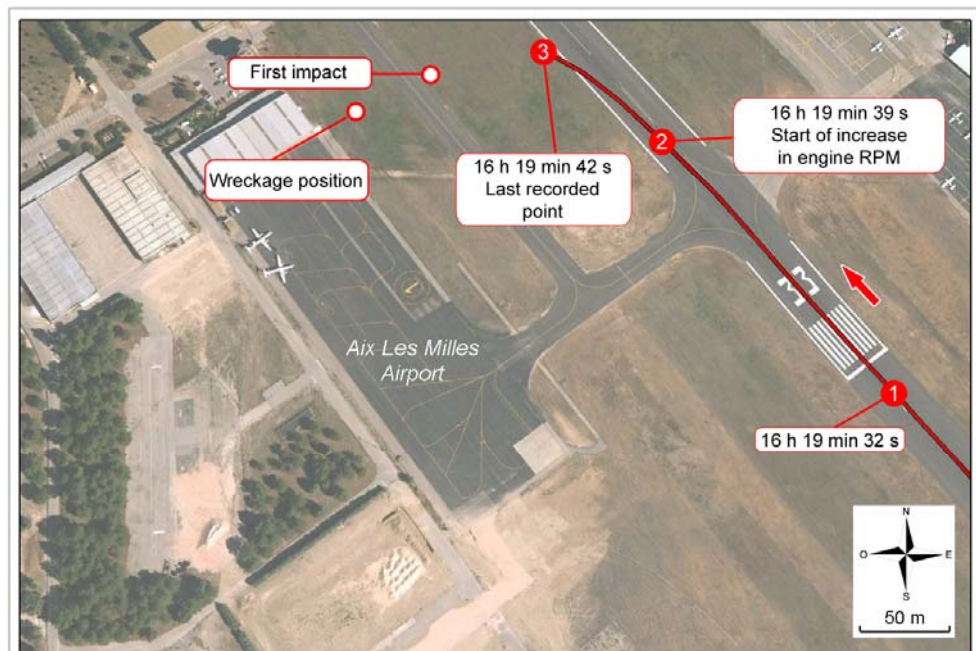
It crossed the taxiway perpendicular to it and came to a halt on its back in front of the hangar at the foot of the control tower.

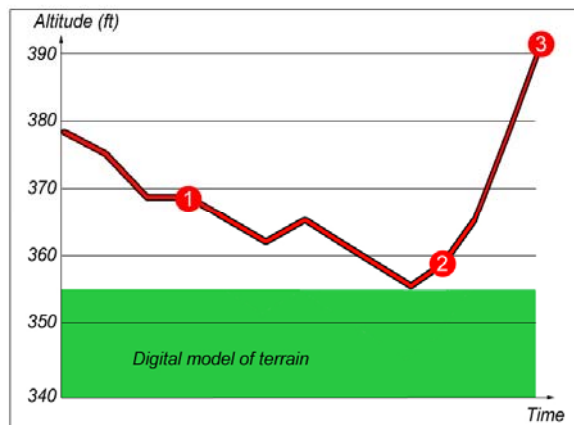
— End of F-HTAV flight path based on Garmin 1000 data

*Times are local
Altitudes on the vertical section have been adjusted to take into account the QNH on the day (1014) and the fact that the aeroplane touched the runway*
